March 7, 2024

MIR-24-05

Fire aboard Fishing Vessel *Marlins II*

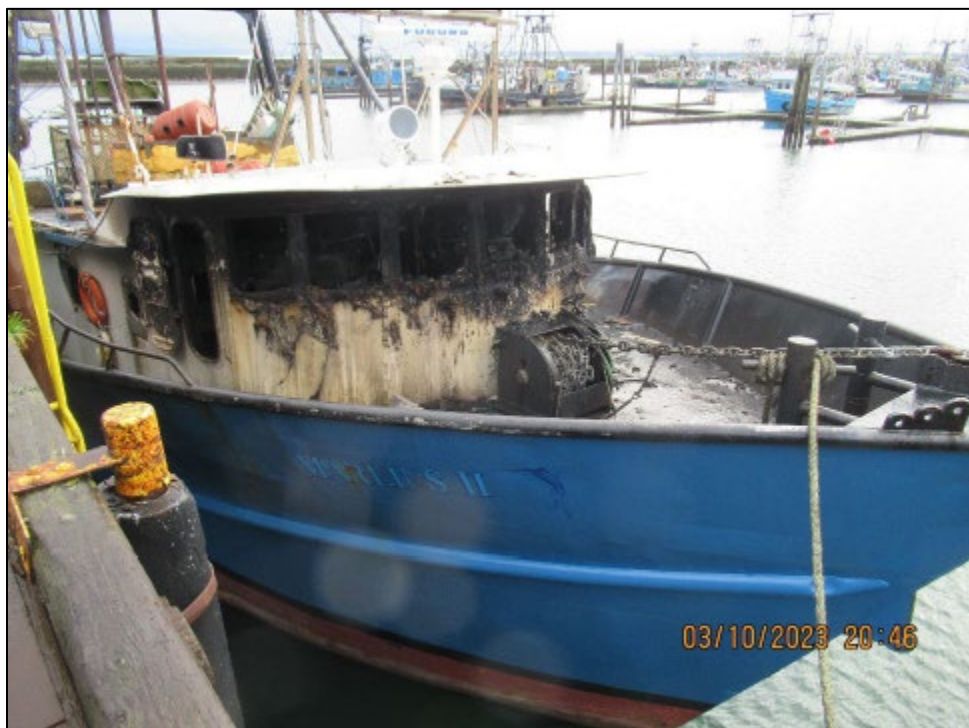
The *Marlins II* had a hull and superstructure of steel construction; however, the vessel's internal accommodation spaces were wood framed and paneled. The fire department indicated that, initially, smoke and flames appeared to be coming from the vessel's galley area. The fire eventually spread to the remainder of the accommodation spaces and the wheelhouse. At 2113, the fire department extinguished the fire, and they departed the scene at 2344. The fire resulted in \$950,000 in estimated damage to the vessel (see figure 3).

Figure 3. The burned-out *Marlins II* after the fire. (Source: Blomquist Marine Surveys)

The fire on the moored *Marlins II* began about 6 hours after the captain hooked up shore power and departed the vessel. The fire consumed most of the vessel's interior accommodation spaces and wheelhouse. A certified fire and explosions investigator ruled out that the fire started from discarded smoking materials, a lightning strike, or from an issue with the shoreside power supply. He concluded that the fire originated from within the vessel's galley near a chest freezer that had been plugged into an extension cord and energized before the fire. The examination report stated that the cause was most likely a failure of the extension cord that was powering the freezer.

The National Transportation Safety Board determines that the probable cause of the fire on board the fishing vessel *Marlins II* was the failure of an extension cord used to energize galley appliances when on shore power.
