April 15, 2024 MIR-24-09

# Contact of Tank Vessel Bow Triumph with Pier

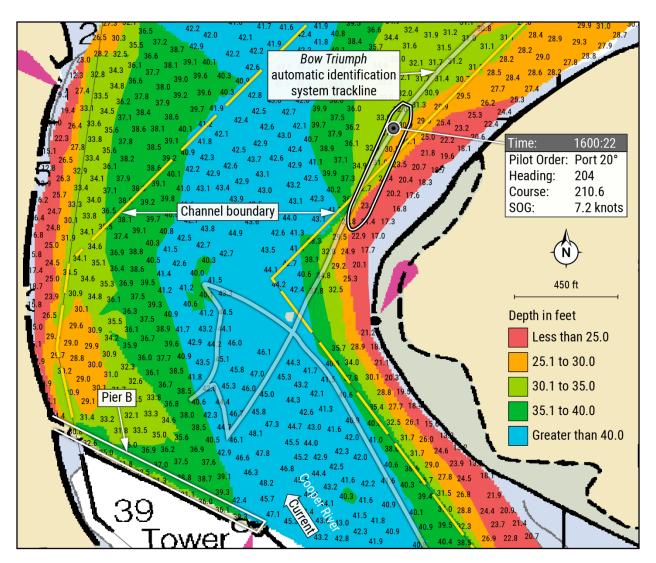
The pilot ordered full ahead at 1600:11, increasing the propeller rpm, and rudder midships at 1600:14. After ordering the rudder to port 20° at 1600:22, he noticed that the "rate of turn was not increasing" (see figure 4). The pilot ordered increased port rudder orders at 1600:31 and 1600:58, and then a full Becker rudder (the main rudder was at 45°, and the flap was at an angle of 90° to the ship's centerline), at 1601:08.<sup>4</sup>

**Figure 4.** Position of the *Bow Triumph* (approximate scale) at 1600:22, based on automatic identification system (AIS) data, about the time the pilot noticed that the rate of turn was not increasing. Pilot order is from the vessel's voyage data recorder (VDR). Soundings (in feet) were recorded during the September 6, 2022, Corps of Engineers survey.

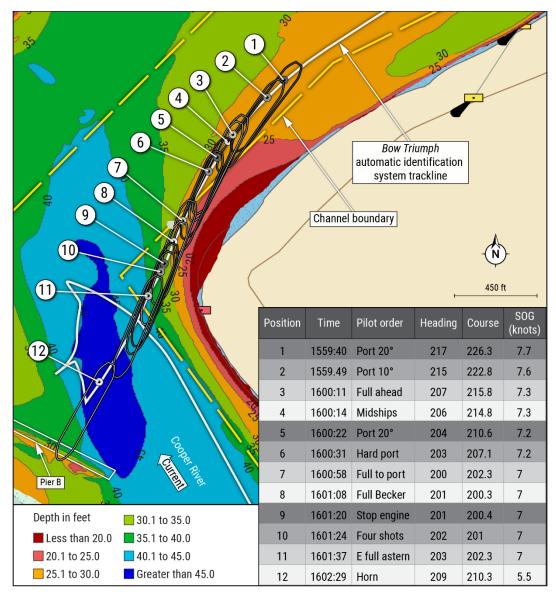
Between 1600:22 and 1601:24, as the vessel drew nearer the left bend, its heading had only changed 2° to port and the vessel's course over the ground showed an increase of about 10° to port as it drew closer to the left bank. At 1601:24, as the vessel was not turning as he expected it to, the pilot gave the order to drop anchor. Less than 1 minute later, at 1602:20, the *Bow Triumph*'s bow struck Pier B at a 90° angle (see figure 5).

**Figure 5.** Positions of the *Bow Triumph* (approximate scale) approaching Pier B at Naval Weapons Station Charleston in the minutes leading up to the casualty, based on AIS data. Pilot orders are from the vessel's VDR. Soundings (in feet) were recorded during the September 6, 2022, Corps of Engineers survey.

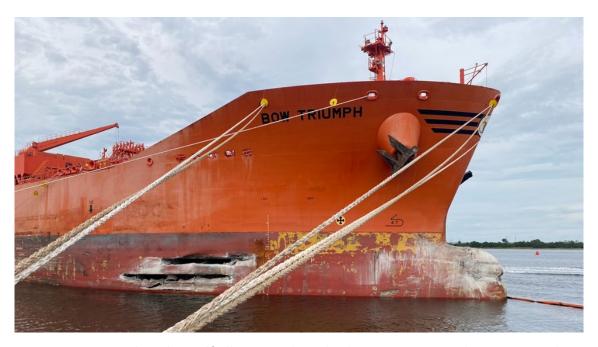
Damage to the *Bow Triumph* included a punctured bulbous bow and damage to side shell, frames, and stringers in way of the forepeak ballast tank and the no.1 starboard ballast tank, which compromised the watertight integrity of the hull (see figure 6). A September 7, 2022, diver survey report noted small areas on the keel, port of the centerline, where there was no marine growth and the hull plate coating (paint) was missing. The total cost of repairs was estimated at \$2,459,570. The cost to demolish and reconstruct the damaged portion of Pier B was estimated at more than \$27 million (see figure 7).

**Figure 6.** Bow Triumph at the Odfjell Terminal in Charleston on September 8, 2022, showing damage to the vessel's starboard side. (Source: US Coast Guard)

The vessel's classification society allowed the *Bow Triumph* to proceed directly to a shipyard in Florida for permanent repairs after temporary repairs were made in Charleston.

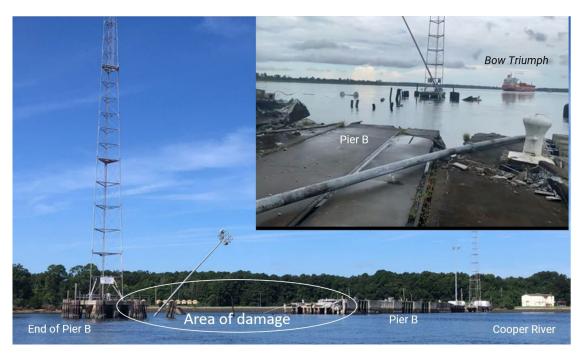
A 300-foot section of the pier collapsed after it was struck by the *Bow Triumph*. The pilot backed the *Bow Triumph* out from the debris with the assistance of the tugs *Capt. Jim McAllister* and *Jefferey McAllister* and ordered the anchor hauled in (1 shot of anchor chain).<sup>5</sup> At 1616, the pilot began conning the ship downriver without tug assistance. The vessel arrived at the Odfjell Terminal on the Cooper River at 1703.

**Figure 7.** Pier B damage. Inset: Witness photograph taken shortly after the contact. (Sources: Corps of Engineers, Jacob Wall [inset])

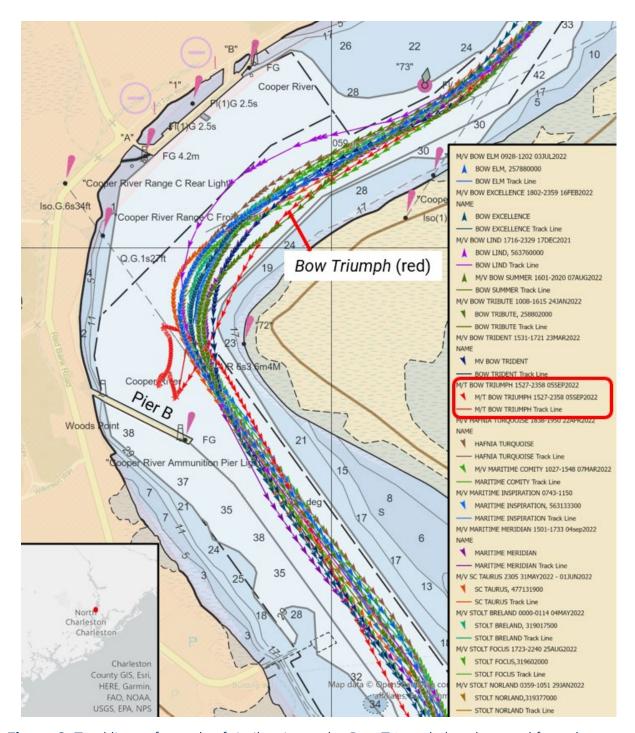
AIS data of the *Bow Triumph* and 14 other vessels of similar size and draft that departed from the INEOS Aromatics Terminal in the 12 months before the casualty show that the *Bow Triumph* pilot attempted to pass the closest to the bend (see figure 8).8 When asked about his trackline, the pilot told investigators that he did not intend to cut the corner. He envisioned a gradual turn through the bend with the flood tide pushing him toward the west bank as the bow entered Range C.

**Figure 8.** Tracklines of vessels of similar size to the *Bow Triumph* that departed from the INEOS Aromatics Terminal within the 12 months before and including September 5, 2022, plotted in the Cooper River near Joint Base Charleston. (Source: Coast Guard)

All the other vessels of similar size and draft departing the INEOS Aromatics Terminal in the previous 12 months approached the bend nearer the center of the channel than the *Bow Triumph* did on its casualty transit, and all were able to safely navigate the bend (see figure 8). Transiting in the center of the channel is prudent to avoid the risks associated with bank effect.
