MIR-24-13

## Fire aboard Passenger Vessel *Lady Delray*

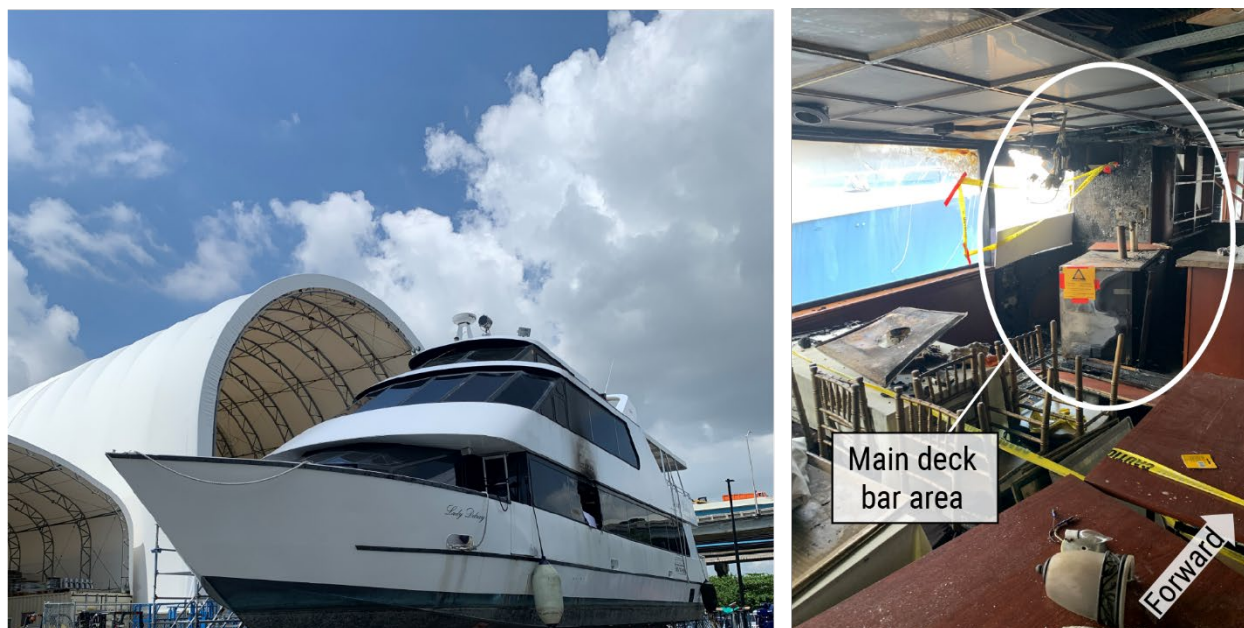
Most of the fire damage to the *Lady Delray* was concentrated on the main deck near the bar area on the port side of the vessel (see figure 3). Smoke, soot, and radiant heat damage from the fire extended out from this area to nearby galley cabinetry, plastic and wood paneling on the overhead and bulkheads, and the deck above. Several of the main deck windows were broken during the firefighting, and firefighting water saturated most of the interior spaces on the main deck and drained into the engine room bilges. Additionally, a surveyor for the vessel's owner stated that the electrical circuitry in the main deck galley area, as well much of the galley equipment itself, was damaged from the fire and would need replacement. The vessel's air conditioning units and ducting were also damaged and needed replacement.

**Figure 3.** (Left to right) *Lady Delray* after the fire, with fire-damaged portside window and portside main deck bar area.

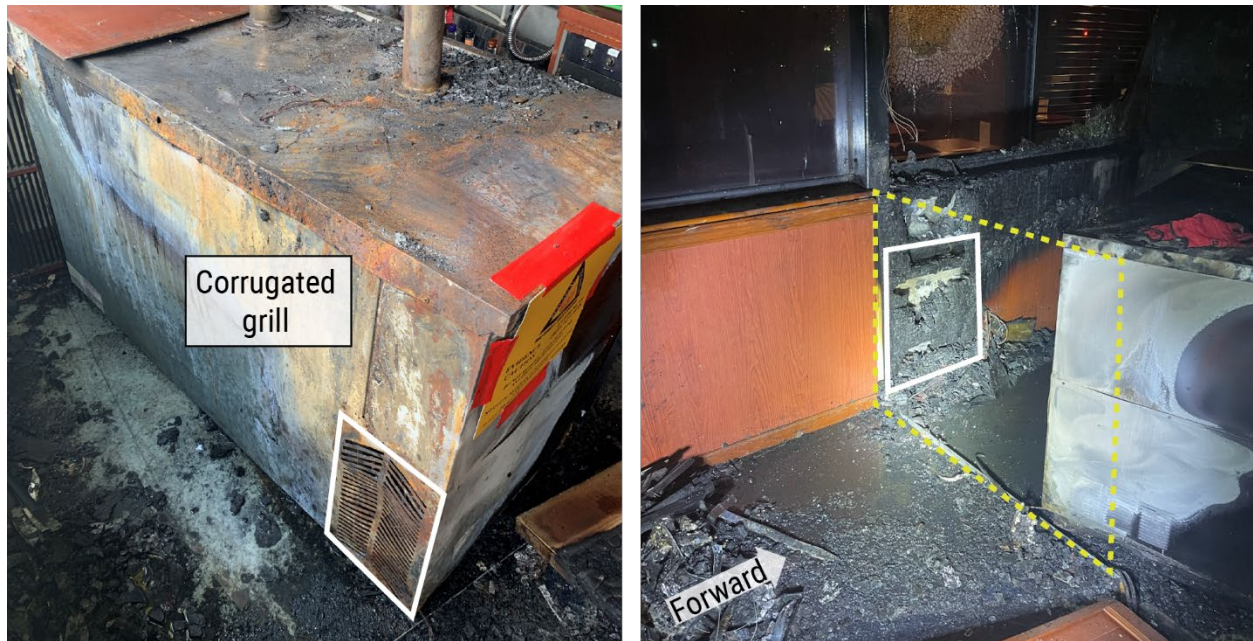
Further, the investigator found that there was heavy charring to the exterior on the back side of the unit as well as charring to the bulkhead immediately behind the unit (see figure 4). The fire had severely damaged the 110-volt receptacle the unit was plugged into, and most of the unit's service cord had been consumed by the fire. The security system's 110-volt power supply was also plugged into the same receptacle as the refrigeration unit, and its service cord was also heavily damaged by the fire.

The fire investigator found that the corrugated grill—which was on the right-hand side of the back of the refrigeration unit and housed the refrigeration unit's hermetically sealed compressor—was also heavily charred. The grill's charred fire pattern was "mirror[ed]" onto the adjacent bulkhead directly outboard (see figure 4).

The investigator determined that all other fire patterns originated from the grill fire pattern and propagated up toward the windowsill and overhead. The fire investigator concluded that the fire was accidental in nature and the cause may have been the refrigeration unit's motor (the hermetically sealed compressor) overheating due to improper ventilation, which led to the combustion of flammable materials in the area.

**Figure 4.** (Left to right) Origin area of the fire on corrugated grill (outlined) on main deck bar refrigeration unit, with fire pattern mirrored (outlined) on portside bulkhead. The area of a cabinet end panel in place prior to the fire is indicated by a dashed line. (Source: Florida Bureau of Fire, Arson, and Explosives)

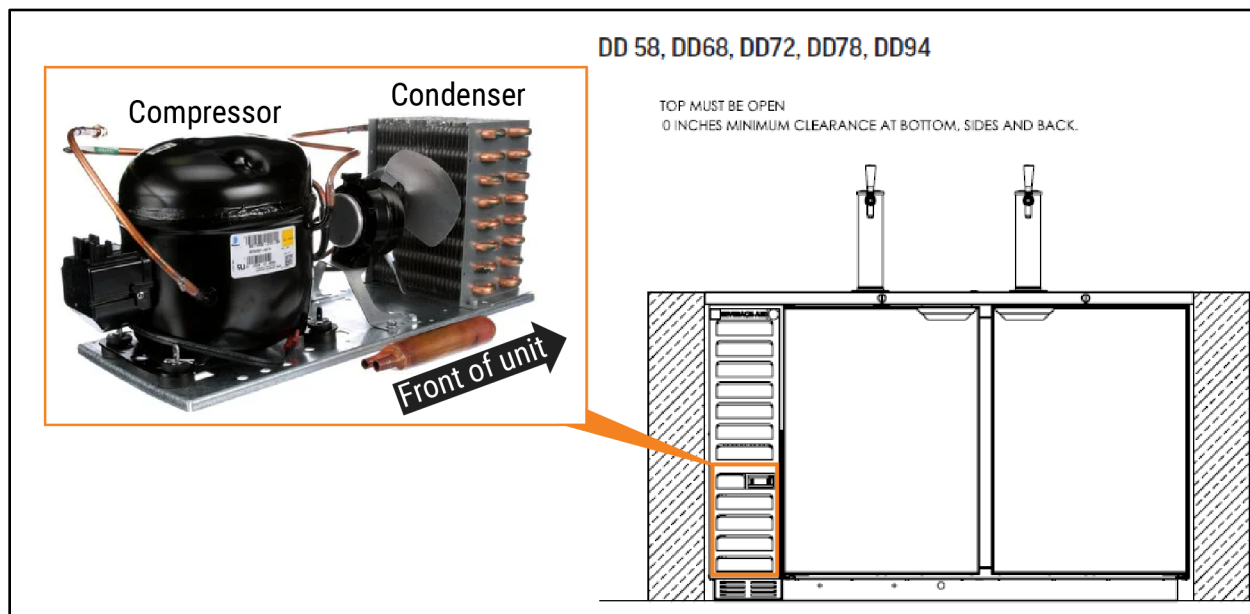
The unit manufacturer's user manual recommended that the refrigeration unit be positioned with "0 [zero] inches minimum clearance at the bottom, sides, and

back” (see figure 5). The user manual also included a “cleaning and maintenance” schedule, which included daily exterior cleaning, weekly interior cleaning (refrigerated space), and a monthly condenser coil inspection and quarterly cleaning (or more frequently as needed). The manual stated that failure to keep the condenser clean would lead to poor refrigeration unit performance and could cause the compressor to fail.

**Figure 5.** Exemplar hermetically sealed compressor and condenser coil unit similar to the two-door, keg-type refrigeration unit installed aboard the *Lady Delray*. The condenser end of the unit (outlined and shown in inset) would have been directly behind the grill on the front of the refrigeration unit. (Background source: Beverage-Air)
