October 8, 2024

MIR-24-32

## Contact of Barge *San Juan-JAX Bridge* with Pier

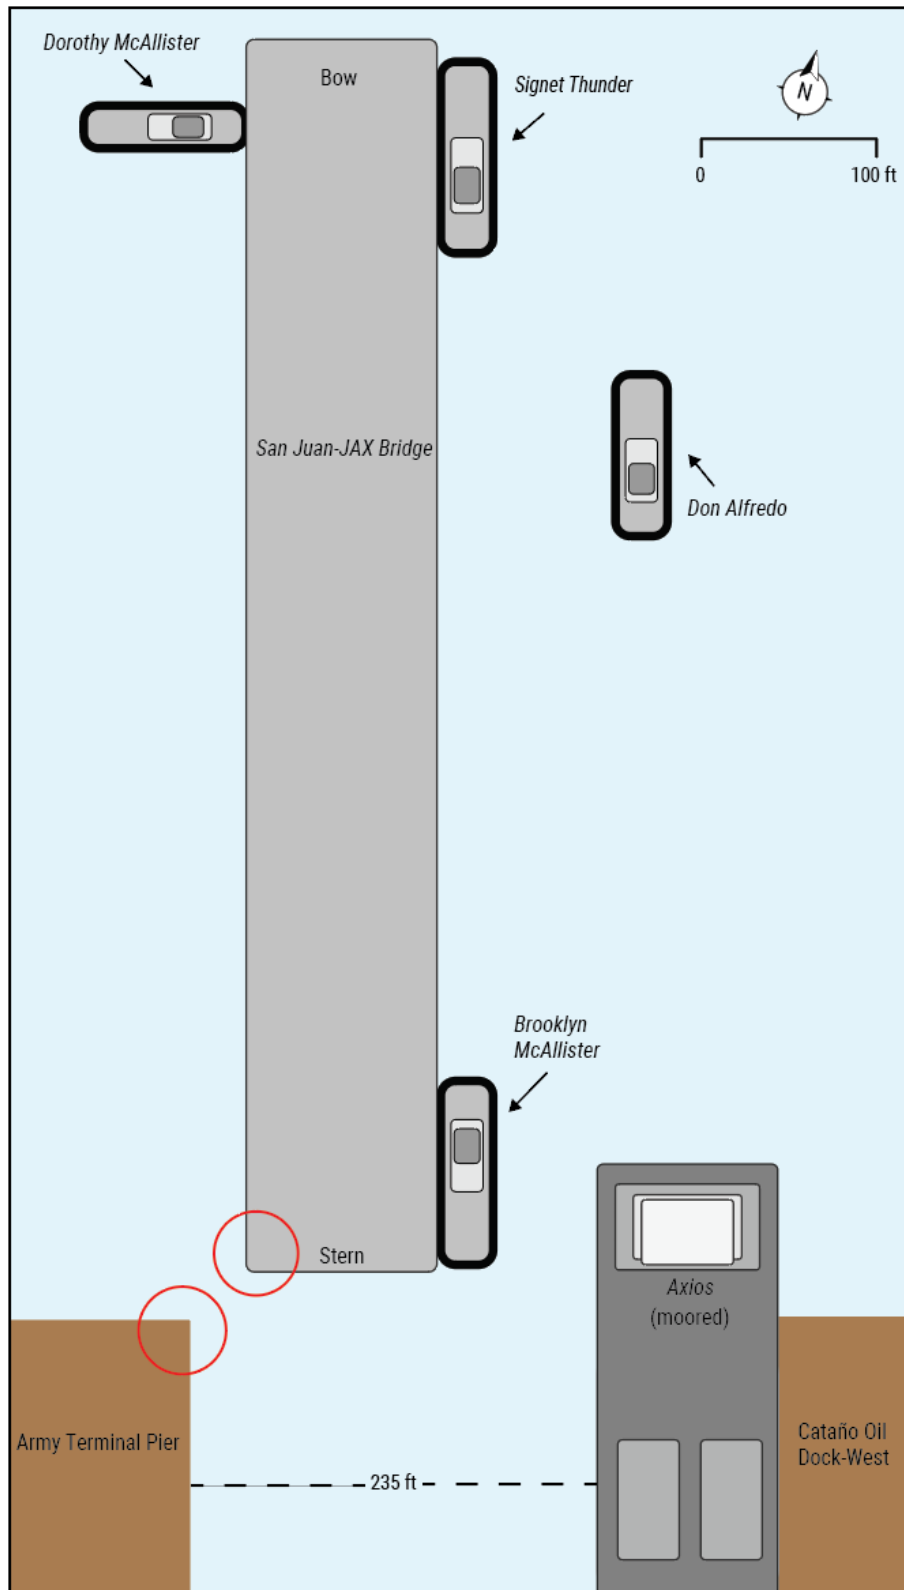
Across from where the *San Juan-JAX Bridge* barge would moor at the Army Terminal Pier, the chemical tank vessel *Axios*, with a beam of 105 feet, was docked at the Cataño Oil Dock-West. The distance between the *Axios* and the Army Terminal Pier was 235 feet. Once the barge, with a beam of 104 feet, was moored, there would be 131 feet separating the two vessels in the slip. During the docking, when tugs (beams of about 34 feet) were assisting, there was even less room to maneuver (see figure 3).

**Figure 3.** Approximate arrangement of the *San Juan-JAX Bridge*, the assist tugs, and the *Axios* as the barge and tugs approached the dock before the contact (scale approximate). The areas of the barge and pier involved in the contact are circled.

The *Brooklyn McAllister* was positioned at the barge's starboard quarter. Due to the height of the barge, the *Brooklyn McAllister* captain was not able to see the Army Terminal Pier from where his tug was positioned. According to the docking pilot, he first instructed the *Brooklyn McAllister's* captain to keep the barge's stern clear of the *Axios*. However, he then gave instructions intended to move the barge's stern away from the Army Terminal Pier so that the barge would clear the corner of the dock while entering the slip, given a light breeze on the starboard beam. The *Brooklyn McAllister* captain later stated that he had heard the docking pilot's instructions as "ahead and to starboard." The docking pilot stated that he requested and received confirmation that the captain was carrying out his instructions. However, the barge moved to port, and the barge's port quarter was pushed into the corner of the pier with enough force to damage the barge.

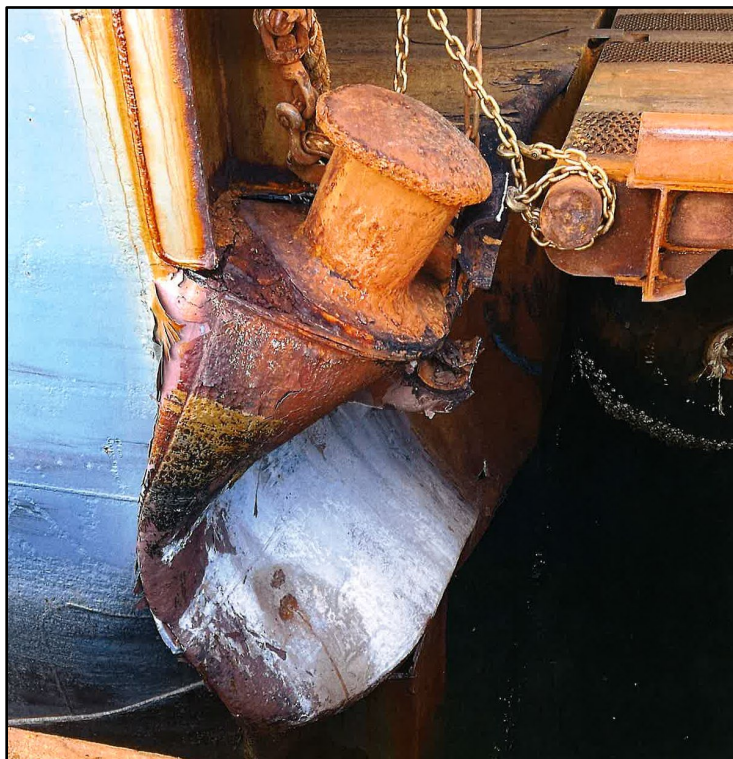
The *San Juan-JAX Bridge* suffered fractured frames and a 3-meter-by-4-meter buckled area of the transom and main deck (see figure 4). The transom and bottom plating were also holed. Repairs were made to the barge at Grand Bahama Shipyard, and the vessel returned to service that month, in June 2023.

**Figure 4.** *San Juan-JAX Bridge's* damaged port quarter. (Source: McAllister Towing)
