January 29, 2025

MIR-25-05

## Engine Room Fire aboard Cargo Vessel *Stride*

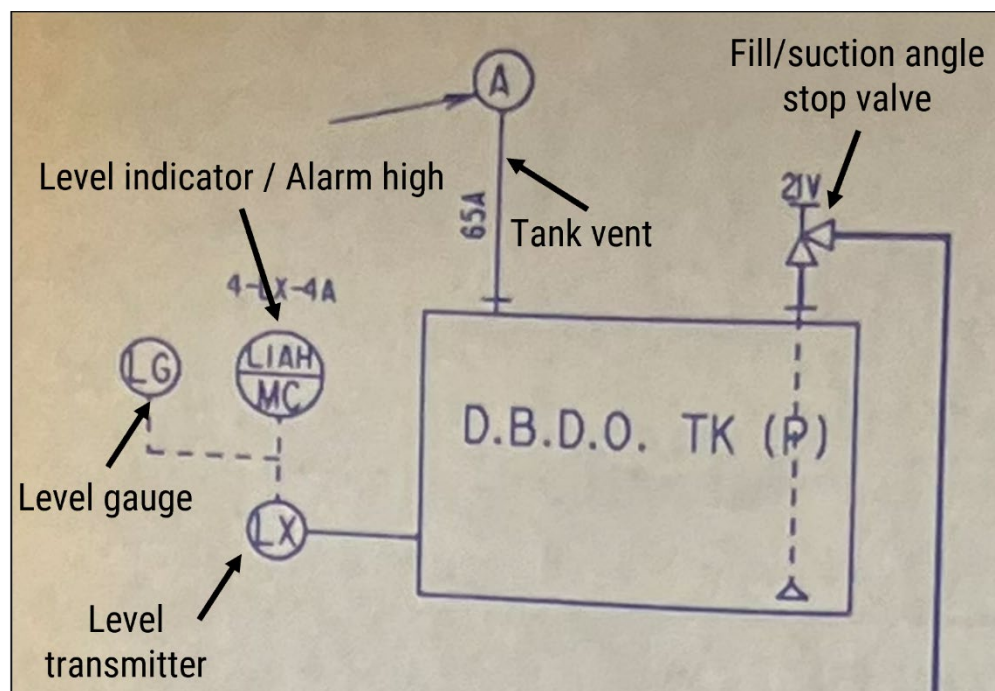
**Figure 5.** Vessel fuel oil diagram showing port DBDO tank, fill/suction angle stop valve, vent, and level instrumentation. (Background source: Danaos Shipping Company LTD)

Due to the configuration of the new valve (an angle stop check valve), once installed, diesel oil would only be able to flow out from the DBDO tank; even when the valve was in the fully opened position, diesel oil would be prevented from flowing into the tank due to the check function of the valve. (A stop check valve is a modified version of a stop valve, which has a sealing disc attached to the valve stem. In a stop check valve, the disc floats on the valve stem and allows fluid to flow in one direction only.) The previous stop valve that had been removed from the port DBDO tank was not a stop check valve; it had allowed diesel oil to flow in both directions when open.

Six weeks before the fire, a replacement valve was ordered for the port DBDO tank. The vessel's fuel oil system drawing clearly showed an angle stop valve for the port DBDO tank. This valve would have allowed fuel to flow through it in both directions when open. However, after the fire, investigators discovered that although the replacement valve that was ordered and installed looked similar from the outside and was of the correct dimensions, it was not the same type of valve specified by the vessel's fuel oil system drawing; instead, an angle stop check valve, which allows flow in only one direction, even when open, was ordered. Therefore, even when the crew fully opened the valve, as installed in the *Stride's* fuel oil system, the check valve feature would only allow flow out of the tank. The vessel had not bunkered diesel oil into the port DBDO tank since the valve replacement, and therefore the crew had no prior indication that the wrong valve type was ordered and installed.

Vessel drawings contain piping symbols for equipment such as valve types, sizes, and functions. Owners, operators, and crews should carefully note all components of a vessel's drawings and diagrams to ensure that proper spare or replacement parts are ordered to maintain functionality.

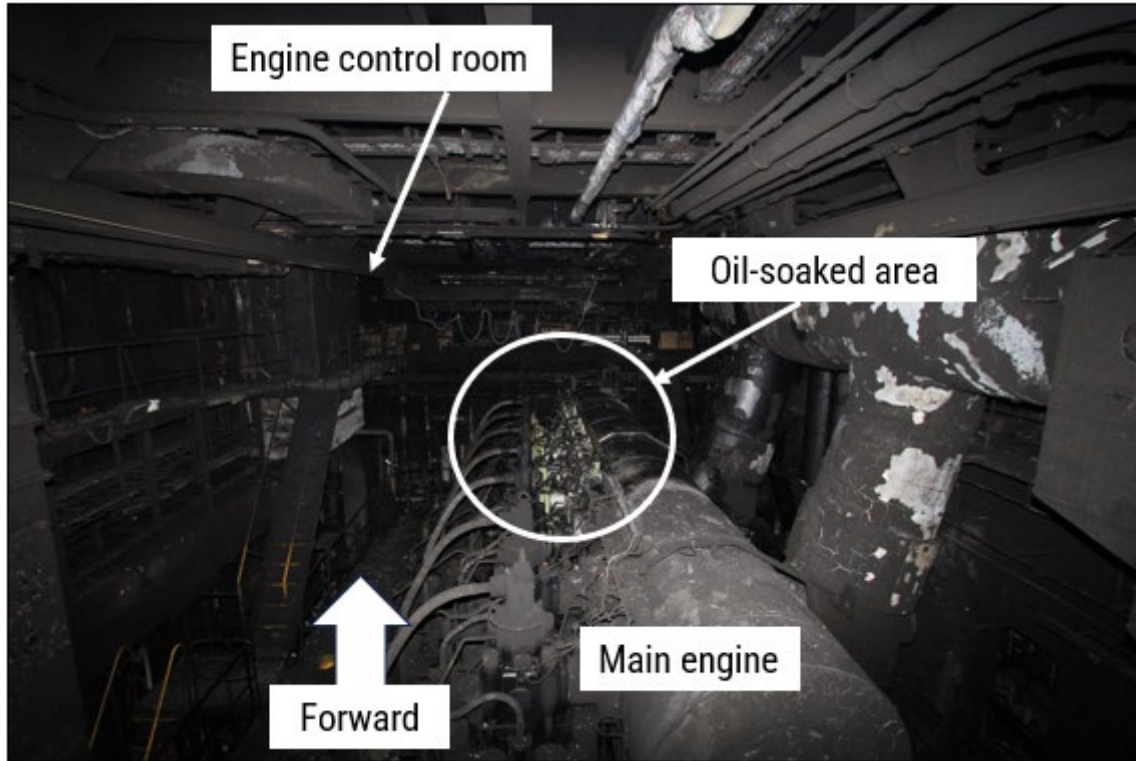
Damage from fire, heat, and soot was present throughout all levels of the engine room, especially within the funnel casing and the area in the engine room directly below the funnel casing down to the lowest level (see figure 6). Outside these areas, several combustible items, such as cardboard boxes and wooden crates, were not damaged by the heat of the fire. There were several electrical cabinets on the starboard side of the 4<sup>th</sup> deck that were damaged and could not be identified.

**Figure 6.** View of the *Stride* engine room 3<sup>rd</sup> deck looking forward, after the fire, showing the main engine and surrounding areas covered in soot and an oil-soaked section of the main engine.

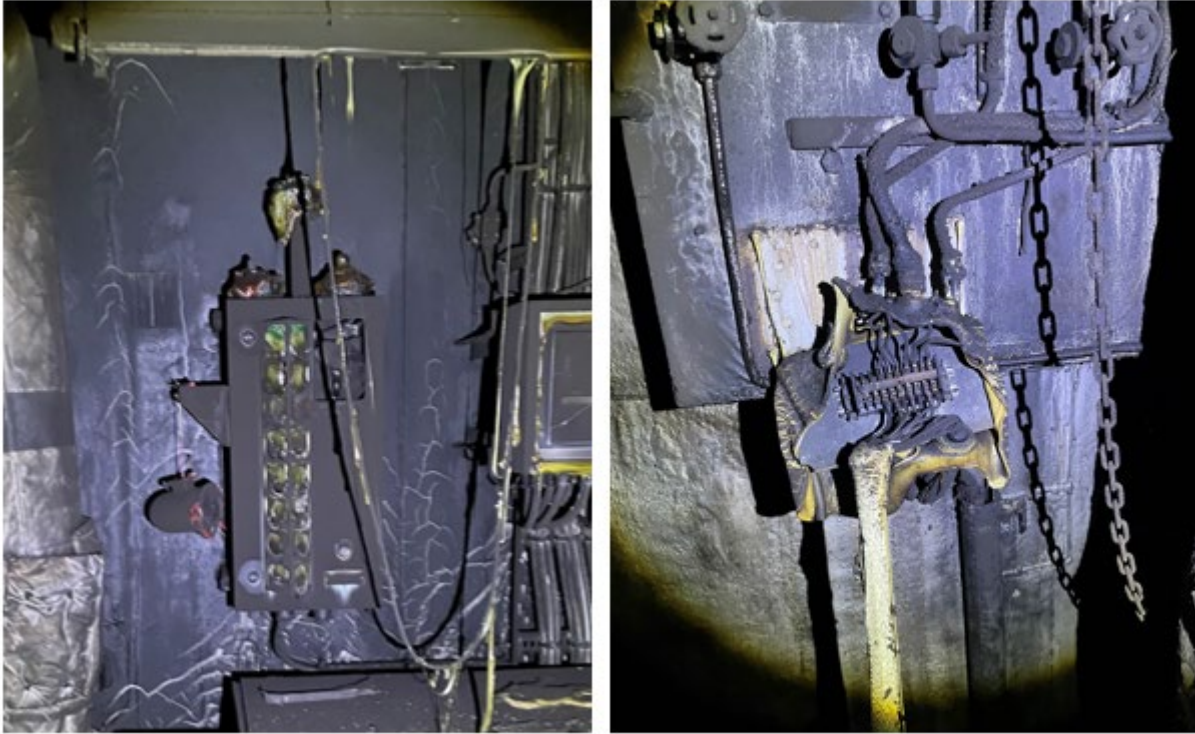
Several light signal columns throughout the engine room were damaged, and multiple electrical panels had melted plastic components, such as push buttons, indicator lights, and control boxes (see figure 7).

**Figure 7.** Left to right: Damaged light signal column in funnel casing and melted electrical component on boiler on D deck.

A surveyor from the vessel's classification society reported that the vessel was "not fit for voyage" due to damaged lighting fixtures; junction boxes; insulation stringers; and smoke, flame, and heat detectors throughout all decks of the engine room. Additionally, all mountings on the boiler and several components of the incinerator were found to be damaged by the fire. Other systems, such as the main engine, electrical panels, motors, compressors, gantry crane, and other pieces of equipment, were identified as damaged and required repair or replacement.

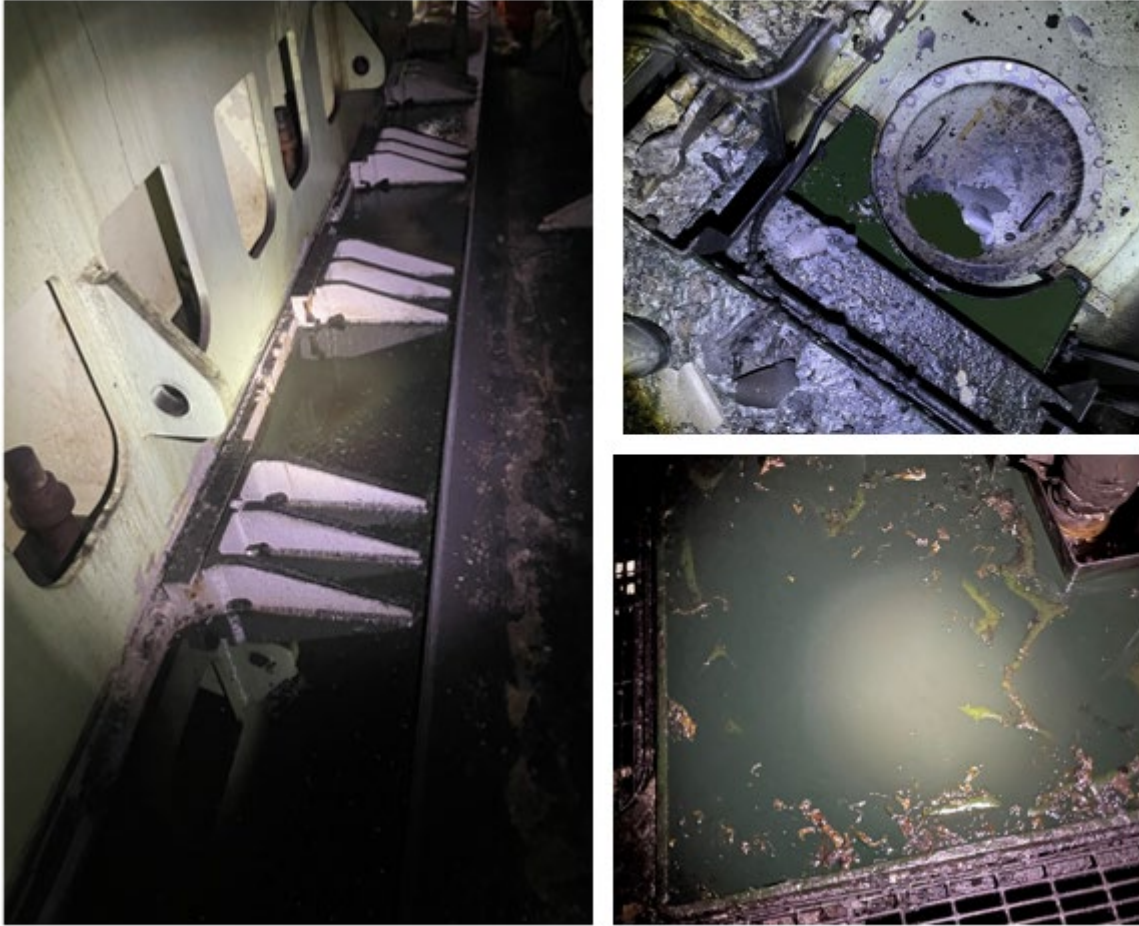
Unburned diesel oil was observed on all decks from the top of the D deck down to the 4<sup>th</sup> deck in the lower engine room below the funnel casing (see figure 8). Diesel oil was found visibly dripping from oil-soaked components in the funnel casing below the upper part of D deck, coating all bulkheads within the funnel casing, and pooling on machinery below the funnel casing. There was no diesel oil observed in the funnel casing above the D deck.

**Figure 8.** *Left:* Diesel oil puddled alongside base of main engine on tanktop. *Upper right:* Diesel oil puddled in main engine air intake manifold. *Bottom right:* Diesel oil puddled in deck containment by boiler on D deck.

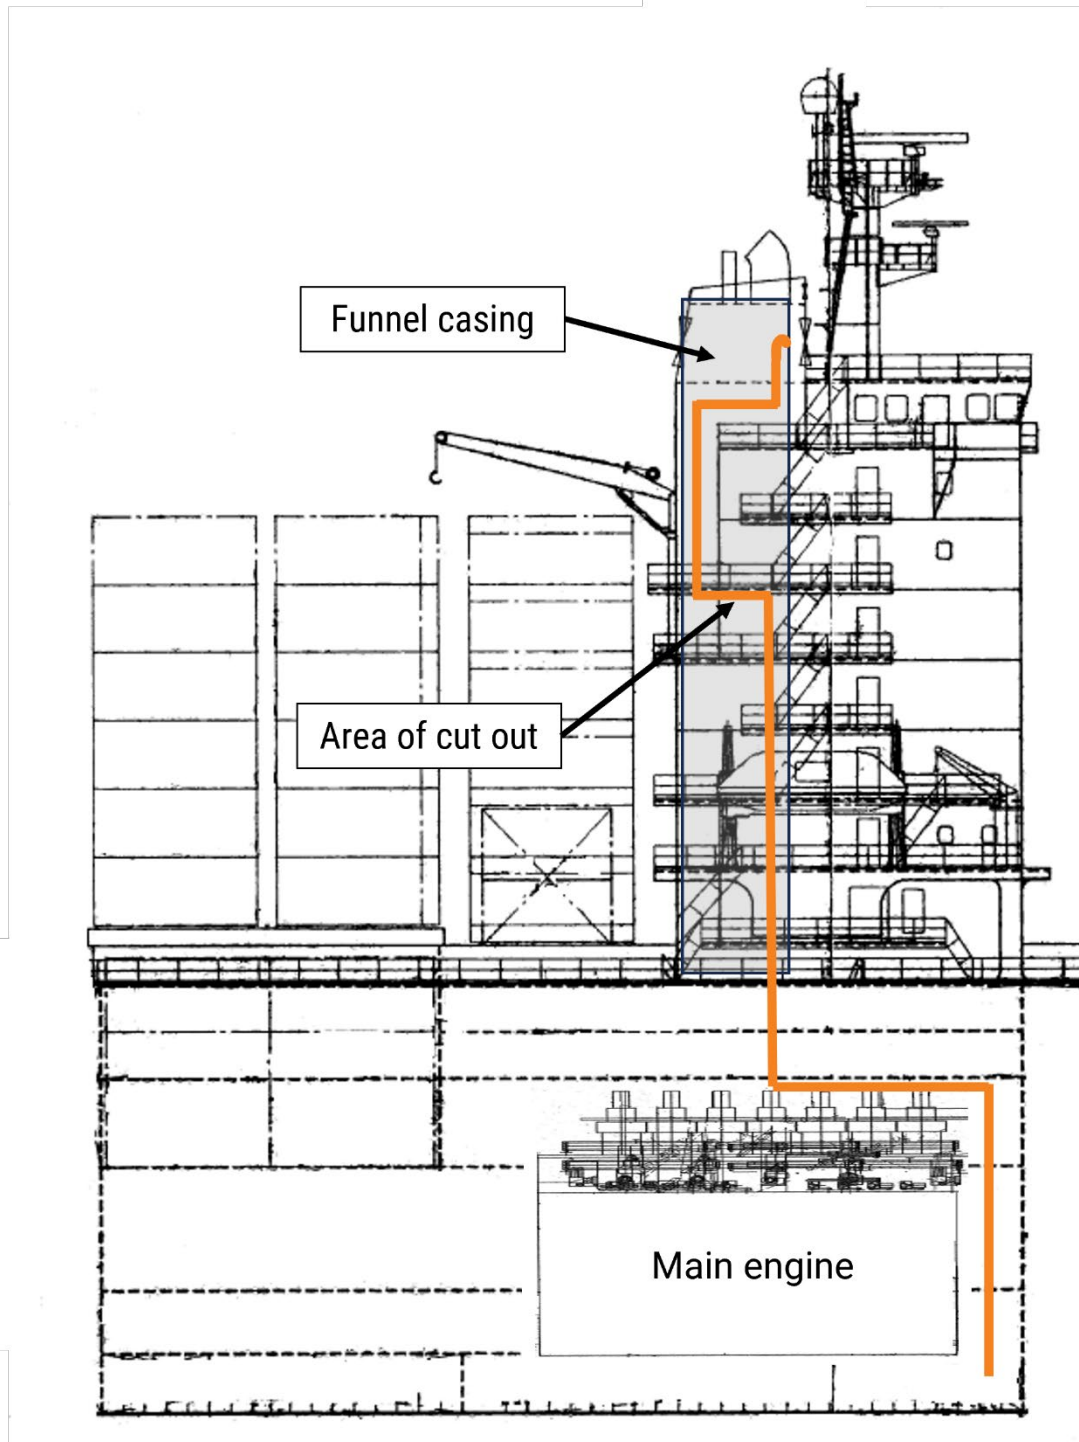
Multiple fuel tanks in the engine room, such as the fuel oil settlers, diesel oil day tank, overflow tank, sludge tank, incinerator settling tank, and the port and starboard DBDO tanks, were equipped with vent pipes at the top of each tank. These vent pipes were connected into a common 12-inch steel pipe that ran from the 4<sup>th</sup> deck in the engine room up through the engine room and the funnel casing alongside the exhaust stacks for the main engine, auxiliary generators, boiler, and incinerator, and led to a gooseneck to open atmosphere on the compass deck above the wheelhouse (see figure 9). The approximate height of the gooseneck on the compass deck was about 125 feet above the DBDO tanks.

**Figure 9.** Side profile view of the engine room and funnel casing area with the combined fuel tanks vent pipe, annotated in orange, up to compass deck. (Background source: Danaos Shipping Company LTD)

After the starboard DBDO tank became full, the incoming fuel was forced up the tank's vent piping as the barge continued to pump diesel oil to the *Stride*. Investigators estimated that about 14.8 mt of diesel oil was pushed into the vent piping. The vent piping had several engine room fuel tanks' vents connected into a common 12-inch pipe that ran upward within the funnel casing directly above the lower engine room and was designed to vent to open atmosphere through a gooseneck on the compass deck above the bridge.

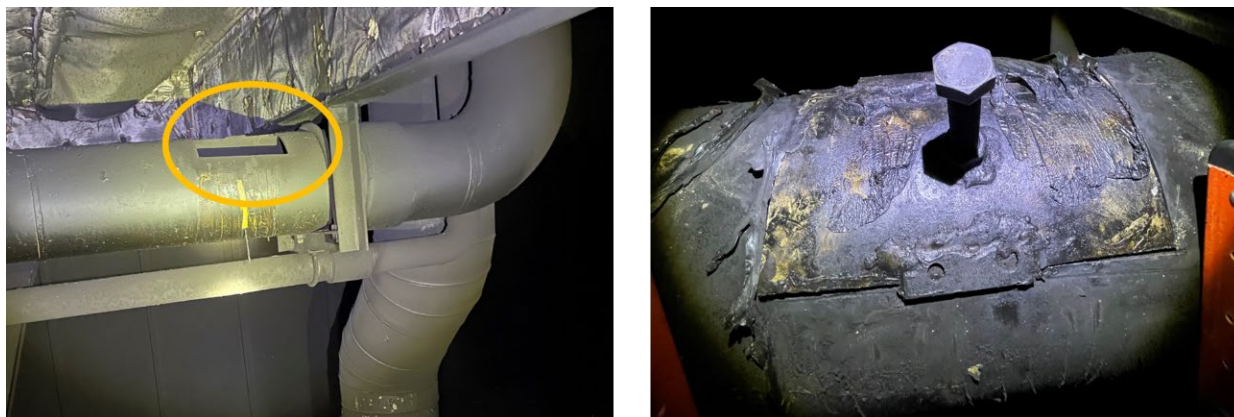
After the fire, in the overhead of the D deck above the boiler, investigators observed a 7-inch-wide-by-11-inch-long "inspection port" that had been cut out of the upper section of the fuel vent pipe on a horizontal run in the fuel vent piping (see figure 10). The section of pipe that had been cut out at some unknown time was found on the deck below the pipe after the fire, leaving the upper section of pipe open to the funnel casing in the upper engine room. This cut out was about 98 feet

above the tank top level of the vessel. The company's technical director stated that the company was not aware that a section had been cut out of the tank vent piping.

**Figure 10.** Left to right: Circled area identifying the open section of fuel vent piping and cut out placed back in position after the fire.

At some unknown time in the vessel's 26-year history, a 7-inch-by-11-inch section of pipe had been cut into the top of a horizontal section of the 12-inch vent pipe on the D deck (see figure 9 and figure 10). The vent pipe ran from the lower engine room up to the compass deck. There were no records of this alteration and no records of approvals, nor were there any records of inspections of this unauthorized

alteration. The cut out section of pipe had been replaced with a flexible sealant and then wrapped in tape.

Once the diesel oil reached the area of the vent piping with the cut out affixed with a flexible sealant and tape, the diesel oil pressure in the pipe exceeded the flexible sealant's capacity and ejected the cut out section of vent pipe onto the deck below. Diesel oil then poured out of the opening in the vent pipe and cascaded down through the funnel casing, onto the incinerator, the running boiler, the main engine, various lighting fixtures, operating equipment, and machinery. The diesel oil ignited, resulting in a fire in the engine room. Had the cut out not been present, the diesel oil would have likely exited the vent pipe on the compass deck and spilled onto the exterior of the vessel and into the water, rather than directly into the engine room, which contained operating machinery and other ignition sources.

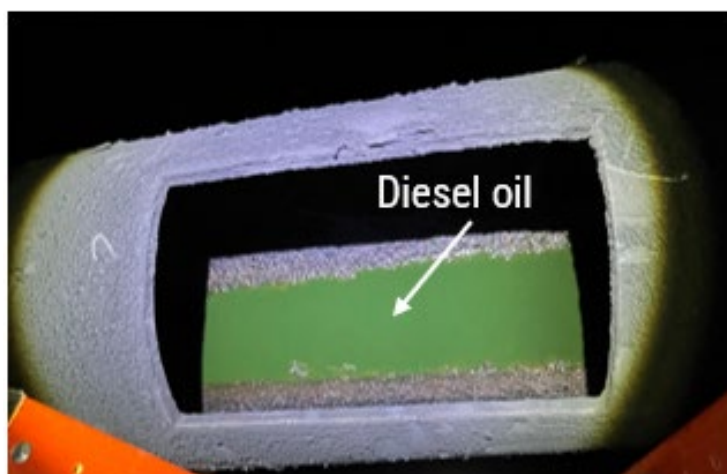
Investigators looked into the opening in the vent pipe and found diesel oil in the horizontal section of piping, which was eight decks above the diesel oil tanks that were being filled (see figure 11). Remnants of tape and a flexible adhesive were observed in the area where the cuts had been made. The removed section of pipe had a bolt threaded into a nut that had been welded onto the removed piece as well as tabs on two sides creating a flange so the piece could be held in position when placed onto the vent pipe. There were no records of this alteration, approvals, or inspections to the vent pipe. Below this cut out, diesel oil was observed on the boiler on the C deck, the incinerator on the upper deck, and all decks, equipment, and surfaces below the funnel casing on the starboard side of the engine room, down to the tank top and base of the main engine. No diesel oil was observed above the cut out on the D deck.

**Figure 11.** Diesel oil observed in vent piping, seen from above, through cut out section on D deck.
