Contact of Crane on board *Royal Engineer* Tow with Terminal Cargo Crane

On January 4, 2024, about 1620 local time, the towing vessel *Royal Engineer* was transiting the Cooper River near North Charleston, South Carolina, while pushing the crane barge *Stevens 1471* when the barge crane contacted a ship-to-shore crane at the North Charleston Terminal (see figure 1 and figure 2).¹ There were no injuries, and no pollution was reported. Damage to the terminal's crane was estimated to be over \$4.5 million.²

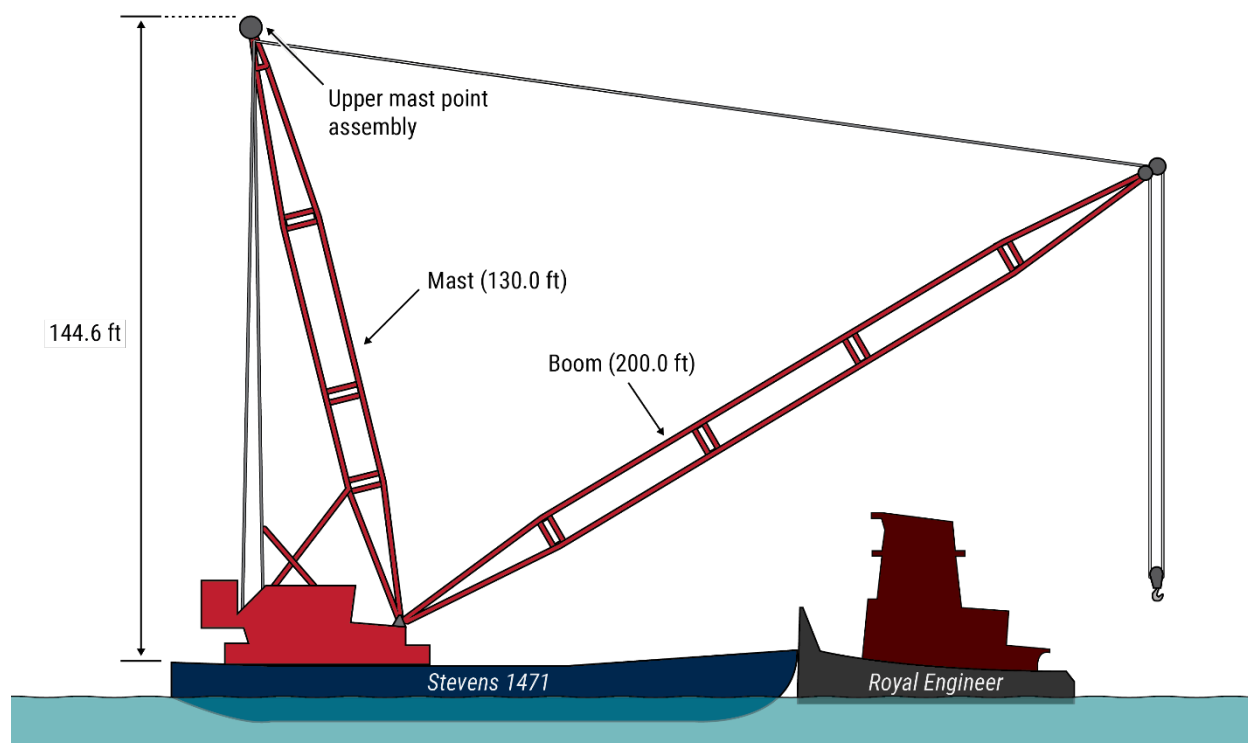
While in transit, the crane boom on the *Stevens 1471* was positioned over the wheelhouse of the *Royal Engineer* toward the stern of the tow (see figure 3). The fixed mast of the crane created the highest air draft of the tow while stowed for transit.⁴

According to technical drawings, the mast reached a height of 144.6 feet above the deck of the barge. The air draft of the crane barge was noted on the towboat's voyage plan as 145 feet.

Figure 3. Approximate towing configuration of the *Royal Engineer* pushing the *Stevens 1471*. The crane components and their measurements are labeled.

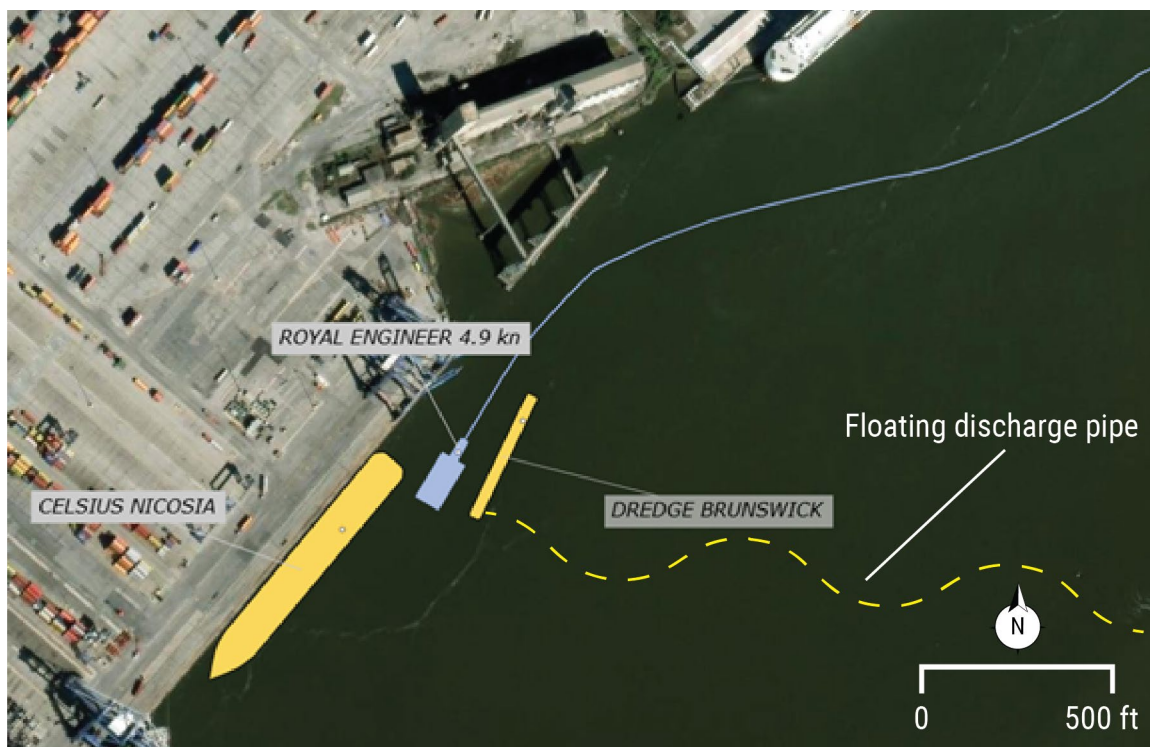
The dredge captain informed the *Royal Engineer* mate that his preference was for the tow to pass between the dredge and the dock because “I had guys downstairs that were working on something. ... and I’d have to stop them to go do something else.” He said he could swing the dredge around and provide about 300 feet of clearance to the seawall, not including the width of the *Celsius Nicosia*. The mate informed the dredge captain that he would have enough room to maneuver the *Royal Engineer* tow so it would pass between the *Brunswick* and the *Celsius Nicosia* (see figure 4).

Figure 4. The *Royal Engineer*’s path between the dredge *Brunswick* and the containership *Celsius Nicosia* at 1620. (Background source: Esri satellite image as viewed on Made Smart)

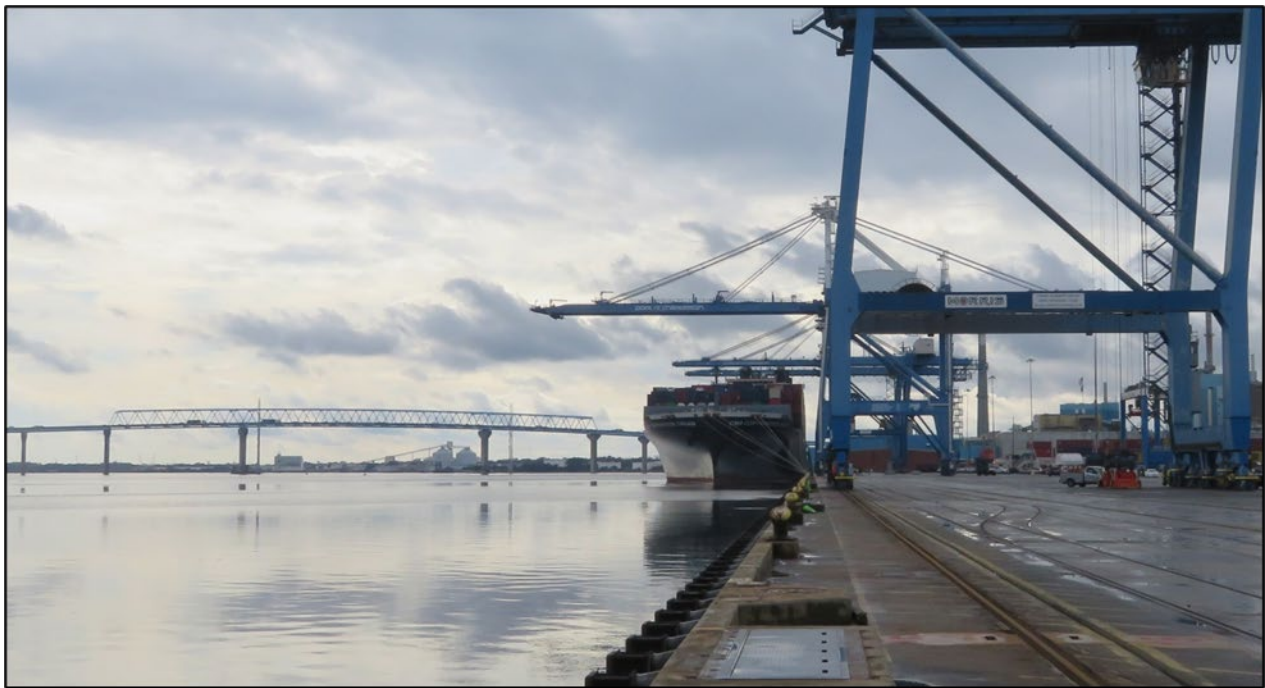
At 1619, the mate maneuvered the *Royal Engineer* tow past the *Brunswick* at a speed of about 4.5-5 knots. According to the mate, "that's when I realized the ship-to-shore crane was overhanging the ship [*Celsius Nicosia*]. ... I didn't realize that they would be boomed out past the ship" (see figure 5). The mate asked the deckhand to watch the height of the STS crane, reduced speed, and continued toward the overhanging crane. As the *Royal Engineer* tow moved closer to the STS crane, the mate and the deckhand were in constant communication about whether the tow's crane barge would clear the STS crane. Just after the deckhand informed the mate that he thought they would clear the STS crane, the mate stepped out of the wheelhouse and, "[I] realized we were not going to clear it." He told investigators that he then went back into the wheelhouse and reversed the engines.

Figure 5. View of a North Charleston Terminal STS crane extending over the side of the CMA CGM *F. Sagan* and the Cooper River. The CMA CGM *F. Sagan*'s mooring configuration is similar to the *Celsius Nicosia*'s configuration when the crane on the *Royal Engineer* tow contacted the STS crane. The CMA CGM *F. Sagan* has a 131-foot beam, 26 feet wider than the *Celsius Nicosia*.

Ship-to-shore cranes, when conducting cargo operations on a vessel and in the lowered position, may extend considerably beyond the side of the vessel and become a hazard to vessels with high air drafts transiting nearby. Mariners should always consider their vessel and tow's air draft when identifying hazards to navigation.

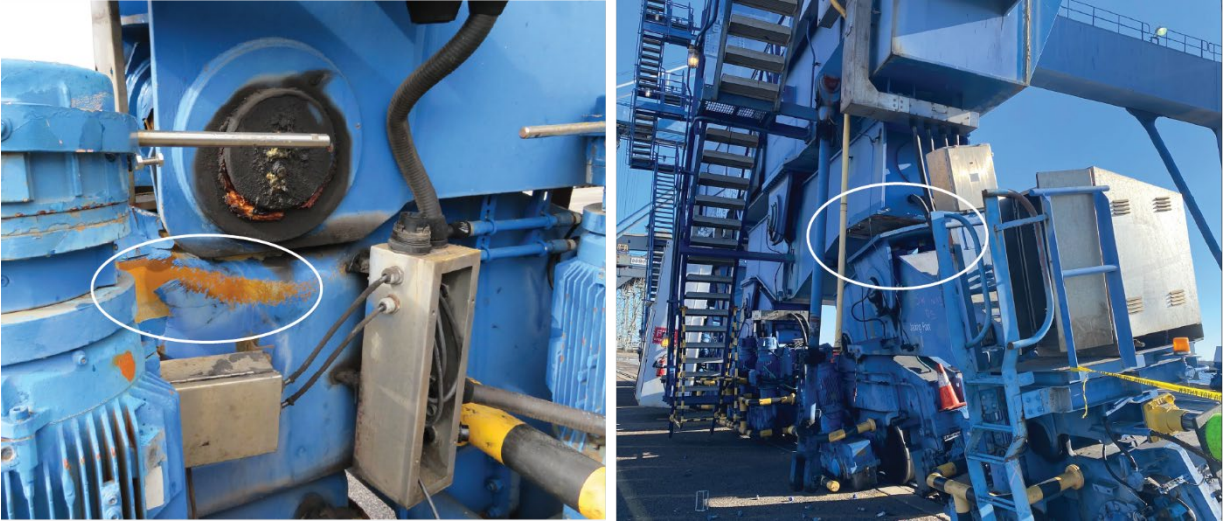
The contact caused the STS crane to twist along its vertical axis, damaging the crane and dislodging it from the pier's gantry rail system. According to a damage assessment report, the damage to the crane included a "nearly complete wrecking" of the gantry assemblies at each corner, which compromised the crane's stability; minor damage to the operator's cabin; damage to the platforms and equipment at the boom tip where the contact occurred; and surface damage to the pier structure (see figure 6). The crane was deemed to be structurally unstable immediately following the incident, and it was subsequently relocated, stabilized, and stored for repairs. Repairs were completed in February 2025. Damage to the terminal's crane was estimated to be over \$4.5 million.

Figure 6. Left to right: The damaged STS crane. Circled areas show (1) metal distress and (2) damage to one of four gantry assemblies.

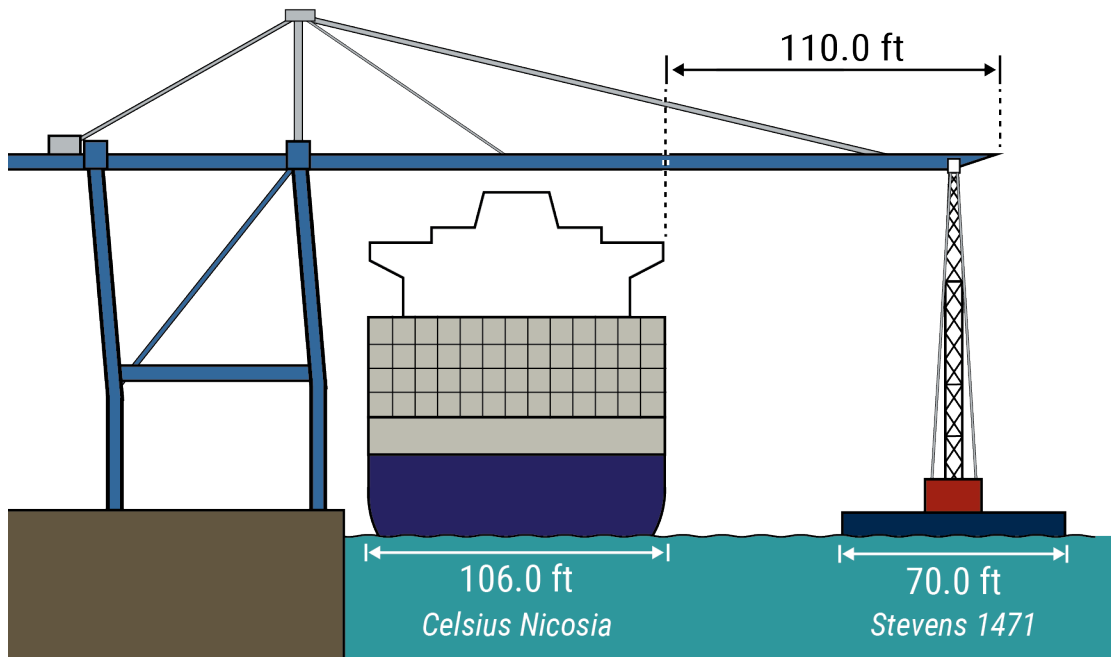
The STS crane that was struck reached 110 feet past the outboard side of the *Celsius Nicosia*, according to technical drawings, and 134 feet above the deck of the pier at the point of contact (see figure 7). At the time of the incident, the water level was about 8 feet 4 inches below the deck of the pier.

Figure 7. The horizontal extent of the North Charleston Terminal STS crane.
