July 10, 2025

MIR-25-28

Contact of *Joe B. Wyatt* Tow with Fort Madison Bridge Protection Cell and Fendering System

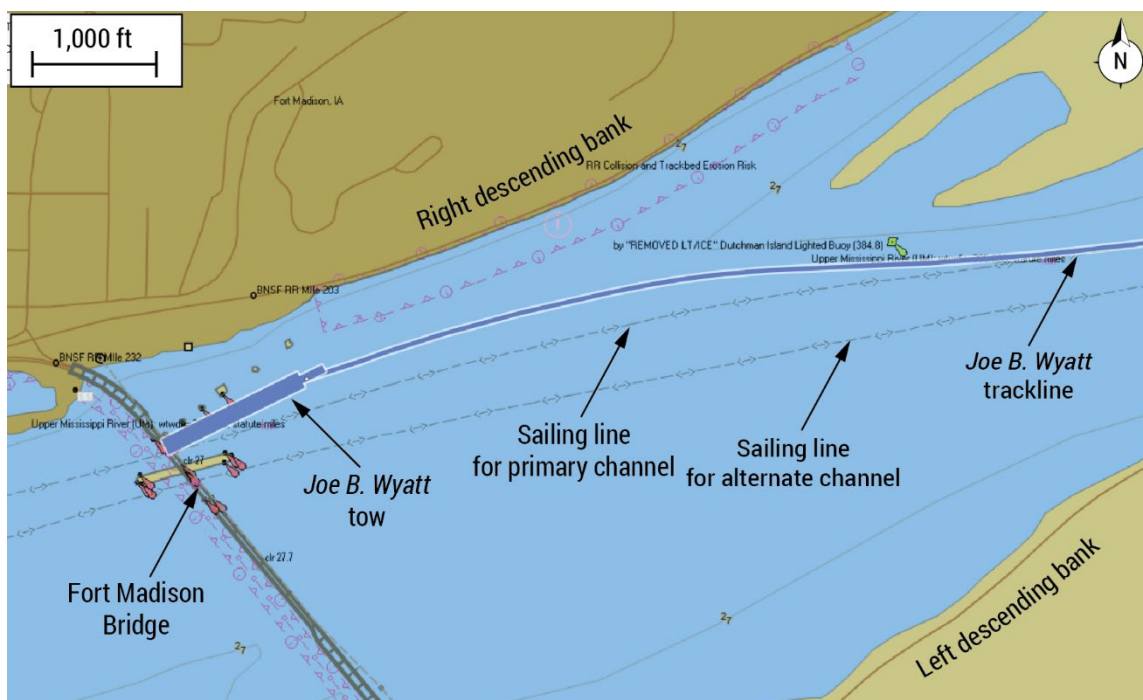
While the pilot navigated the tow toward the bridge, two deckhands were positioned at the head of the tow on the port and starboard sides, relaying distances to the channel opening to the pilot. About 1308, the pilot realized the anticipated cross-current "wasn't holding [him] up" as he had expected and the tow was in danger of striking a bridge protection cell on the right descending bank side. With the tow traveling about 8 mph and the lead barge about 1,900 feet away from the bridge, the pilot increased the engine rpm (power) to attempt to maneuver the tow back toward the center of the channel. About 1311, the head of the *Joe B. Wyatt* tow was passing the eastern (upriver) end of the bridge's central fendering system, the *Joe B. Wyatt* was still right of the sailing line by about 210 feet, traveling 9.8 mph, and the pilot was attempting again to regain position toward the center of the channel (see figure 5).

Figure 5. Track of the *Joe B. Wyatt* tow as it approached the Fort Madison Bridge at 1311 on May 9. (Background source: United States Army Corps of Engineers Inland Electronic Navigation Chart U37UM359 as viewed on Made Smart automatic identification system)

After passing Dutchman Island, the *Joe B. Wyatt* pilot expected a cross-current coming from around the island to set his 1,153-foot-long tow to port before reaching the primary channel of the Fort Madison Bridge. In anticipation of this current, the pilot maneuvered the tow off the sailing line and toward the right descending bank during his approach. The *Joe B. Wyatt* tow, with a following current, was making about 8 mph over ground, typical of a downbound tug and tow of that size. The pilot had decades of experience maneuvering tows, and he had steered tows through the Fort Madison Bridge many times. Based on this experience and his anticipation of a cross-current in the area, he maneuvered the *Joe B. Wyatt* over 200 feet off the sailing line toward the right descending bank. (At the time of the casualty, the river level was rising, but the pilot did not express concern about the river level.) However, the cross-current, if present at the time, did not have the effect the pilot had anticipated. By the time the pilot noticed that the cross-current “wasn’t holding [him] up” and the tow was in danger, the head of the tow was only about 1,900 feet away from the bridge. Because the pilot overcompensated for the anticipated cross-current, the tow was out of position as it approached the bridge.

The National Transportation Safety Board determines that the probable cause of the contact of the *Joe B. Wyatt* tow with a protection cell and the fendering system of the Fort Madison Bridge was the pilot overcompensating for anticipated river crosscurrents during the tow's approach to a bridge.

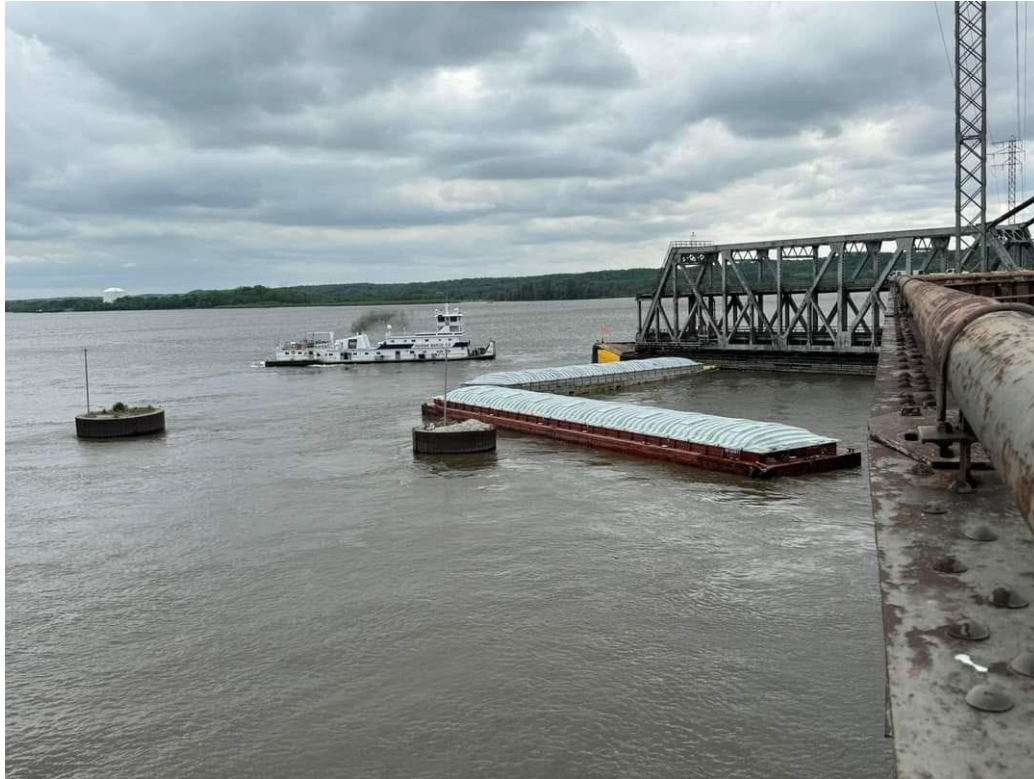
The pilot noticed the aftmost barge (*IN155499*) taking on water and blocking the channel as it rested alongside the bridge's central fendering system (see figure 6 and figure 7). He pushed the sinking barge along the central fendering system through the span and grounded it on the right descending bank, about 1,920 feet downstream of the bridge.

Figure 6. Barges *IN122011* and *IN155499* immediately after impact blocking the primary channel. The *IN155499*, next to the central wooden fendering, sinking. The *Joe B. Wyatt* is visible in the background. (Source: Coast Guard)

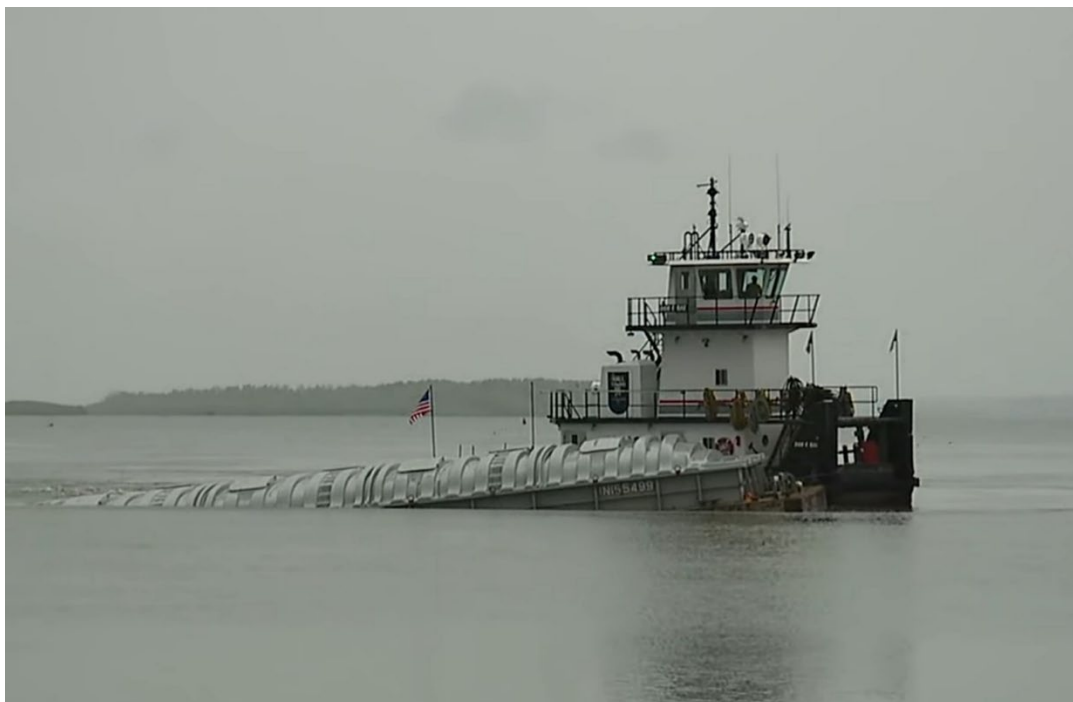
Figure 7. The sinking barge *IN155499* being held in place by an assist boat. (Source: WQAD News 8, youtube.com)

The barge *IN155499* eventually sank along the shoreline after river levels rose in the week following the casualty. The barge was later salvaged.

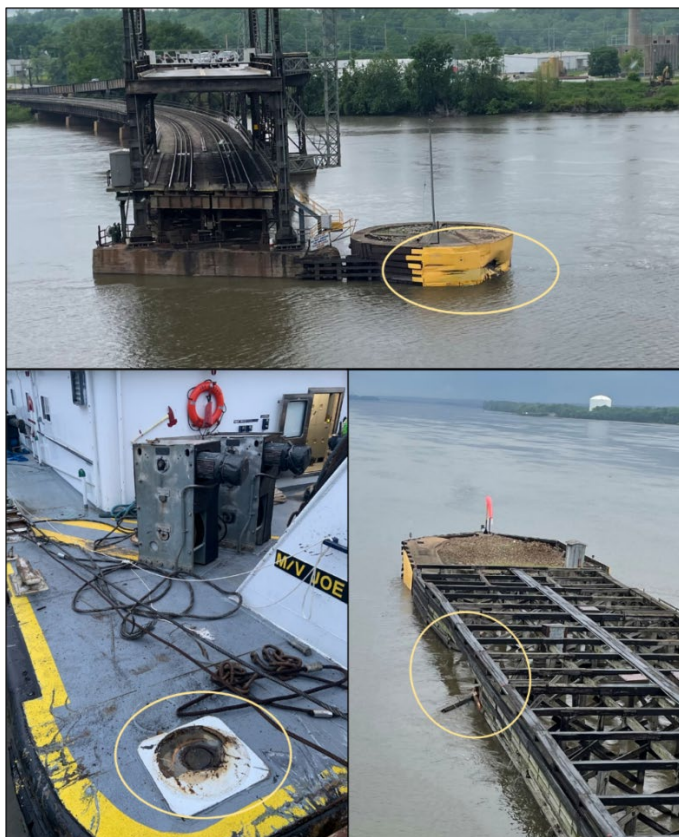
As a result of the contact, the hull plating, rub rails, tow knee pads, and deck fittings on the *Joe B. Wyatt* were deformed or damaged. The steel plating of the bridge protection cell was deformed. The central wooden fendering system was damaged as a result of the *Joe B. Wyatt* pushing the sinking barge through the bridge channel (see figure 8). Damage to the protection cell, fendering system, barges, and *Joe B. Wyatt* was estimated at \$3.28 million.

Figure 8. Clockwise from top: Damaged protection cell; damaged central wooden fendering of the Fort Madison Bridge; and severed bitt on the starboard bow of the *Joe B. Wyatt*.
