MIR-25-29

Listing and Partial Sinking of Yacht *Lovebug*

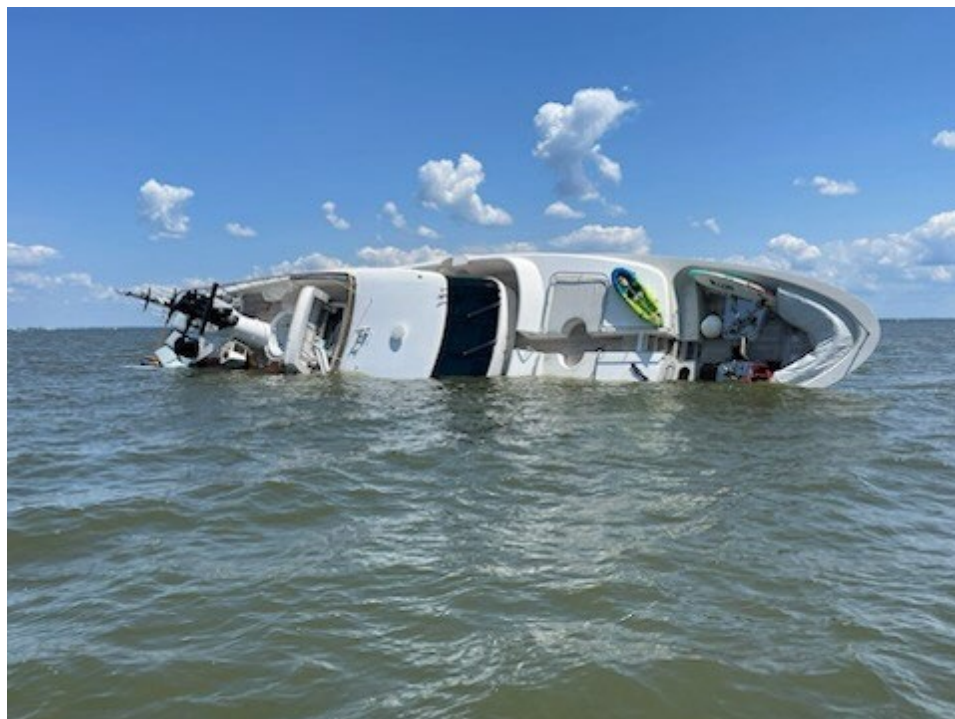
On July 27, 2024, about 1235 local time, the yacht *Lovebug* was transiting the Chesapeake Bay in the West River north of Shady Side, Maryland, when the vessel started listing heavily to starboard (see figure 1 and figure 2).¹ The four crewmembers and one owner on board abandoned the vessel and were rescued by nearby vessel crews. The yacht partially sank in about 12 feet of water. There was one minor injury. An oil sheen, visible around the vessel, was contained with a boom. Damage to the vessel was estimated at \$8 million.²

Figure 1. The partially sunken *Lovebug* on July 27, 2024, at 1342. (Source: Maryland Natural Resources Police)

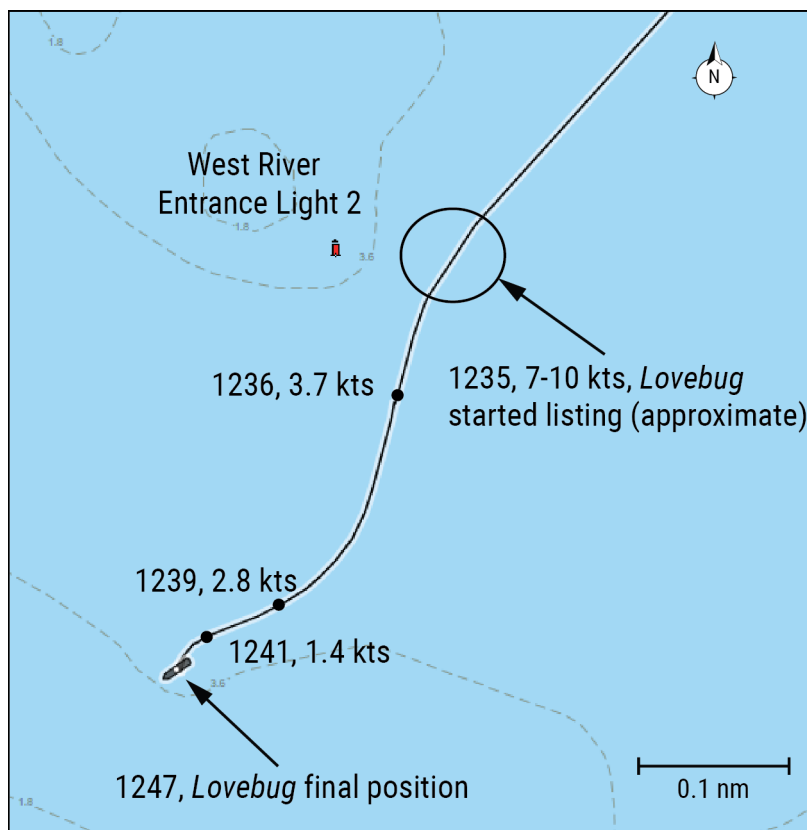
About 1235, when the yacht was near the West River Entrance Light 2, the captain noticed the *Lovebug* had developed a starboard list (see figure 4). He checked the steering, rudder indicators, and stabilizers on the bridge and found no problems. The captain told investigators that, when the vessel first began listing, he did not hear any alarms. The list rapidly increased. According to the captain, about a minute after the vessel started listing, the vessel, which had been powered by its starboard generator, lost power. The captain backed off the throttles, and the vessel's speed dropped to about 4 knots.

Figure 4. The *Lovebug*'s track from the approximate area the vessel first was observed listing to its final position. (Background source: National Oceanic and Atmospheric Administration Electronic Navigation Chart US5MD1LC as viewed on Made Smart automatic identification system)

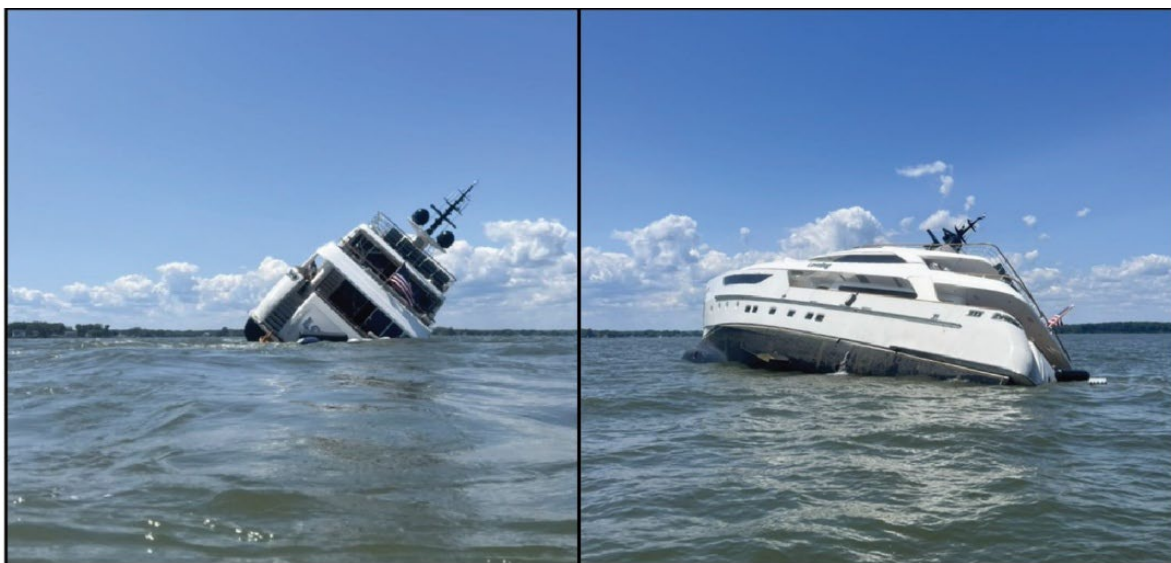
crew were in the water, less than 4 minutes had elapsed. The yacht had listed over about 45–50° and grounded in the mud, visibly down by the stern (see figure 5).

Figure 5. The *Lovebug* at 1238:48 and 1241:45, shortly after the owner and crew abandoned the vessel. (Source: *Lovebug* owner)

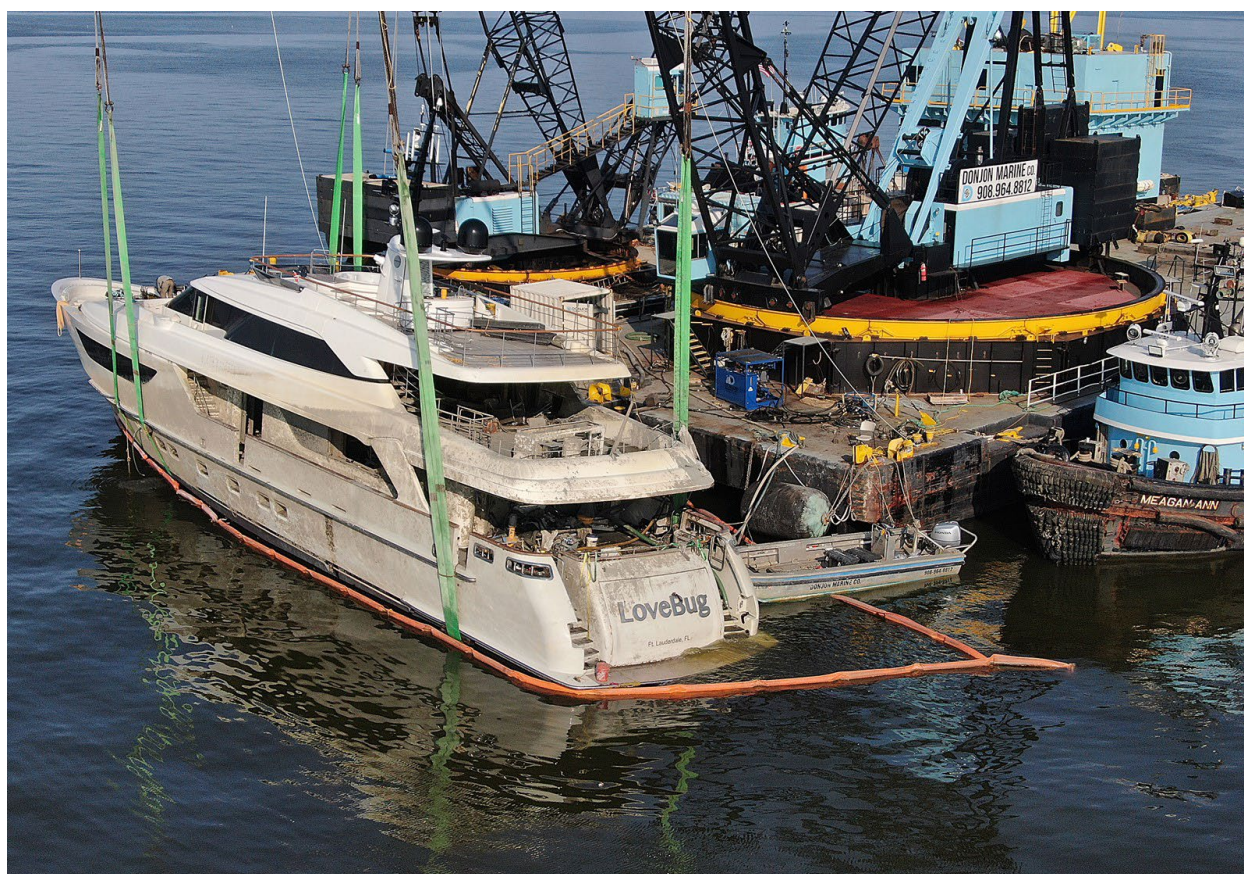
In preparation to move the *Lovebug* out of the West River, it first needed to be raised out of the water from its position partially sunken in the mud (see figure 6). The opening in the garage door was temporarily sealed with a soft patch for water removal. When sufficient dewatering was completed, the seal was removed, and the door was closed. Divers patched openings below the waterline and repaired leaks found during the salvage efforts, allowing the vessel to float on its own.

Figure 6. The *Lovebug*, with garage door visible at the stern, as it was raised out of the water after it partially sank. (Source: *Capital Gazette*)

Nobody on board observed flooding in the short time before they abandoned the vessel. Additionally, after the yacht was raised from the water and towed to a shipyard, a marine surveyor and National Transportation Safety Board investigators did not find any visible hull breach or indication of a source of water ingress. However, before the *Lovebug* was raised from the water, during dive operations, salvors found that the external garage door was partially open. Because the door's lower edge was situated at the waterline and no other potential source of water ingress was identified, it is likely that water entered the yacht via the partially open garage door.

Salvors also found the watertight door between the garage and engine room compartment to be open. Water in the garage would have decreased the yacht's draft aft, accelerating water ingress through it. If the water level in the garage space reached the lower edge of the open watertight door, seawater would have flooded into the engine room compartment.

The National Transportation Safety Board determines that the probable cause of the listing and partial sinking of the yacht *Lovebug* was undetected flooding through an open watertight door, resulting in the vessel losing stability.
