July 22, 2025

MIR-25-30

Grounding of Recreational Vessel *6 Saturdays*

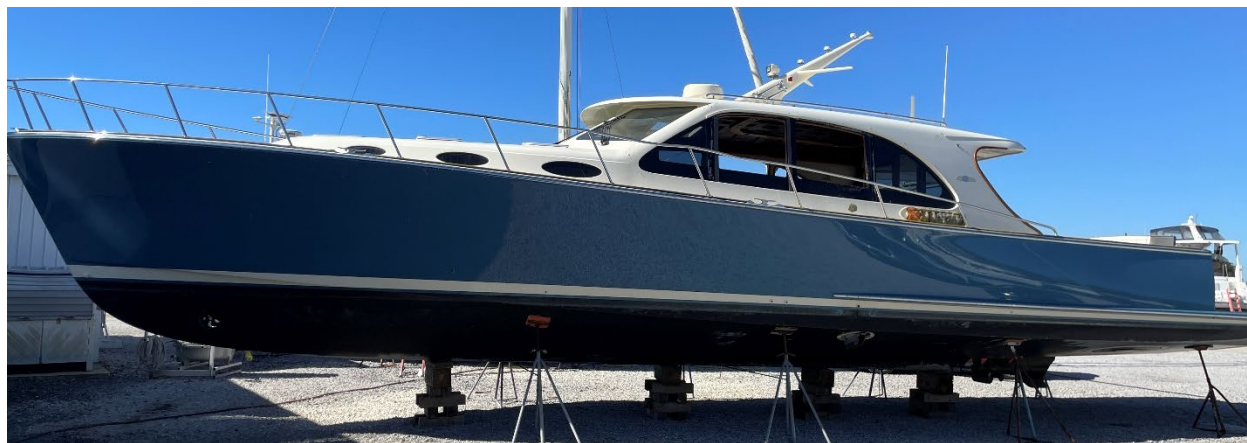
Figure 1. *6 Saturdays* in the boatyard after the grounding, on November 22, 2024.

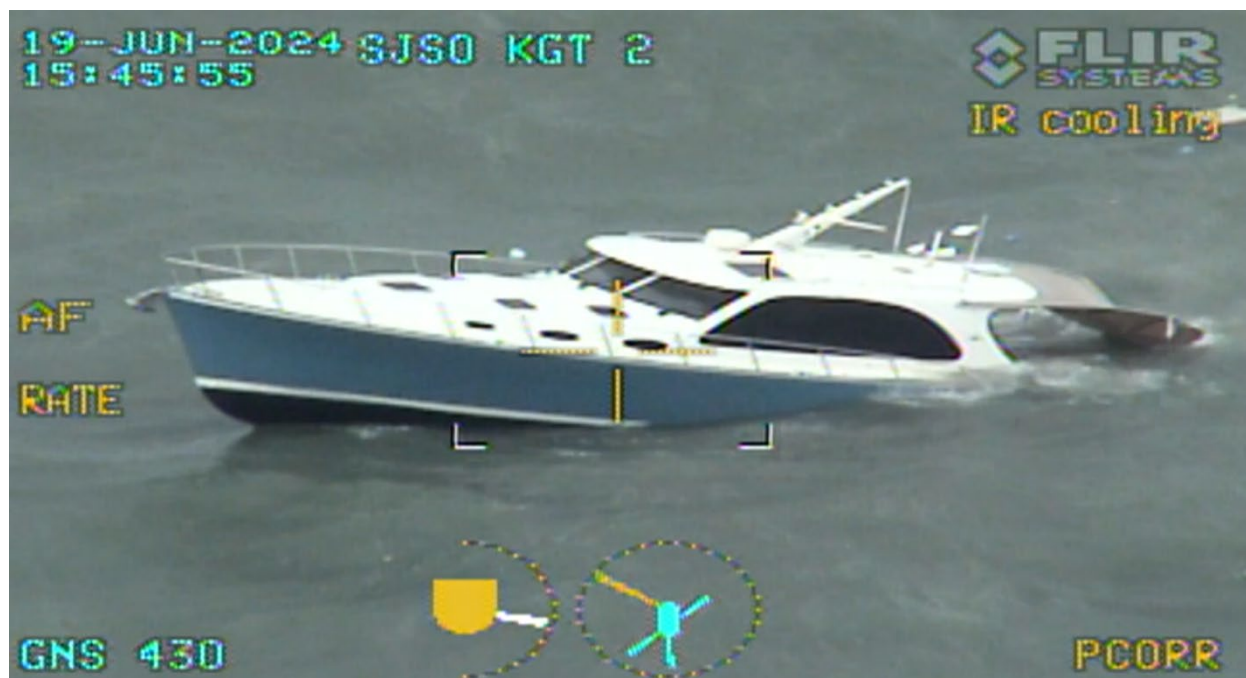
The St. Johns County marine operations unit first responder saw the *6 Saturdays* move away from the area of the grounding and observed waves coming over the stern of the vessel with its bow “sticking out of the water.”

Figure 3. The *6 Saturdays* as viewed from the St. Johns County Sheriff's Office helicopter at 1546. (Source: St. Johns County Sheriff's Office)

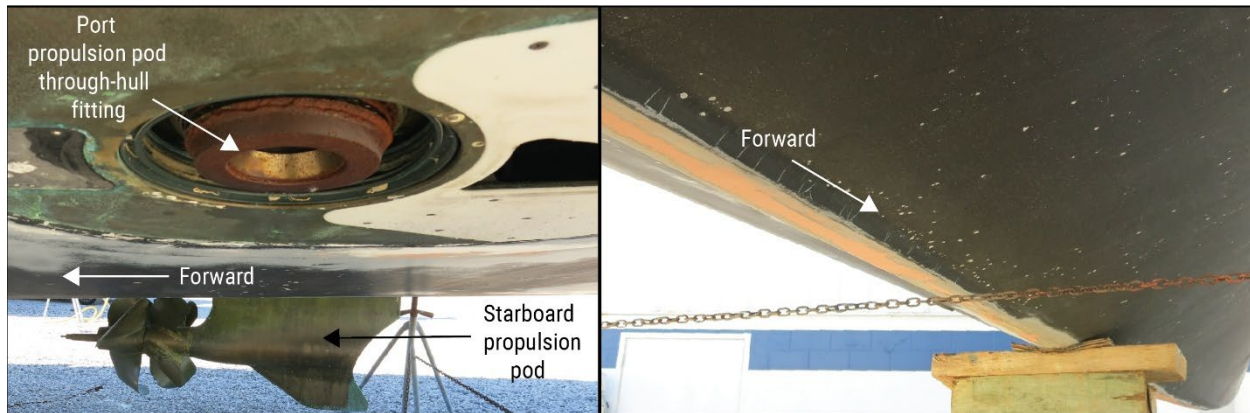
After the casualty, the *6 Saturdays* was refloated and towed to a boatyard, where it was later examined for damage. The portside propulsion pod and stabilizer were missing. The starboard-side propulsion pod was missing its forward hub. All propeller blades were bent in the aft direction and were severely damaged. The keel had scratch marks extending on both sides of the hull from the bow to the stern. There were scratch marks through the bottom paint at the aft port quarter of the boat near the port propulsion pod's through-hull fitting. There were no observed holes or cracks in the hull (see figure 4).

Figure 4. Left to right: The aft bottom of the *6 Saturdays*, including the through-hull fitting for the missing port propulsion pod and damage to the propeller blades of the starboard propulsion pod. Scratch mark damage to the keel of the *6 Saturdays*.

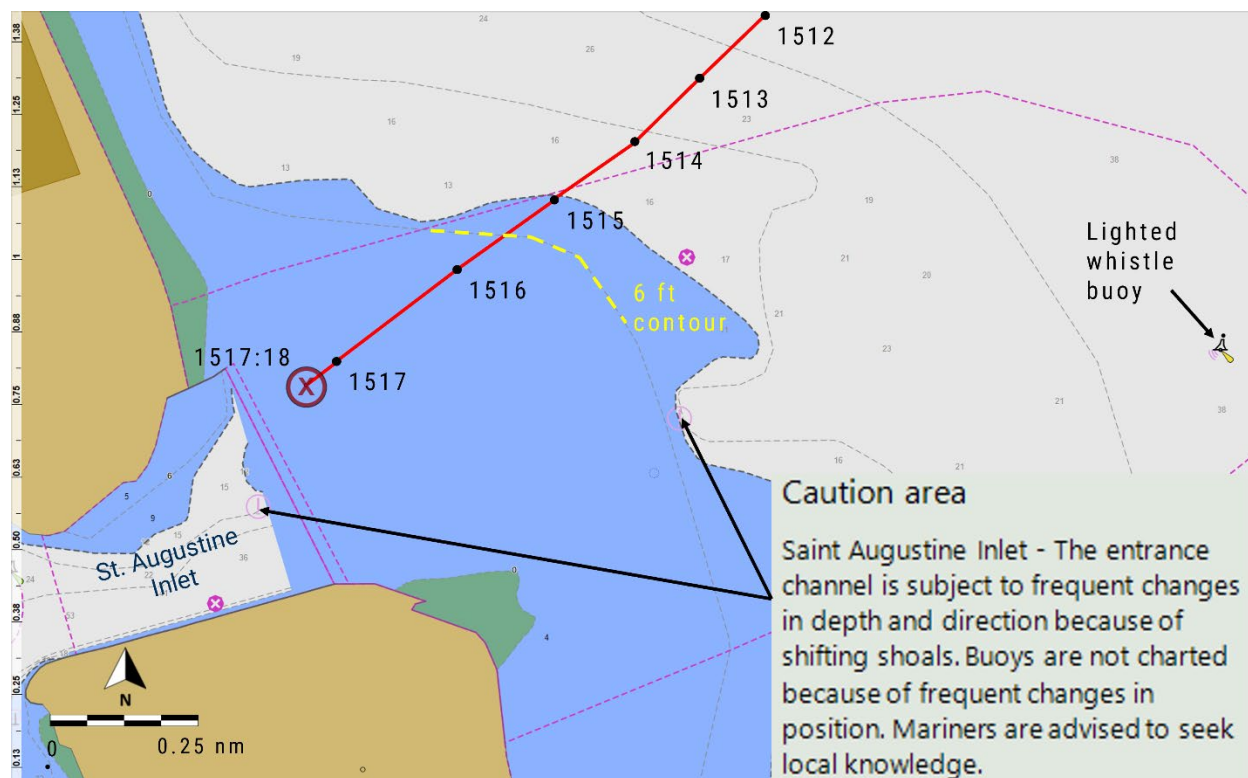
About 1515, the *6 Saturdays* transited into an area with charted water depths that ranged from 0 to 5.9 feet. Just after 1517, at a speed of 15 knots, the *6 Saturdays* grounded and came to an abrupt stop about 0.2 miles east of the beach on the shoals at the north side of the inlet. The captain described that it felt like "going over a speed bump too fast."

The location where the *6 Saturdays* grounded was known to have shoaling and sand buildup. The electronic navigation chart for the area had a cautionary note for mariners for St. Augustine Inlet that stated:

The entrance channel is subject to frequent changes in depth and direction because of shifting shoals. Buoys are not charted because of frequent changes in position. Mariners are advised to seek local knowledge (see figure 5).

Figure 5. Electronic navigation chart with the positions and track of the *6 Saturdays* up to the grounding location, and caution area inset. (Background source: National Oceanic and Atmospheric Administration electronic navigation chart US5FL7RG)

The navigation chart for the area where the grounding occurred contained a cautionary note warning of frequent changes in depth due to shifting shoals. Additionally, the *Coast Pilot* warned of dangerous and shifting shoals extending 1 mile seaward. Although the captain of the *6 Saturdays* said he had operated vessels many times through the St. Augustine Inlet, he was unaware of the shoaling and published cautions and warnings. The captain did not navigate the vessel to the lighted whistle buoy off the entrance of the inlet to follow the buoyed channel inward, which would have kept the vessel in safe water. Instead, he proceeded directly through the shoal water at a speed of about 15 knots. The captain's decision to navigate the vessel through shoal water with charted depths that were likely less than the vessel's draft led to the vessel's grounding.
