September 26, 2025

MIR-25-35

# Contact of Tanker *Cosflourish Lake* with South Texas Gateway Terminal Dock

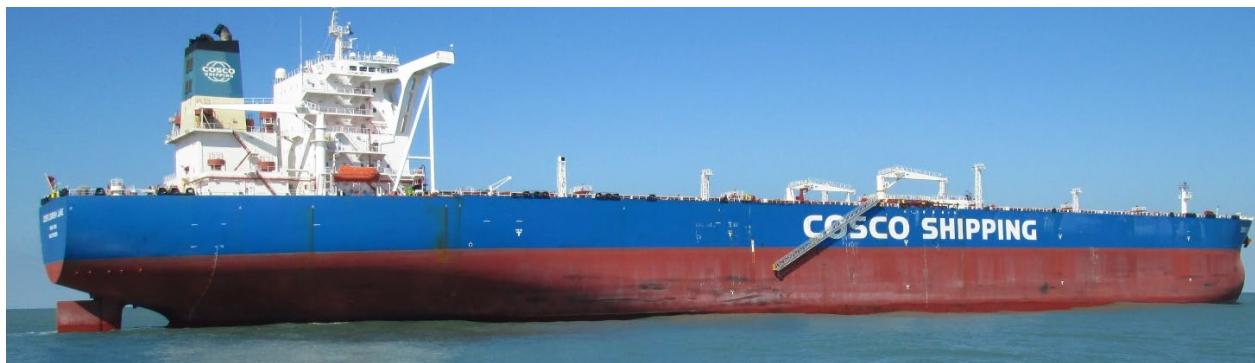
**Figure 1.** The *Cosflourish Lake* at anchor on November 15, after the contact. (Source: US Coast Guard)

There was no structural damage to the *Cosflourish Lake*. A postcasualty survey by the ship's classification society determined that there were no hull plate deformations and only minor scratches on the hull.

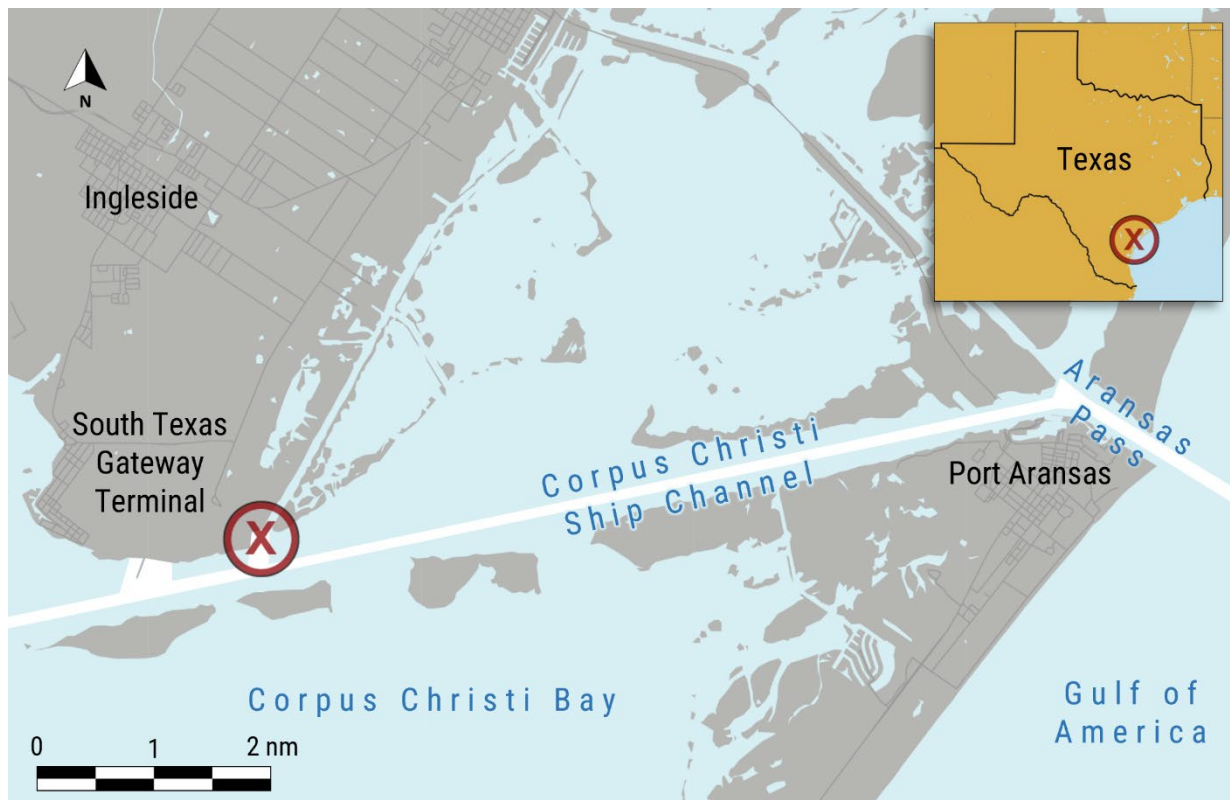
On November 14, 2023, about 1415 local time, the tanker *Cosflourish Lake* struck protective pilings and two breasting dolphins while docking at the east dock of South Texas Gateway Terminal (STGT) in Ingleside, Texas (see figure 1 and figure 2).<sup>1</sup> There were no injuries, and no pollution was reported. Damage to the terminal was estimated at \$18 million.<sup>2</sup>

**Figure 2.** Area where the *Cosflourish Lake* contacted the South Texas Gateway Terminal east dock protective pilings and mooring dolphin, as indicated by a red X. (Background source: Google Maps)

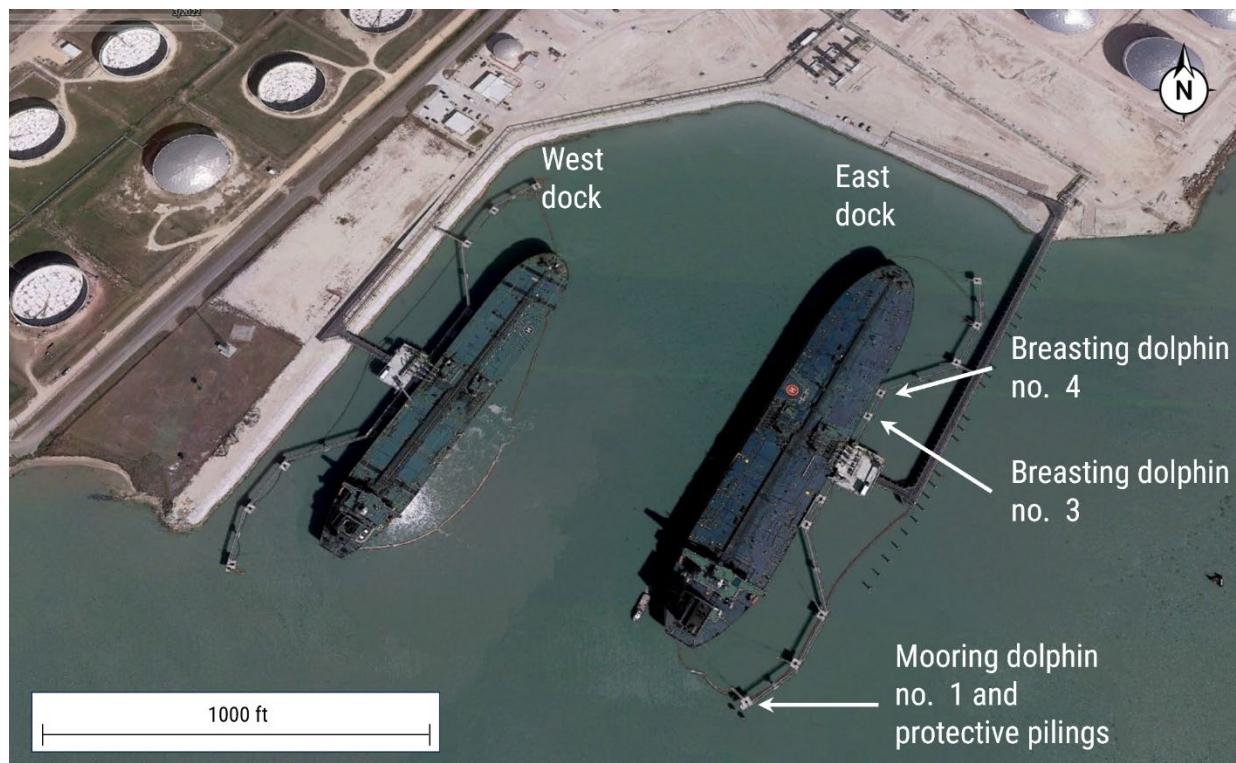
**Figure 3.** Overhead view of the STGT with two tankers (not involved in the casualty) moored at the east and west docks in 2022. The east dock protective pilings and breasting dolphins that were damaged are indicated. (Background source: Google Earth)

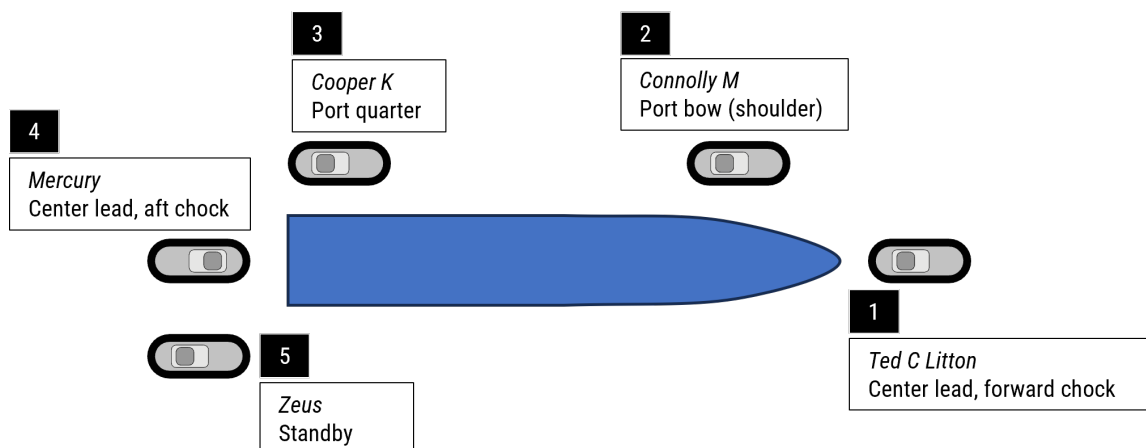
About 1301, Pilot 1 took the conn. Pilot 1 briefed the master that the plan was to dock the tanker starboard-side-to using five tractor tugs: four 6,772-hp, tractor tugs would have a line to the tanker, and one 5,150 hp-tractor tug would be standing by to assist where needed (see figure 4). The pilots assigned numbers to the tugs from bow to stern, with the no. 1 tug (*Ted C Litton*) being the first tug at the bow, the no. 2 tug (*Connolly M*) on the port shoulder, the no. 3 tug (*Cooper K*) on the port quarter, the no. 4 tug (*Mercury*) at the stern, and the no. 5 tug (*Zeus*) as the standby tug. About 1308, the no. 4 tug was secured with a line on the stern through the center chock.

**Figure 4.** Planned tug positions for the docking. Tug positions and orientations are approximate (not to scale).

Pilot 3 used five tugs and engine and rudder orders to turn the *Cosflourish Lake* to starboard to align the vessel with the STGT east dock. He ordered the two tugs at the vessel's bow to push the bow to starboard, toward the dock (tug no. 1 was pushing from the port bow slow toward and tug no. 2 was pushing at full power toward from the port shoulder) until about a minute before the contact with the breasting dolphins, when he ordered both tugs to pull the bow to port (away from the dock) at full power. However, Pilot 3's order came too late to arrest the bow's momentum to starboard, resulting in the contact.

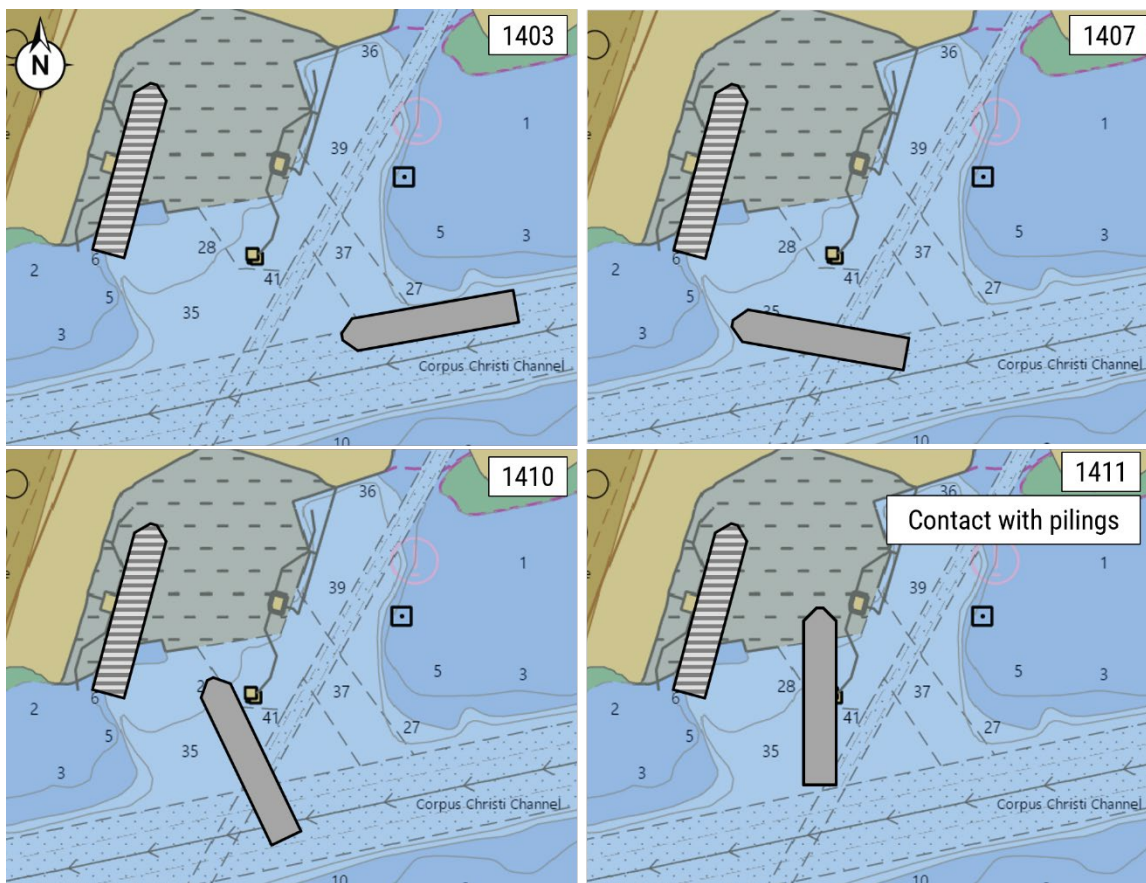
At 1411, as the pilot continued to issue tug, engine, and rudder orders, the starboard side of the *Cosflourish Lake* struck two of three rubber tire-covered pilings at the end of the east dock. The vessel had a speed of 2.2 knots on a heading of about 354°.

**Figure 5.** The *Cosflourish Lake*'s positions, relative to the east dock and the vessel at the west dock, leading up to the initial contact with the east dock's pilings. (Source: Electronic Chart Display and Information System from *Cosflourish Lake*. Background source: National Oceanic and Atmospheric Administration, Electronic Navigation Chart US5CRPBF as viewed on Made Smart automatic identification system)

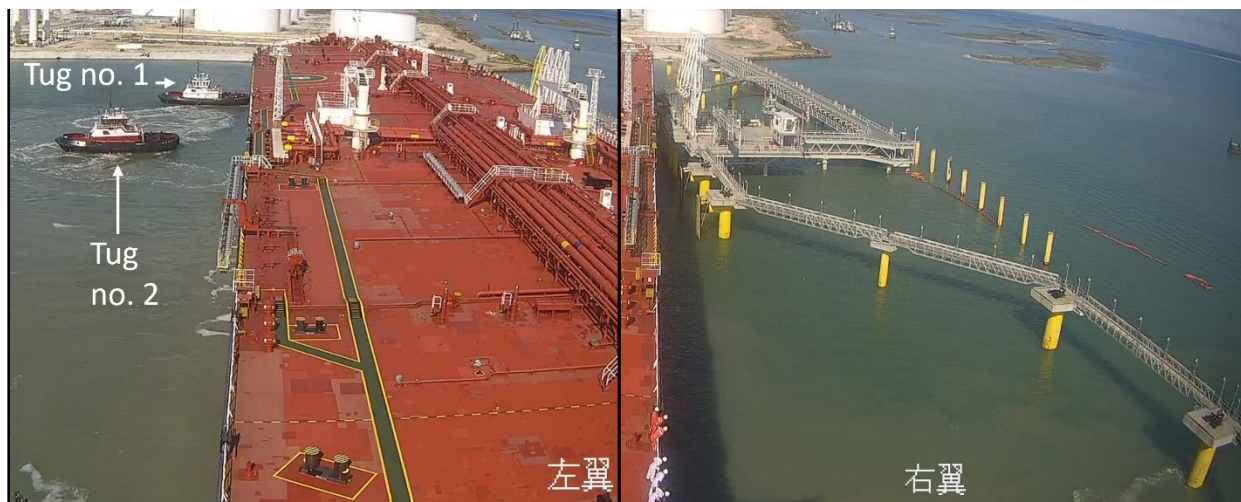
**Figure 6.** Left to right: Image recording system screenshot at 1415, the time of contact with the east dock breasting dolphins, from the port and starboard side of the *Cosflourish Lake*, looking forward. (Source: Cosflourish Lake Maritime Ltd)

At 1415, Pilot 3 ordered tug no. 1 to “half away” (pull the bow to port at half power away from the east dock) and, seconds later, tug nos. 1 and 2 to “full away up there” (pull the bow to port at full power, away from the east dock). Just after 1415, at a speed of 0.6 knots, the pilot ordered the rudder to midship, and the engine stopped. He again requested tug no. 2 to full away. The officer of the watch announced that the engine was stopped, and the pilot ordered tug no. 1 to “full away,” to which tug no. 1 replied, “no. 1 full away.” The pilot then again requested stop engine. At 1415:40, the starboard forward side of the *Cosflourish Lake* struck breasting dolphins nos. 3 and 4 of the east dock.

The National Transportation Safety Board determines that the probable cause of the contact of the tanker *Cosflourish Lake* with the South Texas Gateway Terminal dock was the pilot at the conn not effectively using the tugs at the vessel's bow while docking.

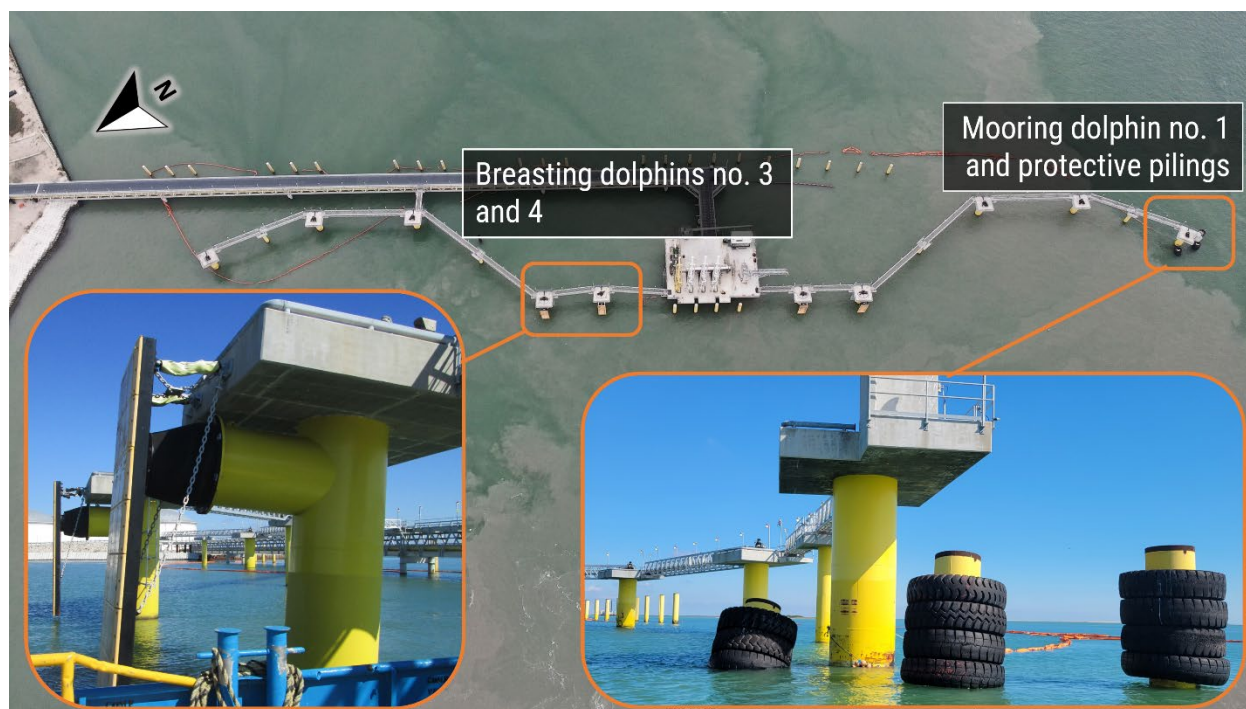
The contact displaced two breasting dolphins, damaged the two connecting catwalks, and damaged two of three pilings for the mooring dolphin located at the south side of the dock closest to the ship channel. The contact shifted one of the breasting dolphins east by 3.5 feet; the other breasting dolphin had a slight lean to the east by about 3-4 inches. The middle pile had scarring below the waterline and was pushed over about 2-3 feet, and the westernmost pile was pushed over about 4-5 feet. The easternmost protective pile was not damaged.

**Figure 7.** Drone photo of the STGT east dock postcasualty, with the left inset showing damaged breasting dolphin no. 3, and the right inset showing the displaced westernmost and middle protective pilings. (Background source: Gibson Energy. Left inset: Coast Guard. Right inset: Gibson Energy)
