MIR-25-37

Grounding of the Towing Vessel

John M Donnelly

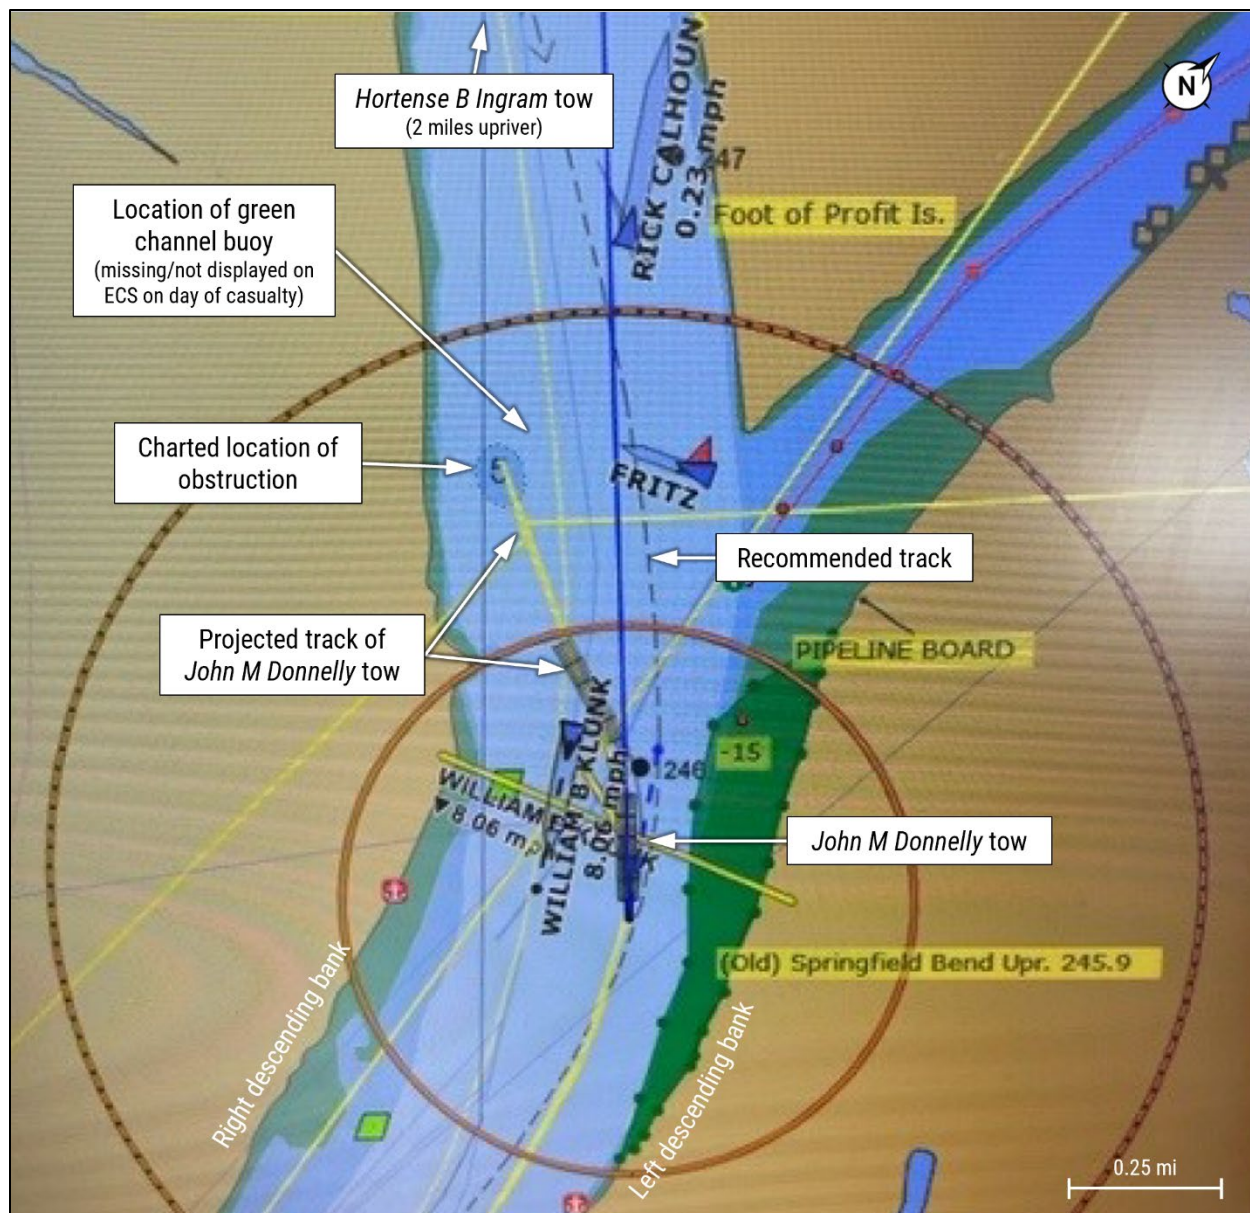
A submerged obstruction was located 600 feet off the right descending bank at mile 246.5. The IENC showed the obstruction as an area of shallow water 5 feet deep (see figure 3). (Depths on IENCs were measured from the local low water reference level.)

Figure 3. Screen capture from replay of *John M Donnelly* Rose Point ECS at 1604:25 on October 30, 2023, 3.5 minutes before the towing vessel grounded. (Background source: Coast Guard)

According to Coast Guard personnel who maintain Mississippi River navigation aids, a green channel buoy had been placed near the obstruction in late 2022 following a previous grounding. However, when investigators arrived at the scene of the *John M Donnelly* grounding, the channel buoy was missing (it is not uncommon for buoys on the Mississippi River to be displaced due to high currents or buildup of debris around the navigation aids). Investigators could not determine when the navigation aid was displaced. Additionally, the buoy was not shown on the *John M Donnelly*'s ECS display when investigators replayed the casualty event on the system. The shallow area marking the obstruction was visible on the ECS display (see figure 3).

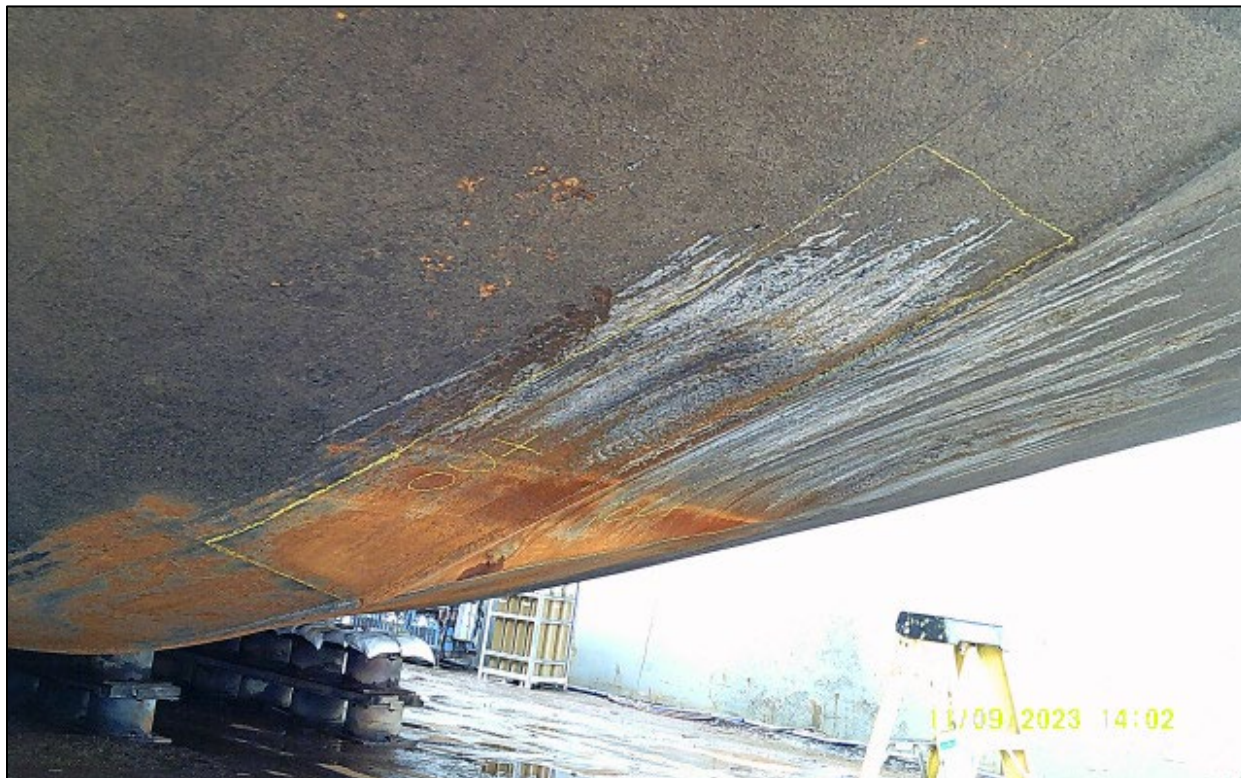
vessel was refloated by salvors and towed to a repair facility. The grounding damaged the vessel; it inset hull bottom plating and tripped vertical stanchions; opened a weld seam on a fuel tank, resulting in an internal leak; and caused other structural damage around the impact site (see figure 4). Damage repairs cost \$505,834.

Figure 4. Bottom plating near the bow of the *John M Donnelly* that was inset when the vessel grounded. (Source: Budwine and Associates, LLC)
