Fire aboard Bulk Carrier *Cuyahoga*

On March 15, 2024, about 1315 local time, the bulk carrier *Cuyahoga* was undergoing maintenance while docked in Ashtabula, Ohio, when a fire broke out in a cargo hold where hot work was being conducted (see figure 1 and figure 2).¹ The crew and maintenance personnel on the vessel were unable to extinguish the fire and evacuated to shore. The Ashtabula Fire Department, with assistance from the ship's crew, extinguished the fire. There were no injuries, and no pollution was reported. The vessel was declared a constructive total loss estimated at \$11 million.²

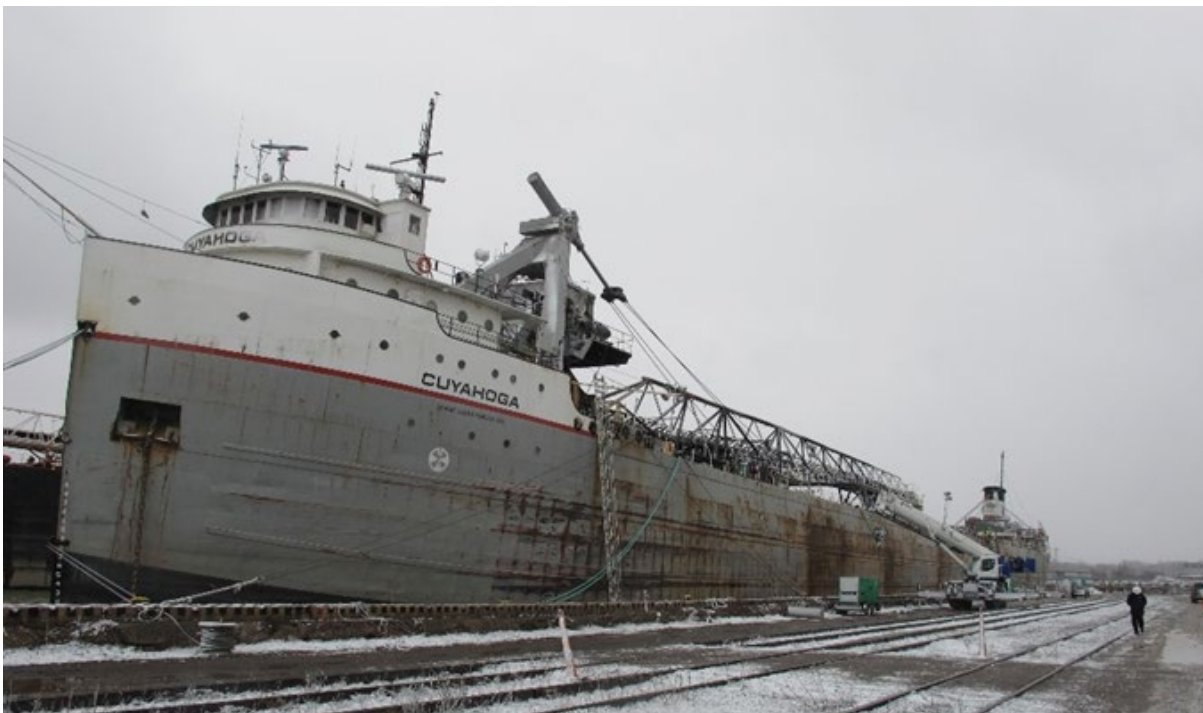
Figure 1. *Cuyahoga* after the fire, on March 20, 2024.

After the fire, investigators from the US Coast Guard, the National Transportation Safety Board, and the Ashtabula Fire Marshall examined the *Cuyahoga*. The vessel sustained damage to the main deck, with warping and deformation around cargo hold no. 2. The unloading boom conveyor belt was consumed by fire, and the metal framing of the boom was deformed. Investigators found extensive fire damage to cargo hold nos. 1 and 2, as well as to the conveyor

tunnel belts. The vessel was declared a constructive total loss estimated at \$11 million.

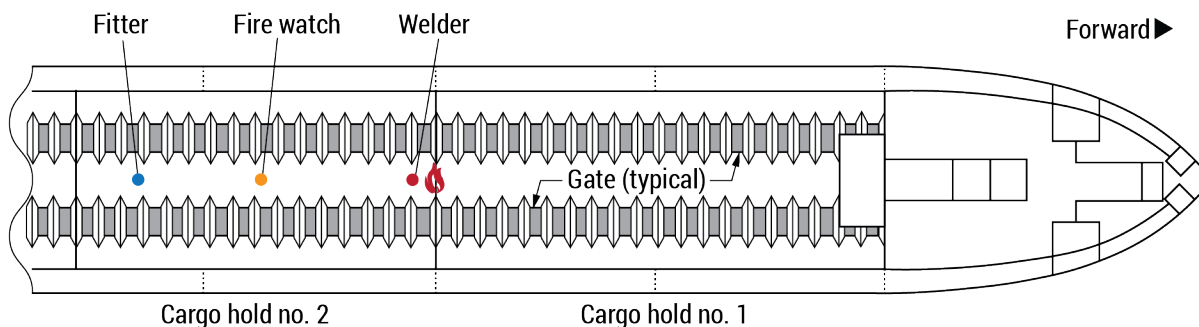
About 1315, the fire watch, who was located near the center of cargo hold no. 2, saw a flame on the forward bulkhead near the ladder and yelled, "Fire!" The fire watch told investigators that the base of the fire was 4 to 5 feet up the bulkhead, near the wooden planking (see figure 4). At the same time, the welder, who was facing away from the cargo hold's forward bulkhead, felt heat on his back. He turned toward the forward bulkhead and saw flames on the bulkhead near the ladder. The fitter also stated that he observed smoke and a fire by the forward ladder. According to the fitter, the fire was about 5 feet above the bottom of the cargo hold and quickly growing up the bulkhead above the location of the wooden planking.

Figure 4. Layout of the cargo hold no. 2 with approximate locations of fitter, fire watch, and welder (not to scale).

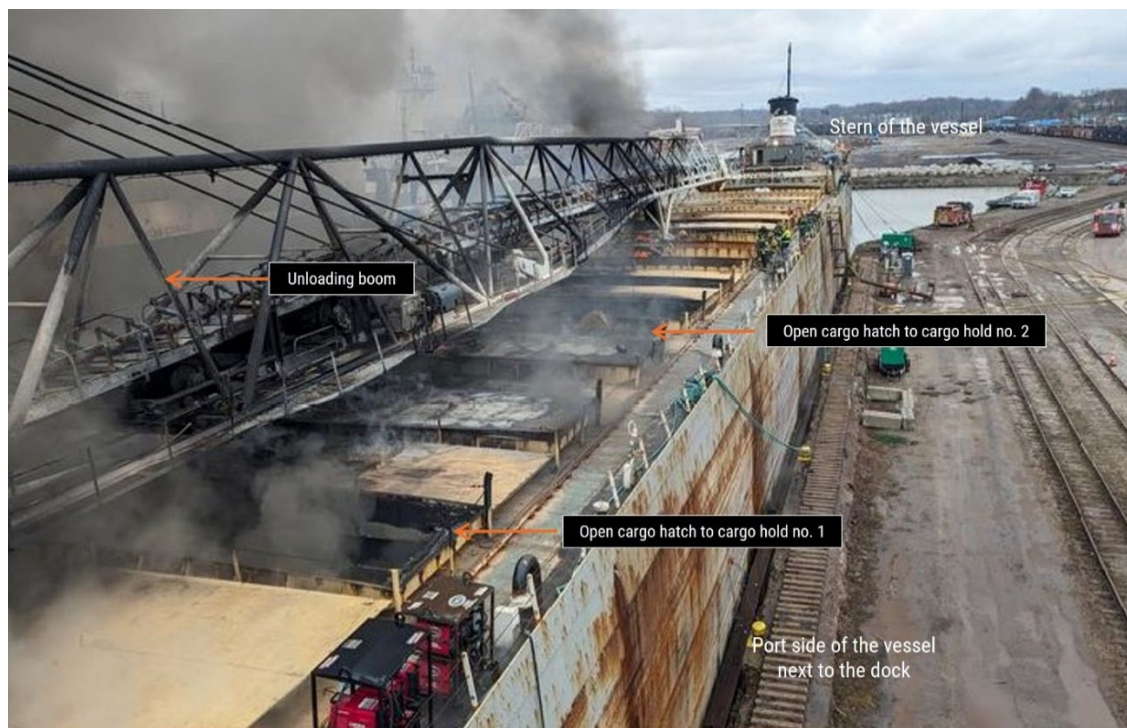
Figure 5. *Cuyahoga* during the fire. (Source: Ashtabula Fire Department)

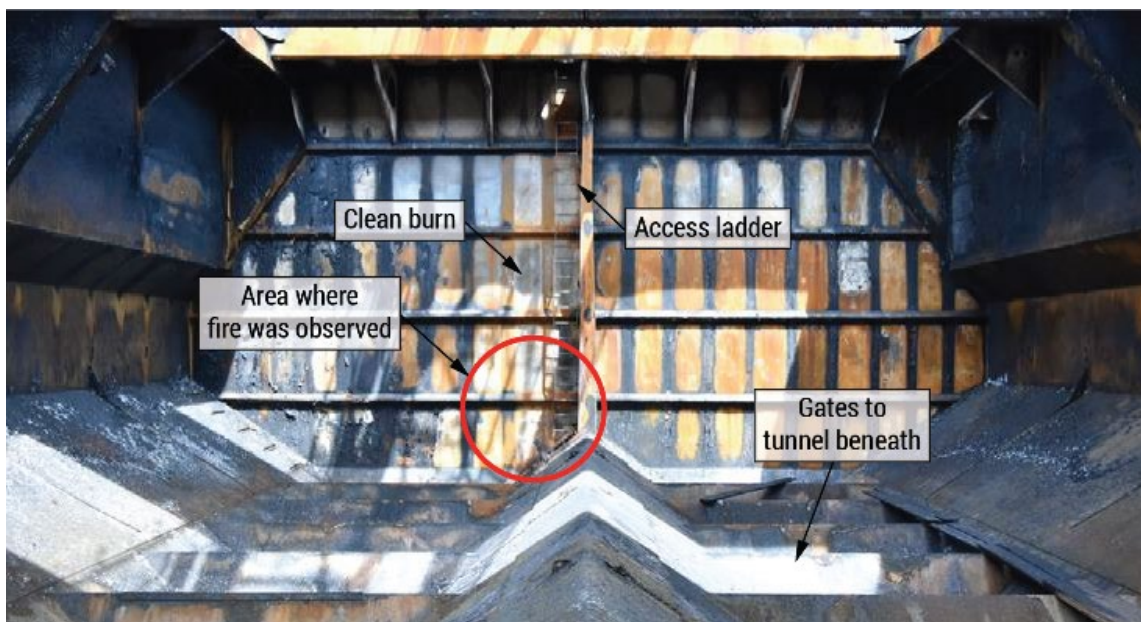
In cargo hold no. 2, investigators found an area of “clean burning” at the bottom of the access ladder, along with heavy soot on areas in alignment with the vertical stiffeners located on the other side (cargo hold no. 1) of the bulkhead (see figure 6).⁵ Additionally, in cargo hold no. 2, investigators found the remains of the welding machine, as well as other wooden planks located within the cargo hold.

Figure 6. Photo of the fire damage to the forward bulkhead of cargo hold no. 2, showing the location circled in red where welder, fitter, and fire watch saw the initial fire. (Background Source: Ashtabula Fire Department).

Personnel in cargo hold no. 2 reported first seeing the fire about 5 feet above the base of the cargo hold forward bulkhead. There were no reports from the workers of any signs of fire or smoke in the unloading tunnels below the cargo hold, and investigators found no fire damage patterns indicating a fire was initiated in the tunnels and moved into the cargo hold. Additionally, a postcasualty examination of cargo hold no. 2 found clean burning in the same area where the fire was first seen by the fire watch. Clean burning is consistent with high temperature fires associated with the epoxy coating on the bulkhead that have a longer period of time to burn and consume the source of fuel. Given the location of the clean burn, it is likely that the fire's origin was on the forward bulkhead of cargo hold no. 2.

The National Transportation Safety Board determines that the probable cause of the fire on the bulk carrier *Cuyahoga* was the ignition of the epoxy coating on the forward bulkhead within cargo hold no. 2, possibly from a smoldering fire from an undetermined source associated with earlier hot work in the hold.

The NTSB has investigated multiple fires caused by a smoldering fire that occurred following the completion of hot work. A smoldering fire is formed when combustible material ignites, but the combustion proceeds slowly and steadily on the material's surface with little heat and no smoke or flame. A smoldering fire is not easily detected, and depending upon its surroundings, it can last for hours after the initial ignition. A smoldering fire can long outlast the time a fire watch observes an area following hot work. Additionally, it can quickly grow into a flaming fire, with no warning. Therefore, it is critical to evaluate work areas for fire hazards and ensure that combustibles are relocated or protected from hot work.
