October 20, 2025

MIR-25-39

Engine Room Fire aboard Dredging Vessel *Stuyvesant*

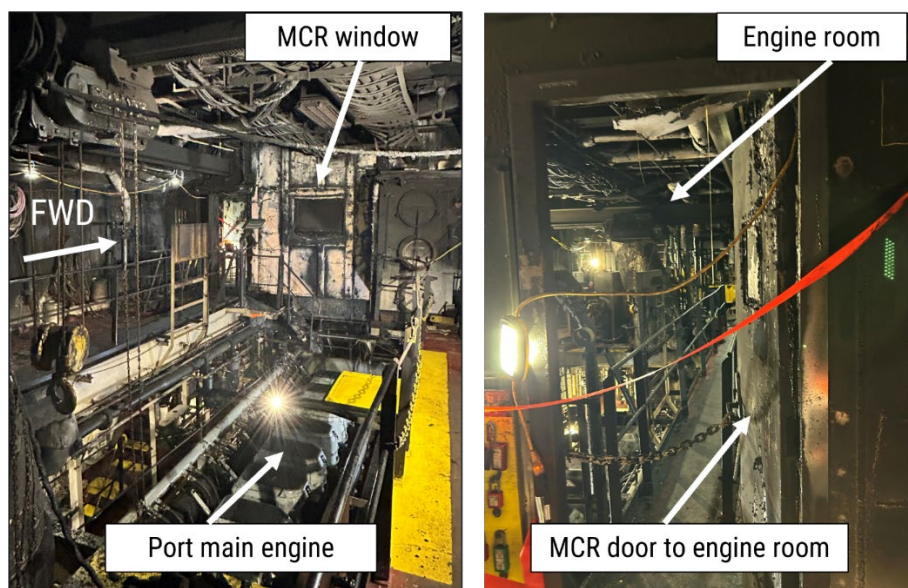
After the fire, National Transportation Safety Board and Coast Guard investigators examined the damage to the engine room and MCR. About 300 electrical and signal cables in the engine room in the area forward and above the port main engine were burned by the fire and required replacement (see figure 5). Inside the MCR, the machinery control system and the main electrical switchboard were damaged beyond repair and required replacement.

Figure 5. Left to right: Upper engine room and MCR after the fire.

After the fire, during the 8 months the vessel underwent repairs, the engine control system was renewed and the electrical control and distribution panels in the MCR were replaced. All switchgear controls were relocated into the MCR and were designed to be operated by a single crewmember. A new fire detection system was installed in the engine room and throughout the vessel, and all damaged lighting in

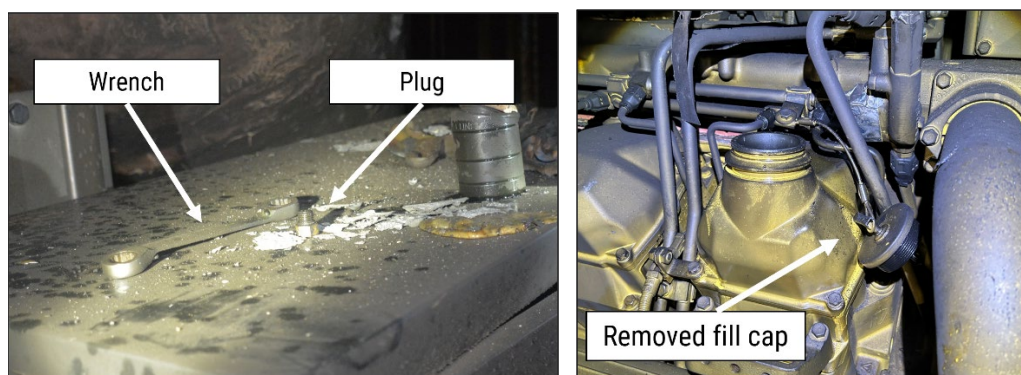
Investigators found the fuel and lube oil filters that had been removed during the routine maintenance from the port auxiliary engine in buckets near the engine unburned and intact. The lube oil fill cap on the port auxiliary engine had not been reinstalled, and the lube oil filter housing plug was not threaded into the internally threaded port; it was found sitting with a wrench on a nearby storage cabinet (see figure 6). The plug's O-ring was intact and not affected by fire. The internally threaded port on the portside auxiliary engine's lube oil filter housing faced forward toward the port main engine and MCR (see figure 7).

Figure 6. Left to right: Removed plug on top of storage cabinet and removed fill cap from port auxiliary engine. (Source [right]: Coast Guard)

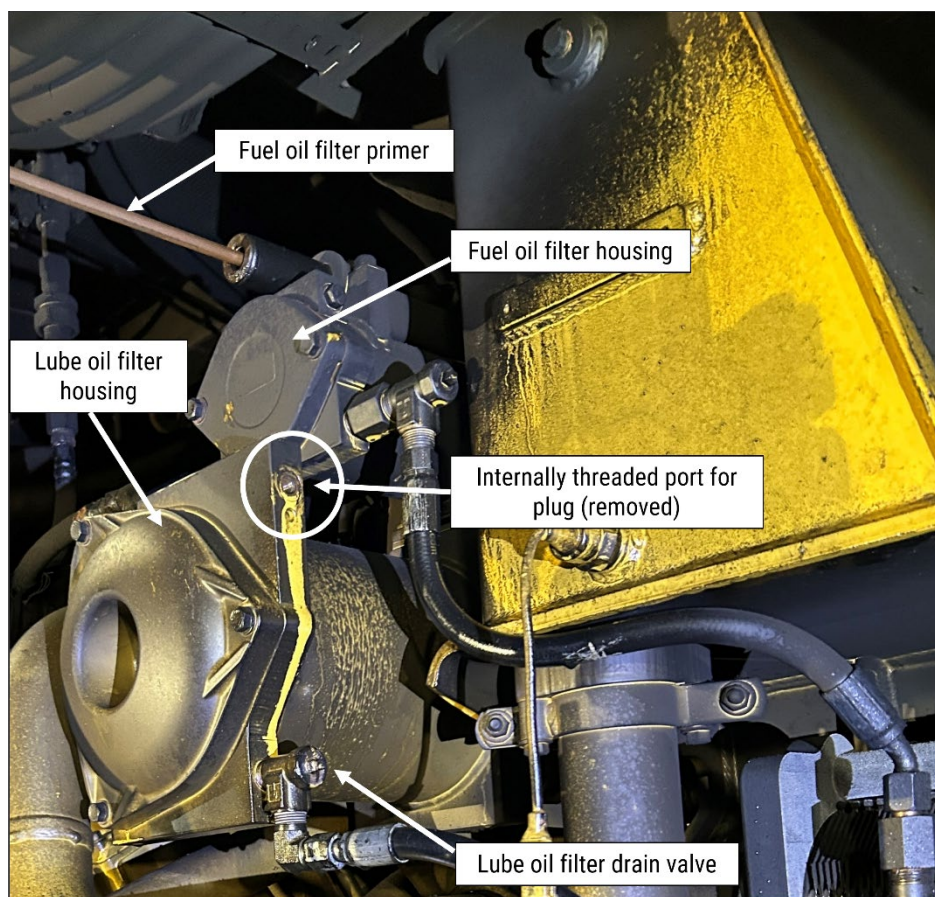
Figure 7. Port auxiliary engine lube oil filter housing aboard *Stuyvesant* after the fire. The internally threaded port with the missing plug is circled at the top of the lube oil filter housing.

On November 2, 2024, while the dredging vessel *Stuyvesant* was holding station in the St. Johns River near Jacksonville, a fire broke out in the engine room. Crewmembers had just completed maintenance on the port auxiliary engine which included replacing the fuel and lube oil filters and the lube oil in the sump. Once the work was complete, the first engineer started the engine remotely from the MCR, and less than a minute later, engineering crewmembers saw flames in the engine room. After the fire, investigators found that the crew had not reinstalled the plug on the engine's lube oil filter housing after completing maintenance. Without the plug reinstalled on the lube oil filter housing, pressurized lube oil would have sprayed out from the port auxiliary engine through the internally threaded port at the top of the lube oil filter housing when the engine was started.

Recorded operating lube oil pressure for the port auxiliary engine was about 65 psi. The orientation of the port auxiliary engine in relation to the port main engine would have provided a path for the lube oil, spraying out in the forward direction from the open internally threaded port in the lube oil filter housing onto the port main engine a deck below. The exhaust temperatures of the port main engine, when in operation, were recorded to be between 614°F and 742°F, which would have been sufficient heat to ignite the spraying lube oil. Additionally, technicians noted that about 57 gallons of lube oil were missing from the lube oil sump of the port auxiliary engine after the fire. Therefore, the fire in the engine room started when pressurized lube oil from the port auxiliary engine sprayed onto a hot surface of an operating main diesel engine.

After maintenance has been conducted on engine room machinery, diligent inspection of the machinery is critical to ensure it functions as expected and all components have been reinstalled properly. Starting up engines locally, rather than remotely, gives crewmembers the opportunity to immediately verify that the engine is operating satisfactorily (to manufacturer's specifications) with no visible fuel, lube oil, or water leaks, and has no atypical noises or vibrations that require it to be stopped.
