December 2, 2025

MIR-25-41

Lithium-ion Battery Fires aboard Cargo Vessel *Genius Star XI*

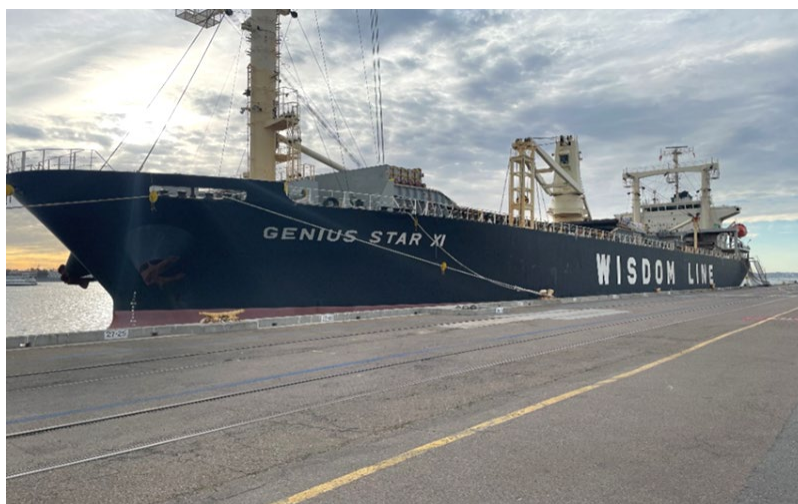
On December 25, 2023, at 0830, while the cargo vessel *Genius Star XI* was transiting the North Pacific Ocean in heavy weather with a cargo of lithium-ion battery energy storage system units on board, a fire was discovered in a cargo hold (see figure 1 and figure 2).¹ Crew discharged the vessel's fixed gas (carbon dioxide) fire extinguishing system into the hold, and the vessel proceeded to the nearest port, Dutch Harbor, Alaska, for assistance. On December 28, about 0215, while the vessel was en route to Dutch Harbor, a fire started in a second cargo hold. The crew externally cooled the cargo hold using fire hoses, and, after the vessel anchored in Dutch Harbor on December 29, the fire was determined to be extinguished. There were no injuries, and no pollution was reported. Damage from both fires was estimated at \$3.8 million.

Figure 1. Cargo vessel *Genius Star XI* on February 24, 2024, after the fires.

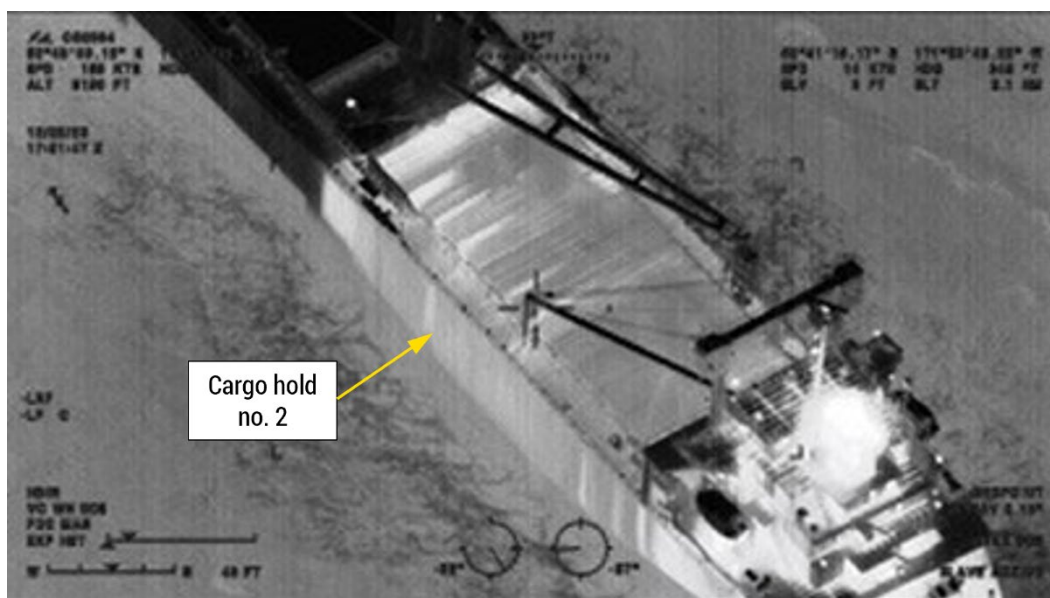
At 0223, the crew started a fire pump, and at 0228, the crew began spraying sea water on the outside of the no. 2 cargo hold with fire hoses. The crew continued to spray water on the area of cargo hold no. 2 for about 4 hours, then monitored the area with the infrared sensing temperature gun. As the vessel approached Dutch Harbor, the temperature within the hold was decreasing, which indicated that the fire was extinguishing and not spreading (see figure 8).

Figure 8. Infrared photo of the *Genius Star XI* en route to Dutch Harbor, showing an indication of heat (in white) within cargo hold no. 2 on December 28. (Background source: Coast Guard)

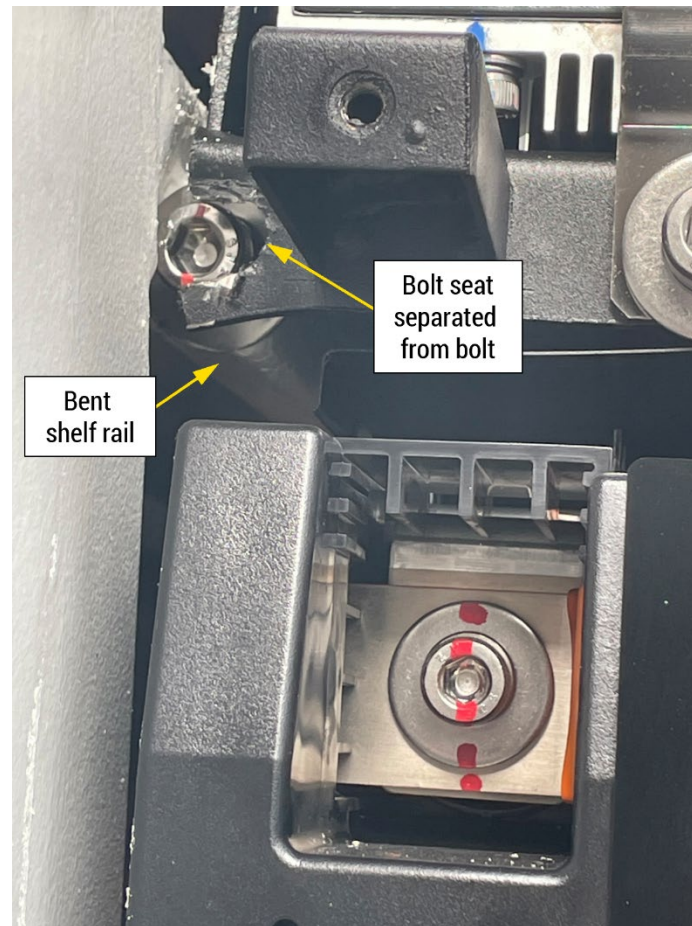
While the *Genius Star XI* sustained no structural damage from the two fire events, investigators identified that three BESS units—two located on the tween deck of cargo hold no. 1 and one located on the tween deck of cargo hold no. 2—had experienced an internal fire (see section 1.5.4). They also discovered that 43 of the 160 BESS units stored on the tween decks of cargo hold no. 1 and no. 2 had been damaged. Forty one of the 43 damaged units had broken from their lashings and shifted, and several of those had experienced some level of internal shelf rail deformation—meaning the shelf rail structure had bent downward, allowing the bolt seat holding the lithium-ion battery cells to partially or to fully slip off the securing bolt (see figure 9).

Figure 9. An example of a shelf rail deformation showing a bent shelf rail with a bolt seat for the shelf separated from the bolt.

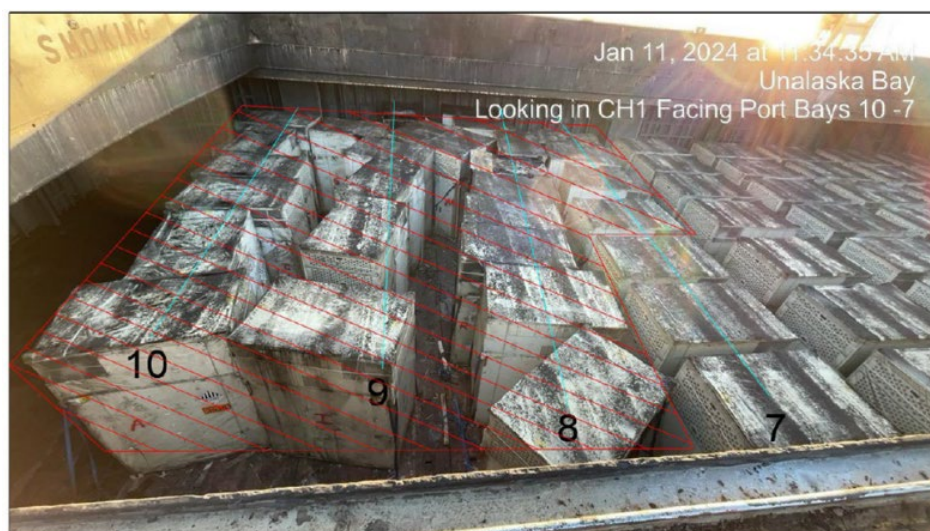
Twenty-four BESS units in cargo hold no. 1, where the first fire was discovered on December 25, became loose and shifted on the tween deck (see figure 10).

Figure 10. Shifted BESS units in tween deck cargo hold no. 1. (Source: ESA)

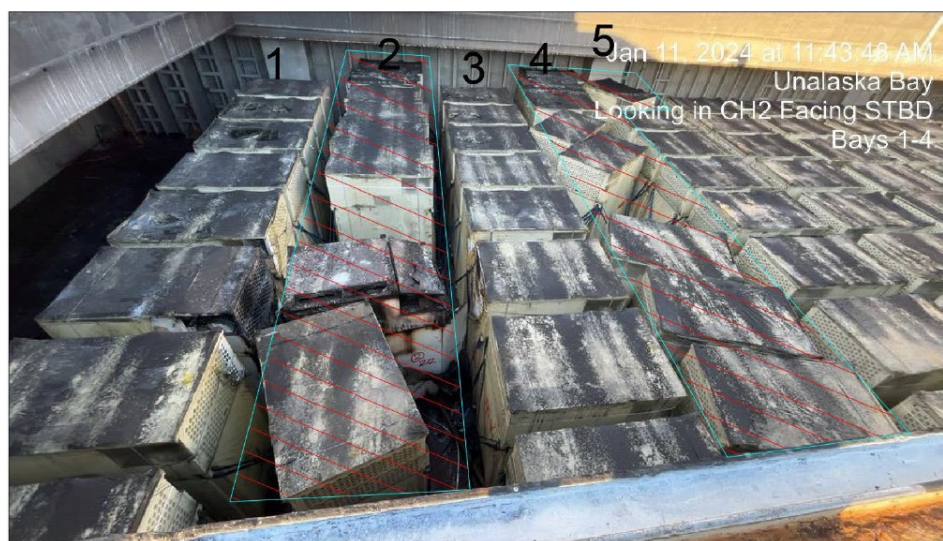
Seventeen BESS units in cargo hold no. 2, where the second fire was discovered on December 28, became loose and shifted on the tween deck (see figure 11).

Figure 11. Shifted BESS units on the tween deck of cargo hold no. 2. (Source: ESA)

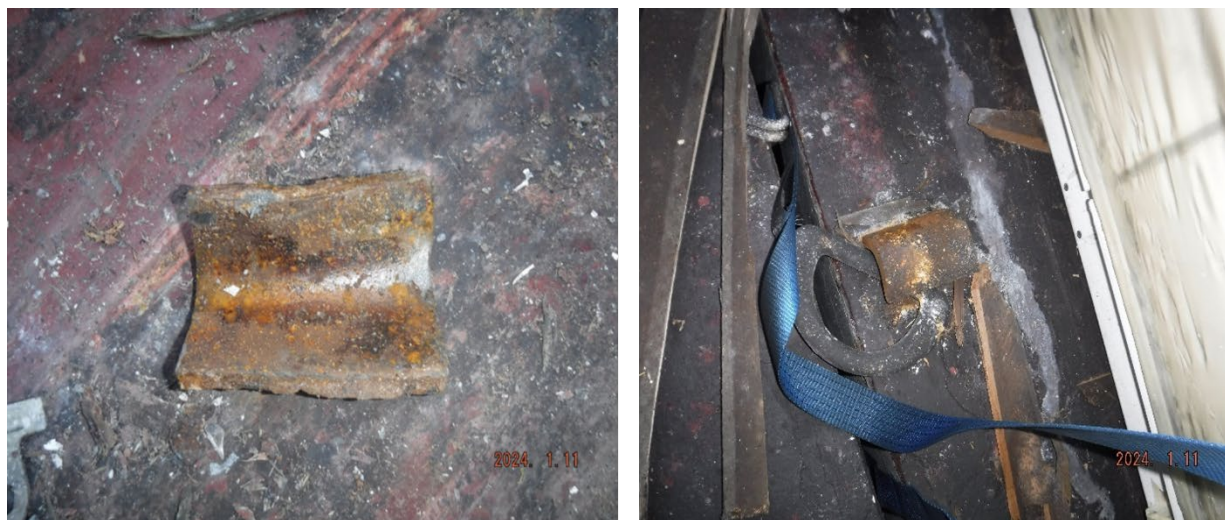
Several brackets securing the D-rings (which had a breaking load of 36 metric tons) to the tween decks of cargo hold no. 1 and no. 2, had separated, allowing the BESS units to shift. The separations occurred at the welds between the brackets and

the deck. Additionally, some of the brackets deformed, and the welds fractured, but these brackets still remained partially connected to the deck (see figure 12).

Figure 12. Left to right: Bracket found separated from the deck, and a D-ring partially pulled from a deformed bracket that was still connected to the deck. (Source: Coast Guard)

Additionally, investigators observed that numerous welded brackets securing D-rings had separated or had partially separated from the tween decks. Once a hook on a lashing belt had fractured, the remaining three D-rings and brackets, still attached to a lashing belt, would have been subjected to higher forces to hold the BESS unit in place during heavy seas. Therefore, it is more likely that the welds holding the bracket to the tween deck would subsequently fracture and separate. Also, once the BESS units started to shift within the cargo hold, they could have struck D-ring brackets, causing the brackets to separate from the tween deck. Therefore, it is likely that in addition to shifting cargo from lashing hook failures, the separation of the D-ring securing brackets from the tween deck also contributed to the BESS units becoming loose and shifting within the cargo holds.

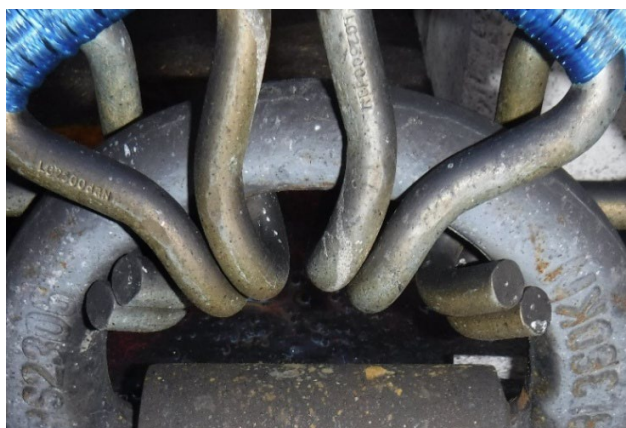
Coast Guard investigators found that the hooks on the ends of the ratchet lashing belts were not compatible with the D-rings. The D-rings were too thick (diameter too large) for the lashing hooks, which resulted in the D-ring not fully seating, or not engaging to the full depth of the throat of the hooks, with only the tip of the hook securing the lashing belts to the D-ring (see figure 13).⁶

Figure 13. Close-up view of hooks to lashing belts holding BESS units, showing only the tip of the hook in contact with the D-ring (Source: Coast Guard)

Investigators found that numerous lashing belt hooks had fractured. A closer examination of the remaining connections between the lashing belt hooks and D-rings found that the diameter of the D-ring and the inner diameter of the hook (throat opening) were not compatible. The D-ring circumference was larger than the throat of the hook; essentially, the hook was not able to fully seat on the D-ring. As a

result, only the tip of the hook was securing the lashing belt to with the D-ring. This concentrated the securing load at the turn, or bend, of the hook, instead of having that load properly transmitted across the full throat of the hook, resulting in the hook's fracture and separation. Since each BESS unit was secured by four lashing belts, the fracturing of one lashing belt hook placed additional stress on the unit's remaining hooks, and, because the hooks were not properly seated on the D-ring, it is more likely that they would subsequently fracture and separate. These lashing belt hook failures would have resulted in loose and shifting BESS units.

In addition to following a vessel's cargo securing manual and implementing the approved vessel storage and lashing plan, a vessel's crew must also conduct a thorough inspection of all the cargo-securing arrangements both during and after cargo loading. Such inspections are critical to identifying improper attachments or other concerns with cargo securement that could compromise the assumptions planners make in implementation of the plan. Not ensuring cargo is properly secured can result in cargo breakaway. Special attention should be placed on examining fitment of components, such as lashing belt hooks, wire, or chain falls used to secure the cargo to ensure they are properly seated (fully engaged) on the D-rings or other points of securement.

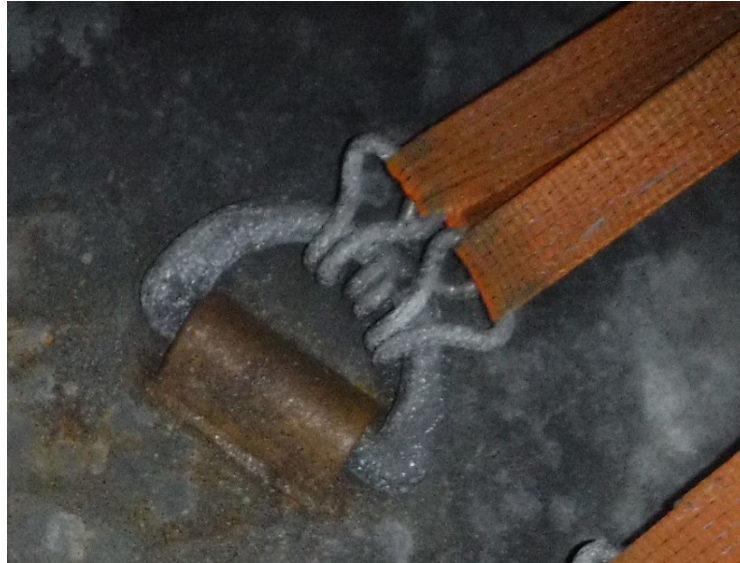
Similarly, the same hook and D-ring incompatibility was found with the lashing belts holding the BESS units and the lashing belts holding the HARPS heat exchangers on the lower deck in cargo hold no. 1 and no. 2, also with a breaking load of 36 metric tons (see figure 14).

Figure 14. Example of hooks and lashing belts holding a HARPS Heat Exchanger, with only the tip of the hook in contact with the D-ring. (Source: Coast Guard)

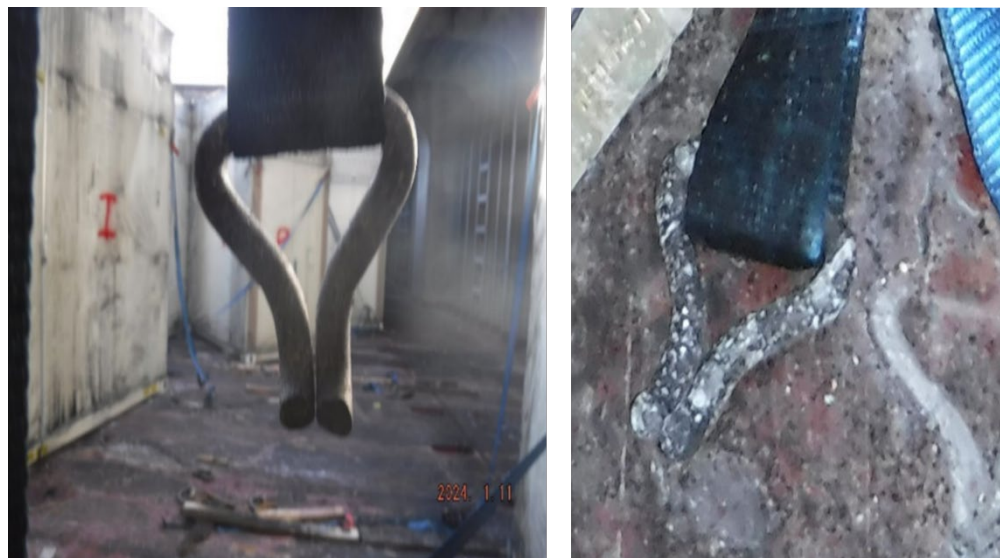
Investigators also found that numerous lashing belt hooks securing the BESS units to the D-rings on the tween deck of cargo hold no. 1 and no. 2 had fractured and separated at the turn of the hook (see figure 15).

Figure 15. Photos of two separate hooks that fractured and separated from a D-ring. (Source: Coast Guard)

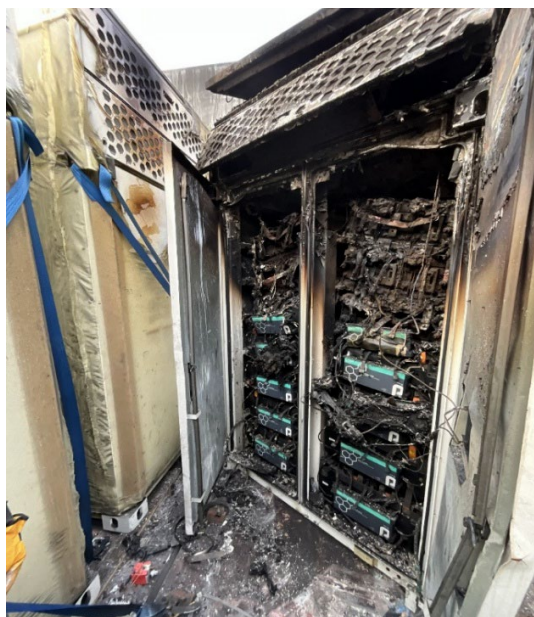
Coast Guard investigators found that the fire damage was limited to the BESS units on the tween decks in cargo holds no. 1 and no. 2. Three BESS units—two on the tween deck of cargo hold no. 1 and one on tween deck no. 2—were determined to be the sources of the two fires (see figure 16).

Figure 16. Example of a BESS unit with internal fire damage. (Source: ESA)

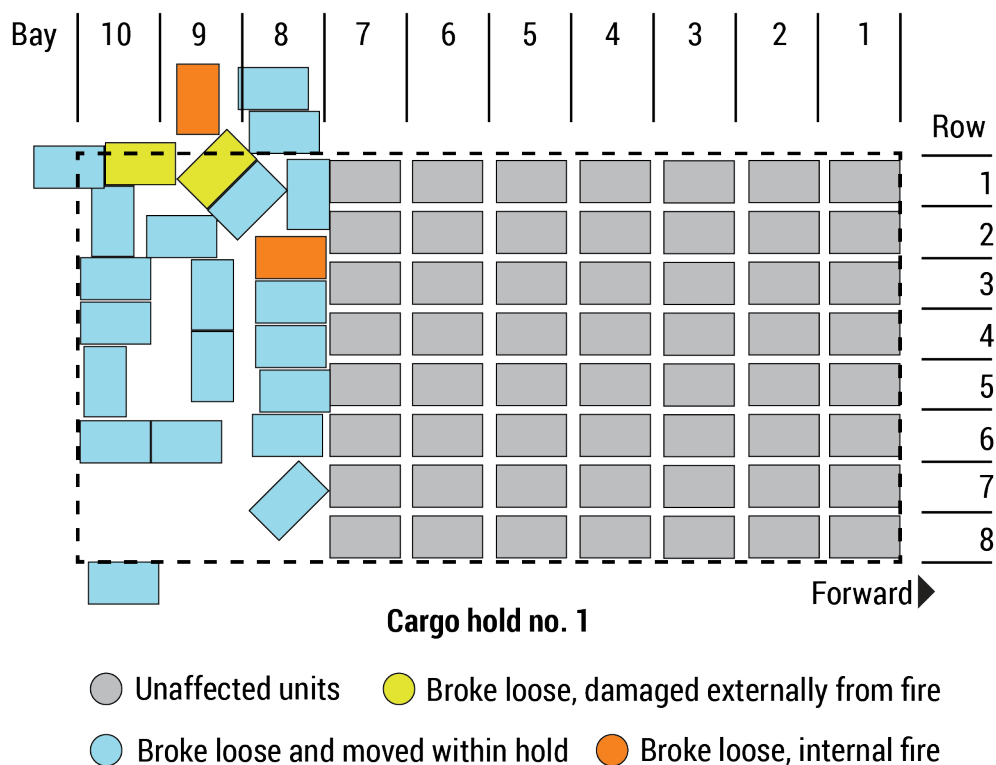
According to Coast Guard investigators, the first fire, reported on December 25, originated on the tween deck of cargo hold no. 1. Two of the units broke loose and experienced an internal fire (see figure 17). In addition, two other battery units broke loose and were damaged externally from the units where the fire originated. Twenty units broke loose from their lashings and moved within the cargo hold but did not experience an internal fire or receive external fire damage.

Figure 17. Post-fire configuration of the BESS units on the tween deck in cargo hold no. 1. (Background source: ESA)

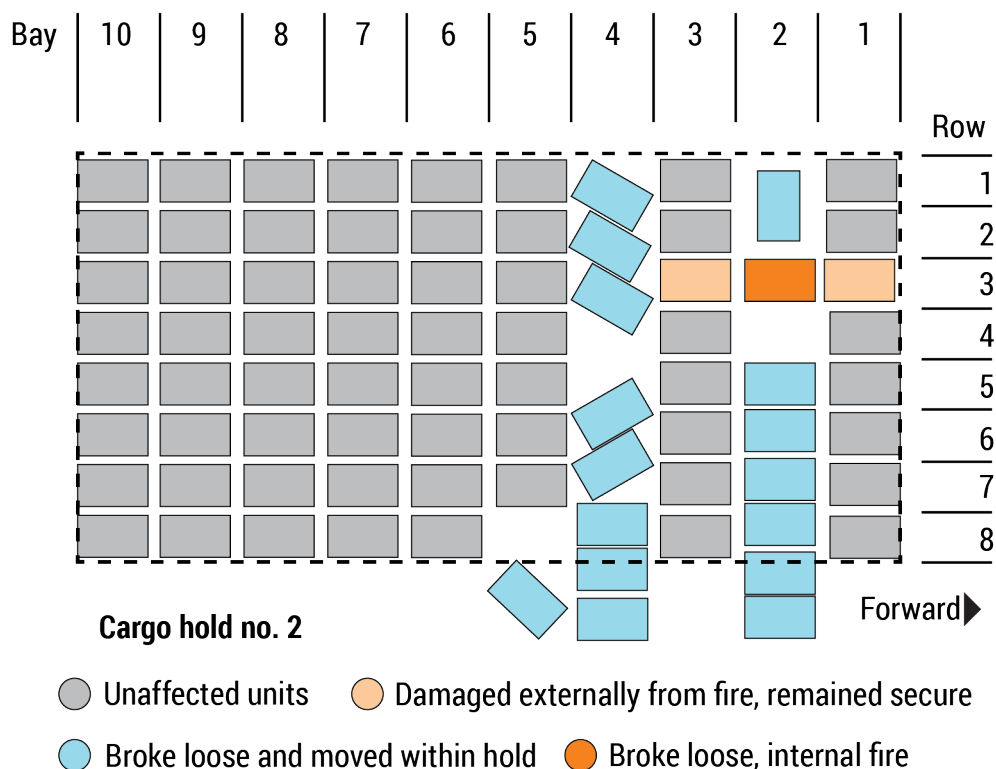
Coast Guard investigators determined that the second fire, reported on December 28, originated on the tween deck of cargo hold no. 2. One of the units broke loose and experienced a fire (see figure 18). In addition, two other units were damaged externally from the original fire, but these units remained secure to the lashing belts and did not move. Sixteen units broke loose from the lashing belts and moved within the cargo hold but did not experience an internal fire or receive external fire damage.

Figure 18. Post-fire configuration of the BESS units on the tween deck in cargo hold no. 2. Background source: ESA)

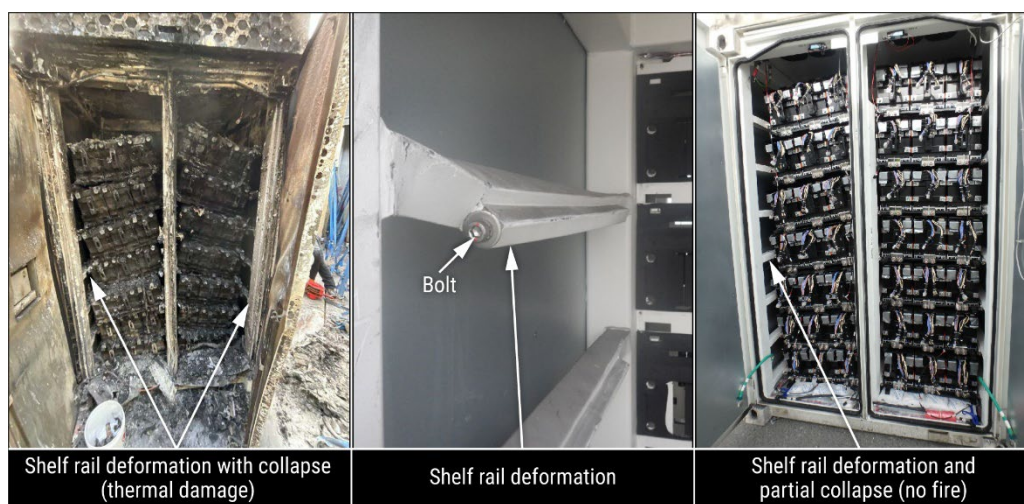
According to ESA, 30 of the 41 BESS units that broke loose from their lashing belts on the tween deck had shelf rail deformation, where the shelf rails bent downward and the bolt seat of the shelf had fully separated from two or more bolts connecting it to the shelf rail, resulting in a shelf collapse. The remainder showed some level of shelf rail deformation with shelves becoming loose or unstable but with no shelf collapse. In some cases, the shelf rail deformation was so significant that it led to a complete collapse of multiple shelves within a BESS unit (see figure 19).

Figure 19. Left to right: Postcasualty examples of shelf rail deformation in BESS units, showing units that experienced (1) shelf rail deformation with collapse and thermal damage, (2) shelf rail deformation, and (3) shelf-rail deformation followed by a several shelf collapses with no fire. Note: the busbars were removed. (Background source: ESA)

The investigation found that the 41 BESS units that had broken from their lashing belts and shifted had some level of internal shelf deformation. Additionally, the 13 units that had broken from their lashing belts and were examined by the NTSB had one or more shelves that had detached from the deformed shelf rail, resulting in shelf collapses within the unit. When a shelf weighing 136 kilograms (300 pounds) detached from its rail and collapsed, it enabled the two lithium-ion battery packs on that shelf to move freely and impact the interior structure of the BESS unit.

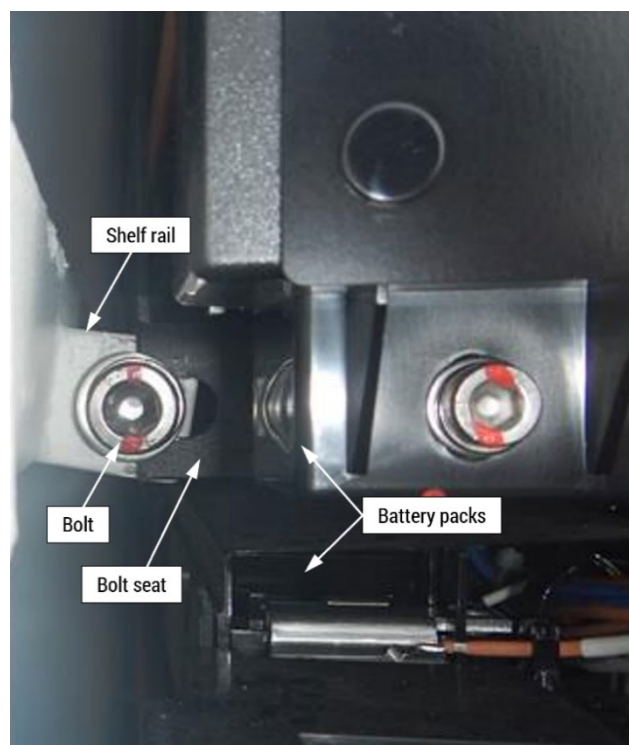
Furthermore, NTSB investigators spot-checked a sixteenth BESS unit, which was located in cargo hold no. 2, row 6, bay 7, that had not broken loose from its lashing belts and had not been damaged by the fire. The exam found that this unit showed signs of structural deformation of the shelf rails. Specifically, the shelf rails were beginning to bend downward. NTSB investigators noticed gaps between the bolts of the shelf rails and the bolt seats attached to the packs (see figure 21). The damage in this unit was generally similar to that seen in those found in the damaged units that had broken free from their lashing belts.

Figure 21. Postcasualty photo of a BESS unit that had not broken loose from its lashing belts but had deformed shelf rails and battery pack shelf separation. (Background source: ESA)

The IMDG Code requirement for the BESS units shipped under the classification "UN 3536" requires that lithium-ion battery packs be securely attached to prevent significant movement within the interior structure. The structural deformation documented in the 41 BESS units that had broken free from their lashing belts was made more severe by the movement of the units in the hold. However, the postcasualty examination showed that shelf rail deformation was also present in one BESS unit that did not break loose from its lashing and was not impacted by other

loose BESS units. The shelf rail deformations seen within this unit highlight a potential weakness in the internal structure and design of the BESS unit (which is intended for stationary land application) when subjected to transportation in the maritime environment.

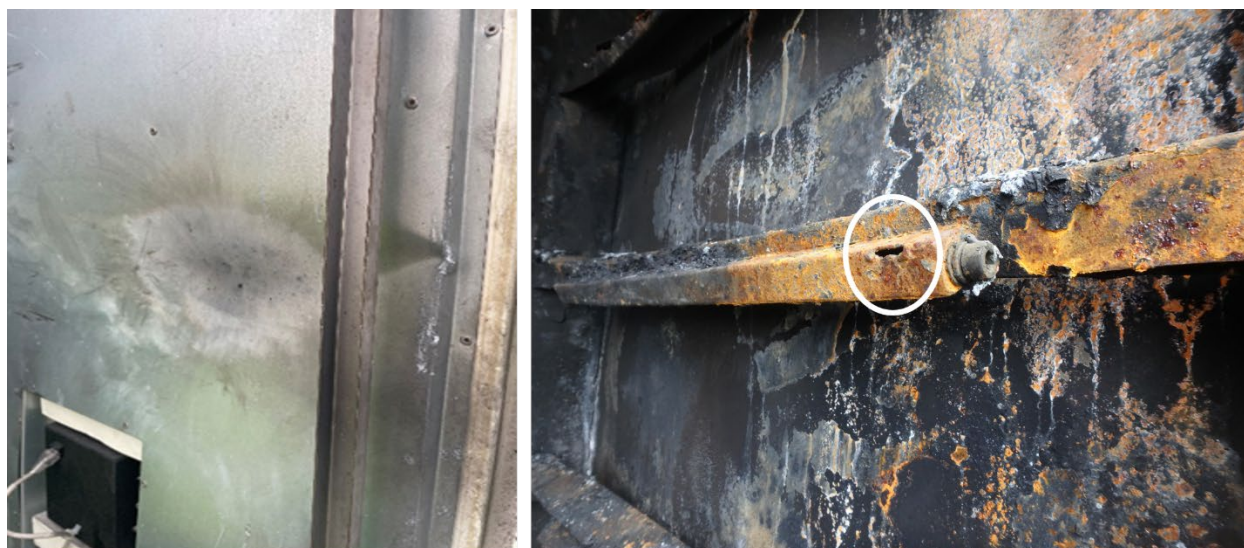
The 13 BESS units with structural deformation and collapsed shelves that were examined on February 25 also had indents, as well as arcing and scorch marks, within their interior structure (see figure 22).

Figure 22. Left to right: Examples of internal damage due to indent and scorching, and arcing (circled) found inside of the BESS units on the tween deck in cargo hold no. 1 and no. 2. (Background source: ESA)

Additionally, arcing and scorch marks were found within those same 13 units, which likely occurred when the exposed battery pack busbar impacted the inside of the unit and caused the batteries to short circuit and create an electrical discharge. The electrical discharge likely caused the lithium-ion batteries to short circuit, which damaged the cells and caused them to overheat, initiating a thermal runaway in three of the BESS units. A thermal runaway can occur when a battery cell is damaged, shorted, overheated, defective, deep discharged, or overcharged. The heat produced from a thermal runaway of a lithium-ion battery cell can exceed 572°F (300°C), which can easily cause the adjoining cells of the same battery bank to ignite, as well as cause nearby combustible materials to ignite, further spreading the fire.
