MIR-25-42

Collision between Offshore Supply Vessel *Jack Edwards* and Cargo Vessel *Julie C*

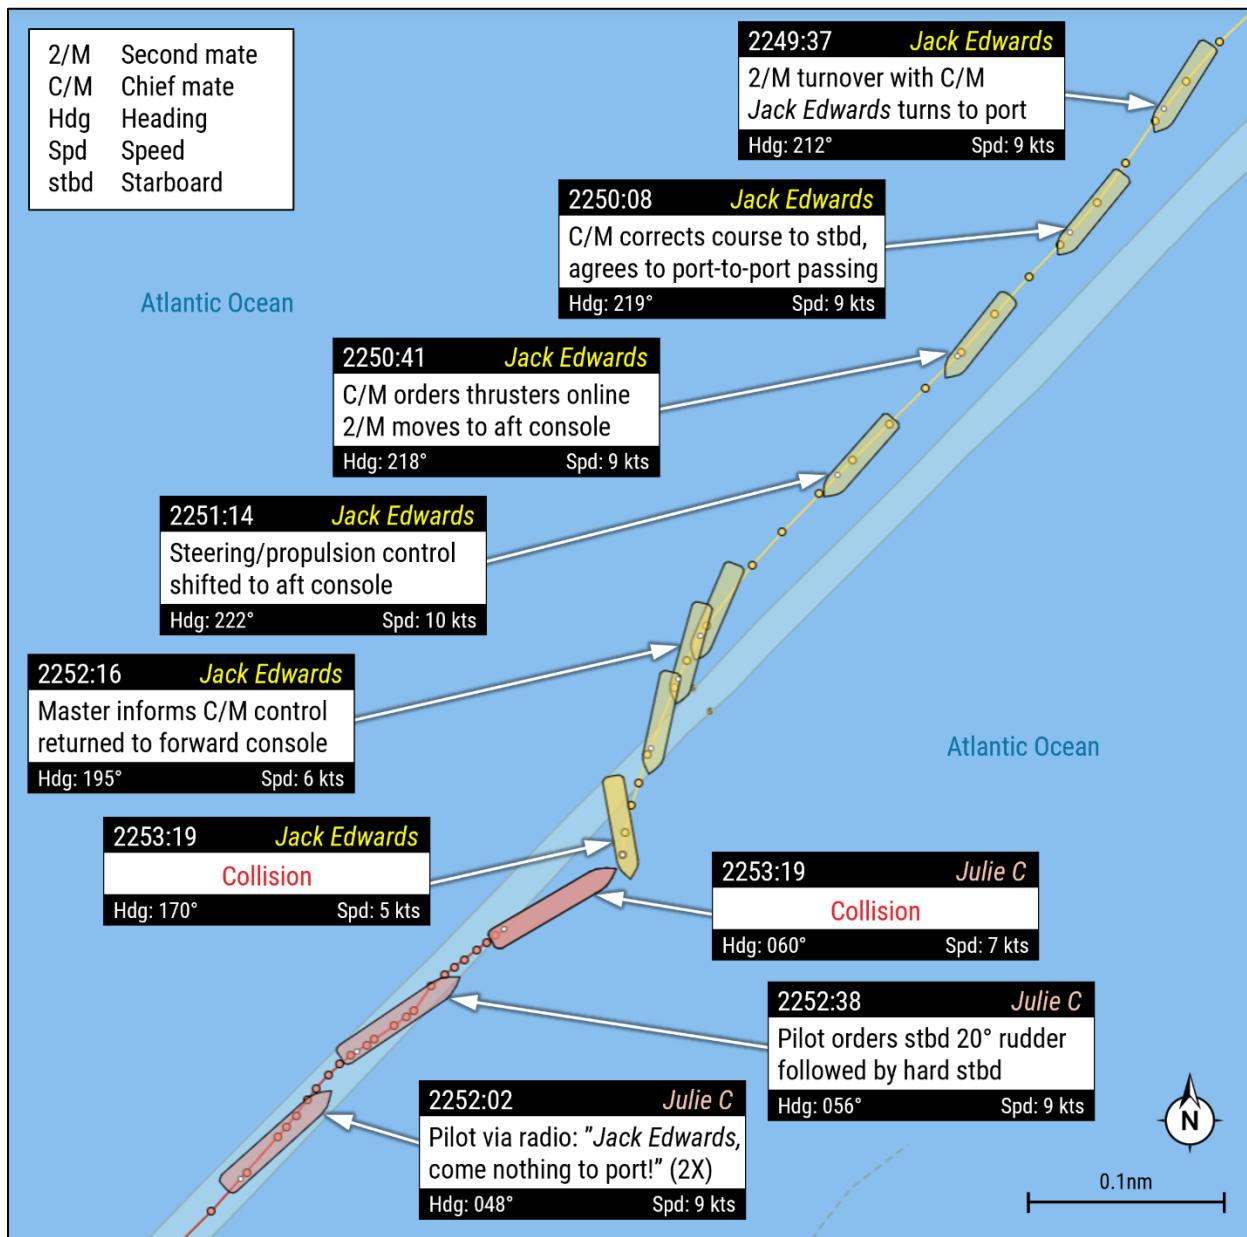
Figure 6. *Jack Edwards* and *Julie C* collision. (Background source: United Kingdom Hydrography Office ENC Z14EH9R0.C00 as viewed on Made Smart on July 16, 2025)

The *Jack Edwards* was now crossing the channel in front of the *Julie C*. Determining he could not avoid a collision by turning back to starboard, the chief mate turned the rudders 45° to port in an attempt to clear the channel on the opposite side.

Still unsure whether he had rudder control, the chief mate attempted to steer the *Jack Edwards* using the engines to avoid a direct hit by the *Julie C*. However, at 2253:19, the *Julie C* struck the *Jack Edwards* at a near perpendicular angle on the OSV's starboard side forward of midships.

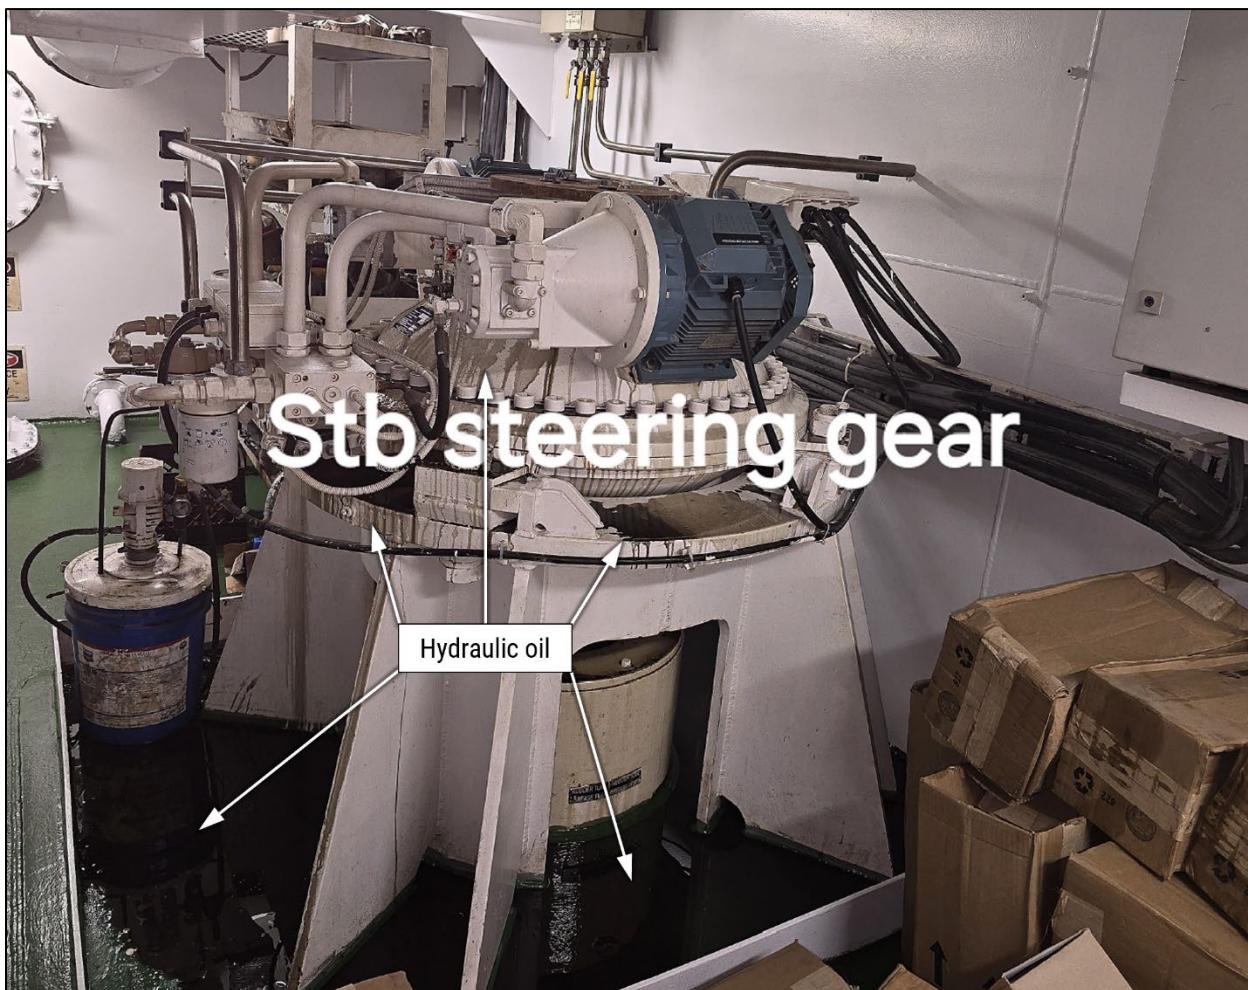
After the collision, the *Jack Edwards* master went below to conduct a damage assessment. The chief engineer, who had injured his shoulder in the collision, joined the master during his examination of the vessel. The master and chief engineer checked for flooding and determined the vessel to be safe; however, they discovered the starboard steering gear was "out of commission" and covered in black-colored oil (see figure 7). The chief engineer also saw "black mud" coming out of the rudder stock. A later inspection identified that the oil level in the starboard steering gear hydraulic oil expansion tank was low.

Figure 7. *Jack Edwards* starboard steering gear as found immediately after collision.
(Background source: ECO)

The expansion tank was low after the collision; however, it could not be determined how long the tank had been low. According to a steering gear

On March 23, 2024, six days after the collision, an ECO technician boarded the *Jack Edwards* to repair the starboard steering gear that the master had reported out of commission. During testing of the system, the technician determined that the system's high-pressure seals were intact. After breaking down the system, the technician found a "bad wiper seal, along with a bad upper low pressure void seal." The seals were replaced, the seal faces and housings were cleaned, parts were lubricated, and the system was reassembled. A functional test was performed, with

no further leakage observed. The technician attributed the wiper and low-pressure void seal failures to "a damaged dust ring, allowing trash buildup past the wiper seal and into the low-pressure void." According to the manufacturer representative, the poor condition of the low-pressure seals would not directly affect the performance of the steering gear, but if "dirt" got into the steering gear system, it could affect other seals and valves.

During postcasualty drydock repairs to the vessel conducted in Navegantes, Brazil, the starboard steering gear pumps were serviced, during which an elastic coupling was replaced and the hydraulic oil in the system was changed out.

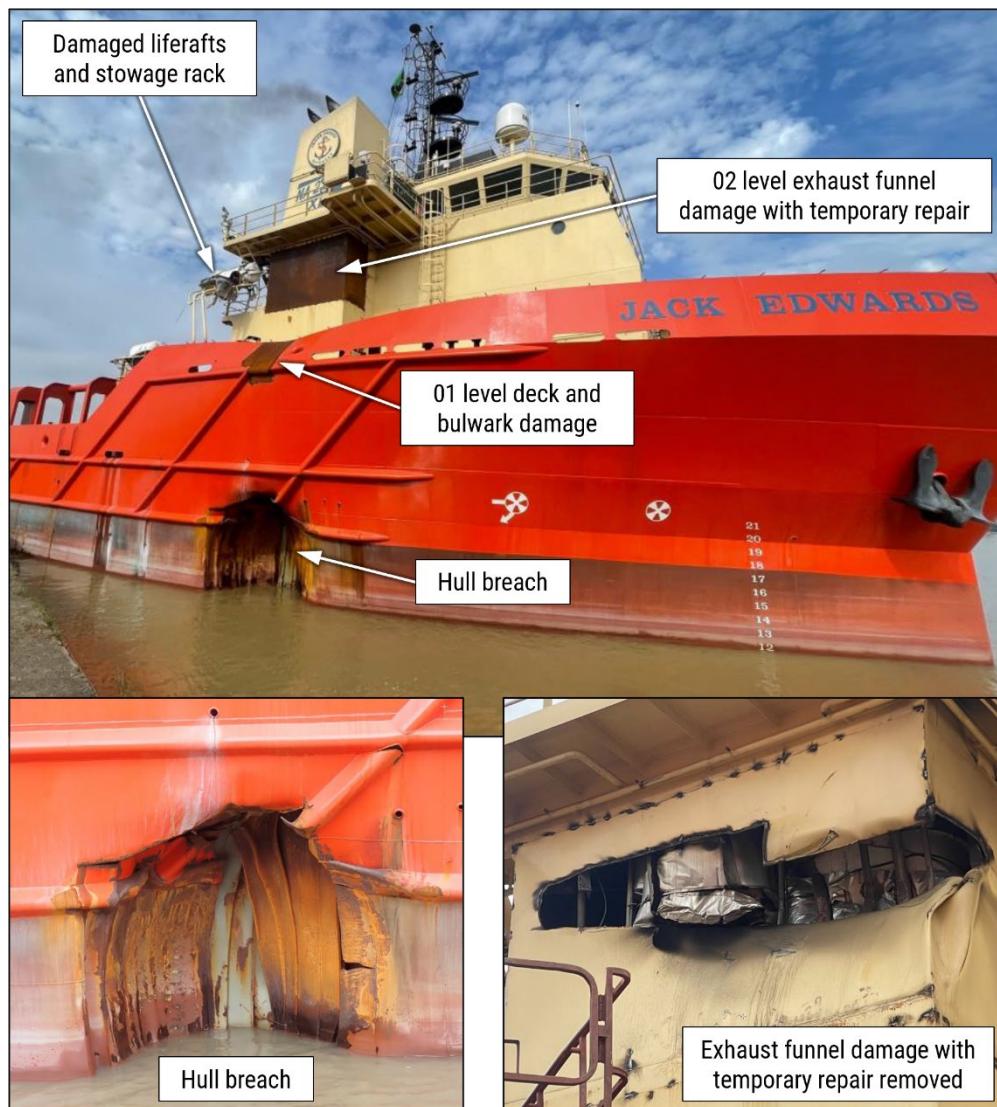
As a result of the collision, the *Jack Edwards*'s hull plating was breached and other structural components were compromised, resulting in seawater intrusion into the swing-down thruster fuel service tank, the starboard-side main engine lube oil tank, the starboard-side fuel oil settling tank, a starboard-side double-bottom fuel oil storage tank, and two spare tanks (see figure 8). About 2,200 gallons of diesel fuel leaked into the water from the swing-down thruster service tank. Although each of the tanks flooded with seawater, the stability of the vessel was not compromised.

Figure 8. *Jack Edwards* external damage. (Source: ECO)

Deck plating, bulwarks plating, and hull plating at the deck edge on the 01-level weather deck were bent inward and fractured, and the starboard-side exhaust funnel plating was fractured at the 02 level. Two liferafts stowed aft of the exhaust funnel were destroyed, and the stowage rack was damaged. Various other components and piping systems in the engineering spaces were also damaged. The total cost of repairs to the *Jack Edwards* was estimated at \$900,000.

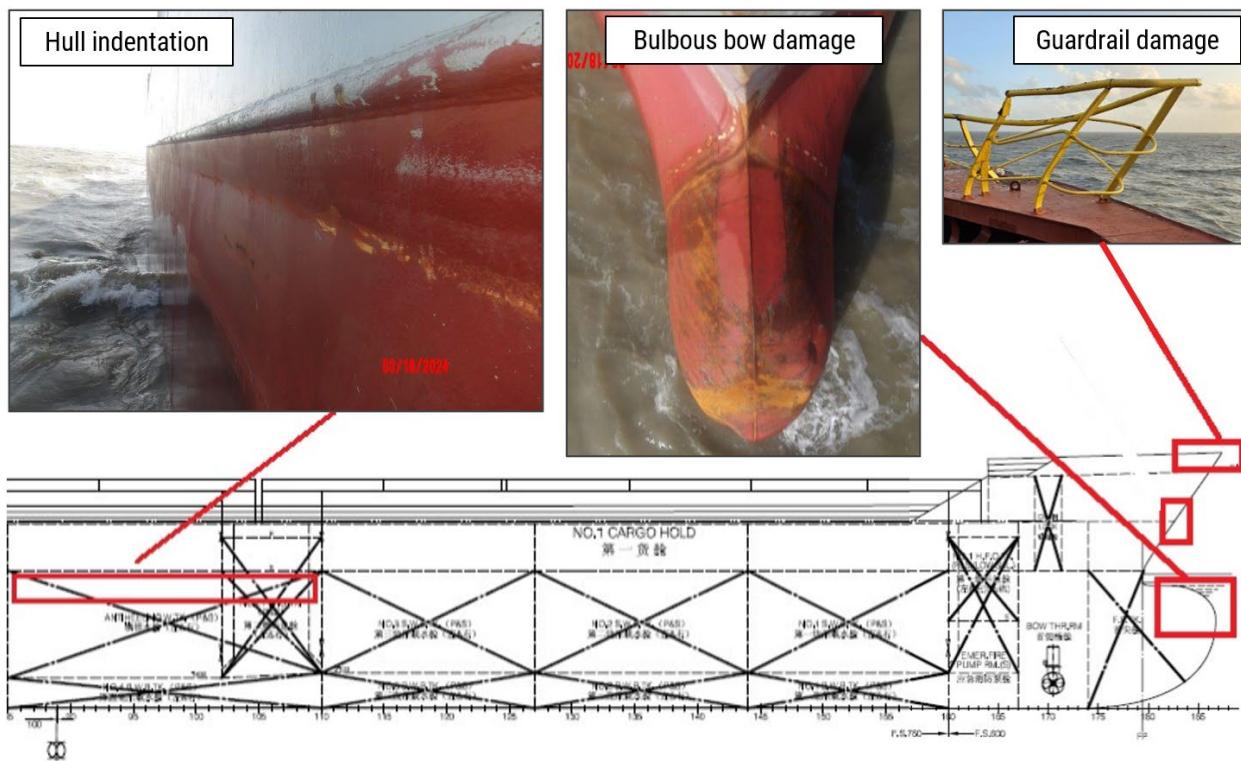
Shell plating on the *Julie C*'s forepeak tank was indented, and internal structural members within the tank were damaged (see figure 9). The bulbous bow was punctured on the port side, leaving an 8-inch-by-8-inch hole. About 50 feet of shell plating on the port side, as well a small area of shell plating above the forepeak tank, was indented. Guardrails on the bow were also damaged. The cost of repairs to the cargo vessel was estimated at \$125,000.

Figure 9. Julie C's external damage. (Background source: Carisbrooke Shipping Ltd.)
