MIR-25-43

## Contact of Towing Vessel *William E Strait* with Moored Barges at Shell Norco Refinery Dock

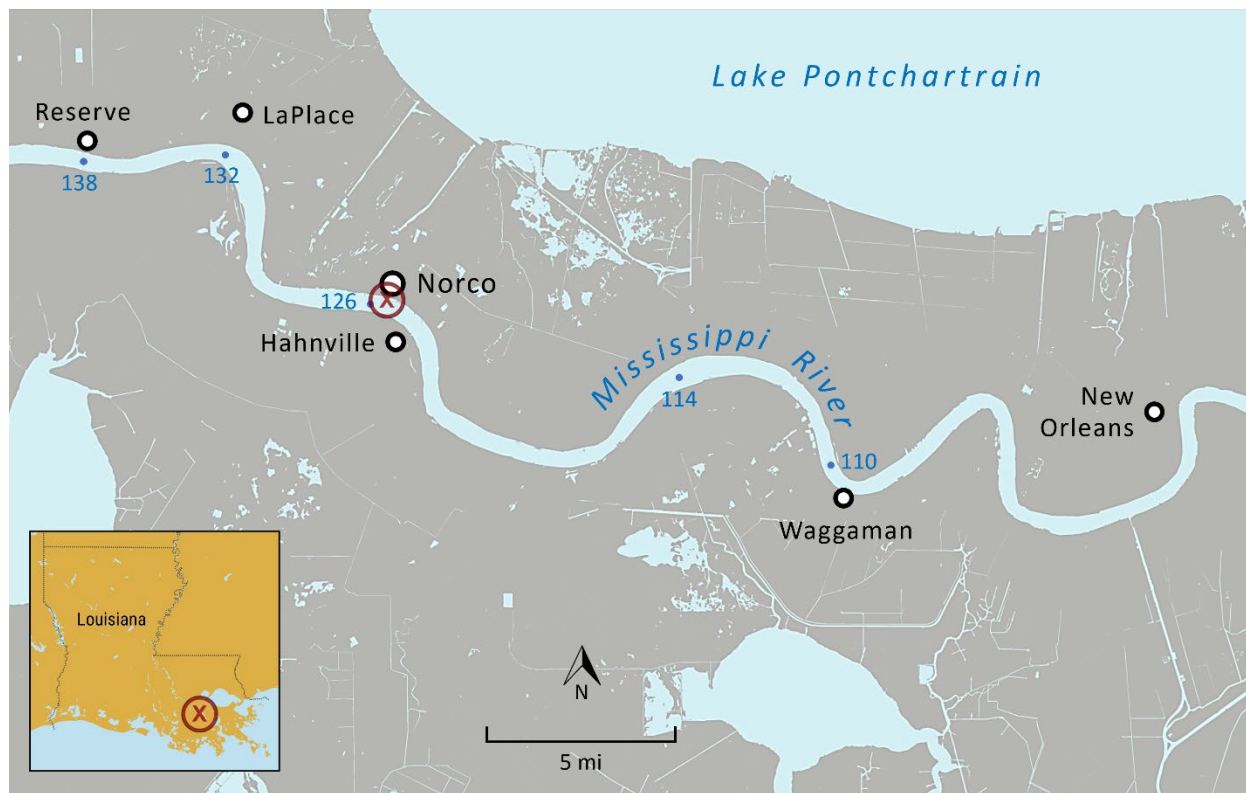
**Figure 2.** Area where the *William E Strait* contacted the *Cajun Courage*, CDB02, and the Shell Norco Refinery dock, as indicated by a circled X. (Background source: Google Maps)

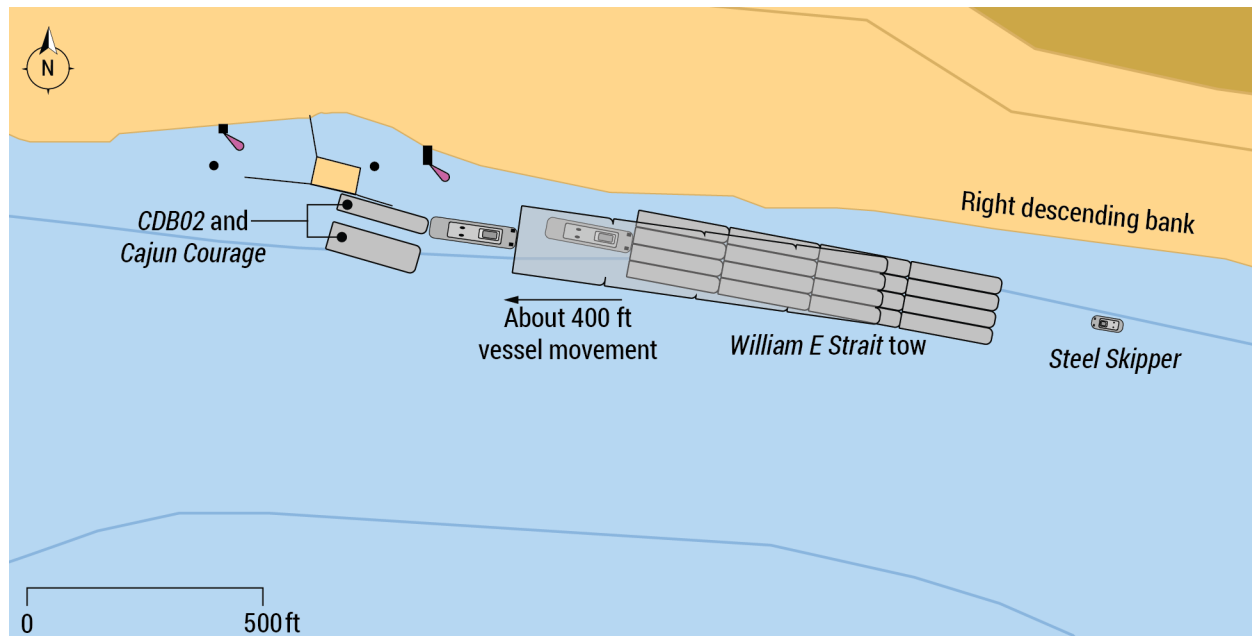
Using automatic identification system and vessel traffic service data, investigators found that, at the time the last two barges were pushed into place by the *Steel Skipper*, the *William E Strait* moved astern about 400 feet toward the moored crane and deck barges at the Shell Norco Refinery dock (see figure 4).

**Figure 4.** *William E Strait* astern movement toward moored barges on December 10.  
(Background source: National Oceanic and Atmospheric Administration electronic navigation chart US5LA52M as viewed on Rosepoint)

Early on the morning of December 10, in darkness, the towing vessel *William E Strait* was pushing 19 barges and stopped downstream of the Shell Norco Refinery no. 3 dock on the Lower Mississippi River to drop off three barges at a fleeting area across the river on the right descending bank near mile 126. While the fleeting tug *Steel Skipper* was repositioning barges, the vessel pushed the *William E Strait* tow astern, and the stern of the *William E Strait* contacted two moored barges at the dock about 400 feet upriver. The two barges were pushed into the dock, damaging it.

According to the mate, the two moored barges did not have deck or running lights and were only lit by a spotlight from the dock. Additionally, a dense fog advisory was in effect at the time, which the mate said reduced visibility. Because of the reduced visibility, the mate, who was on the bridge at the time, did not recognize that his vessel was in danger of contacting the moored barges and dock aft of the tow, and therefore did not use his engines to attempt to avoid them.

The National Transportation Safety Board determines that the probable cause of the contact of the towing vessel *William E Strait* with moored barges at the Shell Norco Refinery dock was the *William E Strait* mate not recognizing the proximity of the unlit barges astern of his towboat as the vessel was pushed astern by an assisting fleeting tug while repositioning barges. Contributing was the dense fog and rain, which obscured visibility during the operation.
