December 10, 2025

MIR-25-44

Flooding and Sinking of Towing Vessel *Cajole*

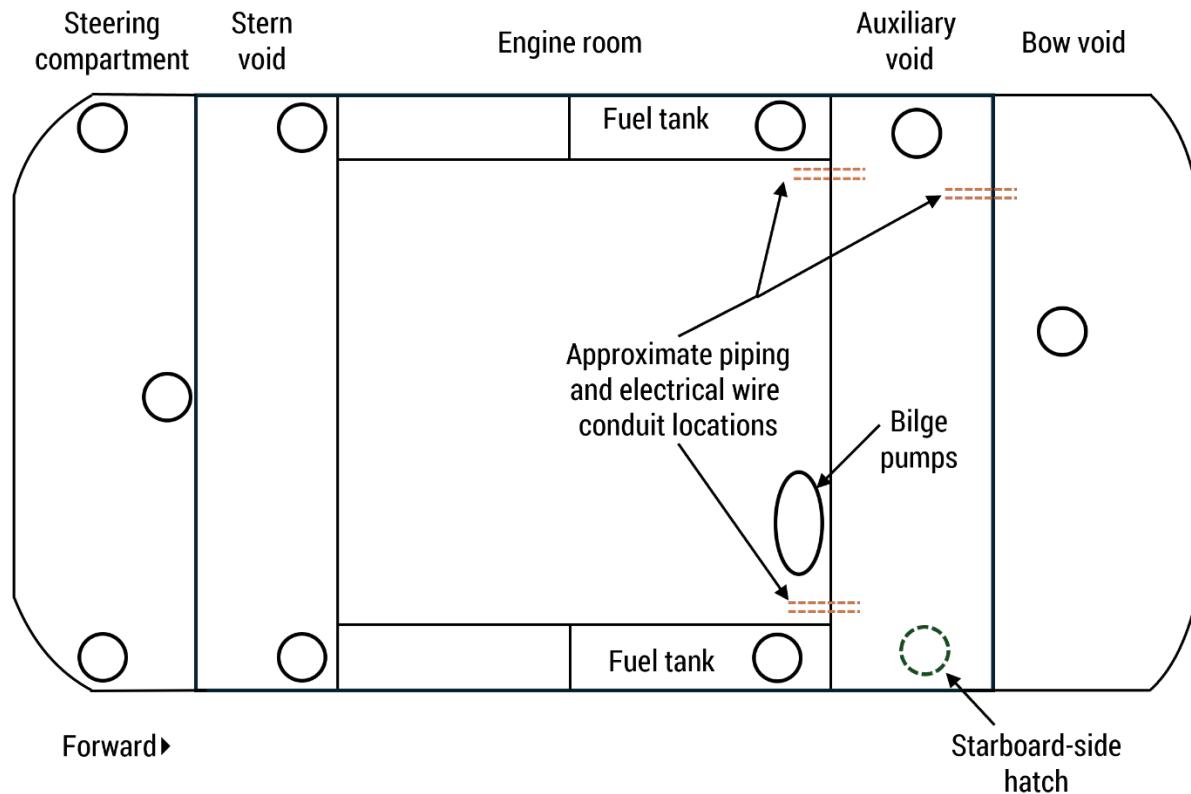
Two sections of 4-inch diameter open-ended steel pipe penetrated the bulkhead between the auxiliary void and engine room, and one 4-inch-diameter steel pipe penetrated the bulkhead between the auxiliary space and bow void. The open-ended pipes (serving as conduits) allowed vessel piping and electrical wire runs to pass through athwartship bulkheads separating the spaces. The openings were about 6-12 inches beneath the main deck near the outboard longitudinal bulkheads (see figure 3).

Figure 3. Simplified *Cajole* below deck arrangement with approximate conduit locations indicated with orange dashes and approximate locations of flush-mounted main deck hatches shown as circles

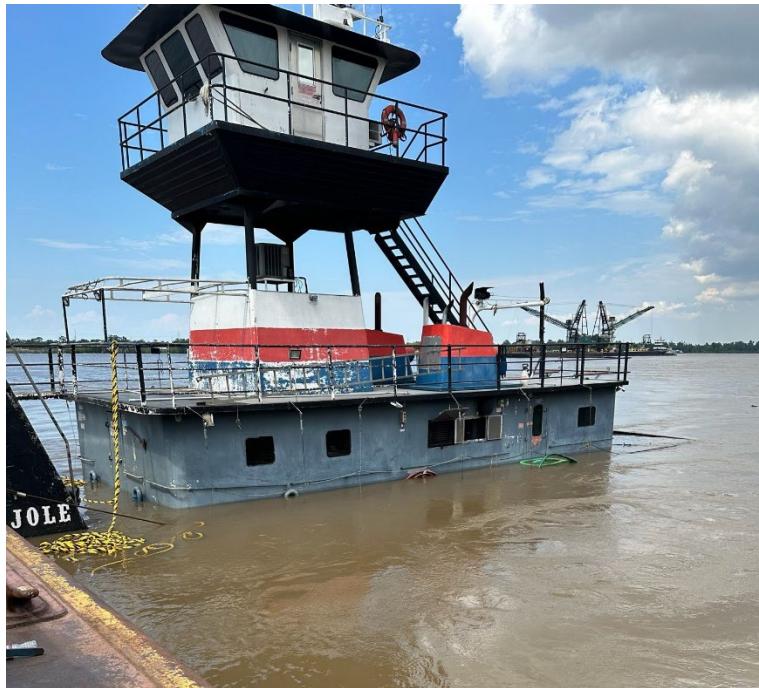
Figure 4. *Cajole* partially submerged and secured to a barge after all involved personnel safely disembarked the vessel. (Source: Coast Guard)

The captain notified the operating company's operations manager of the situation and informed him that everyone was safe. By 2100, the *Cajole* had fully sunk.

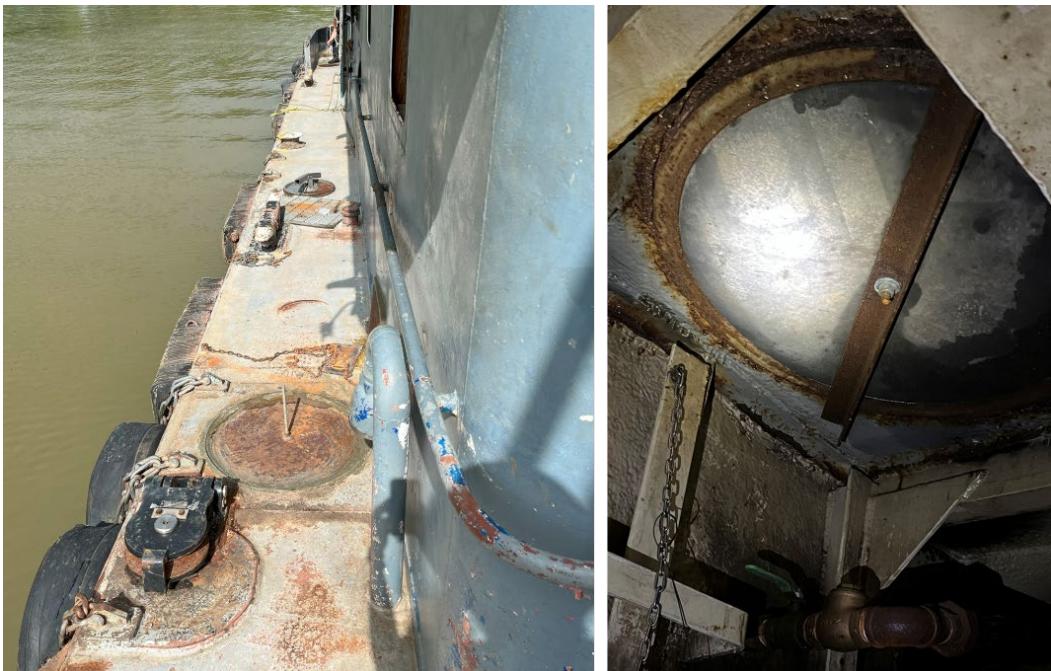
The sinking damaged the *Cajole*'s main propulsion engines and generators, as well as its electrical and hydraulic systems beyond repair. Salvors made temporary repairs to keep the vessel afloat, including welding a replacement cover over the auxiliary space starboard-side flush-mounted hatch on the main deck to ensure watertight integrity as the vessel was towed to the shipyard for repair (see figure 5). (The hatch cover was lost during the casualty, but according to the captain, it was in place when he discovered the flooding in the engine room.)

Figure 5. *Cajole* after the sinking, with starboard side auxiliary void access hatch cover replaced and permanently sealed to the main deck for transit to shipyard.

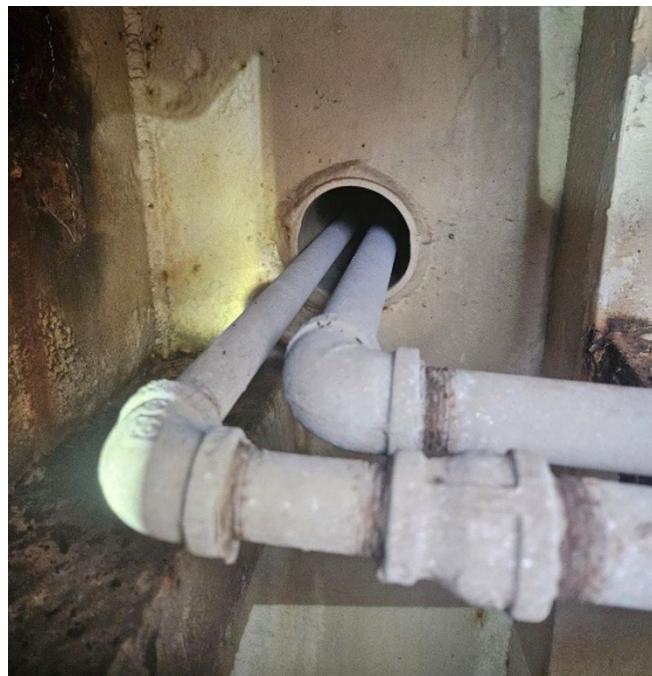
and electrical wire conduits between the forward auxiliary space and engine room that were not properly sealed and watertight (see figure 6). Company personnel sealed the piping and electrical wire conduits before the inspector's departure, and this was not recorded as a deficiency. The inspector told investigators that he received photos showing what he believed were the sealed conduits. He informed the operating company that the repairs were satisfactory. At that time, according to the inspector, the auxiliary space was sealed. No deficiencies were issued in this inspection, and the COI examination was scheduled for June 4, 2024.

Figure 6. View of unsealed conduit penetration between the engine room and auxiliary space from the auxiliary space on May 28, 2024. (Source: Coast Guard)

About 2 weeks before the casualty, a Coast Guard inspector found that piping and electrical wire conduits between the forward auxiliary space and engine room were not properly sealed to be watertight. Operating company personnel sealed the piping and electrical wire conduits, and the inspector signed off that the repairs were completed satisfactorily. However, based on the flooding that the captain saw coming through at least one of the conduits, the repairs the crew had made during the Coast Guard inspection were likely not completely effective. With the starboard-side conduit between the engine room and auxiliary void lacking watertight integrity, water was able to progressively flood between the spaces. Therefore, the water in the engine room was likely the result of progressive flooding, through the conduits, from

The National Transportation Safety Board determines that the probable cause of the flooding and sinking of the towing vessel *Cajole* was likely a compromised flush-mounted access hatch, which allowed water to flood into a forward void space, and unsealed penetrations in a transverse bulkhead, which allowed for progressive flooding aft into the engine room.

For the safety of a vessel and all on board, the integrity of the hull and watertight bulkheads must be maintained, and any deficiencies must be appropriately addressed. Issues with watertight integrity, including unsealed watertight bulkhead and deck penetrations and deck and hull plate wastage, need to be addressed by permanent means. The Coast Guard advises, "Ensure electrical cables and conduits, piping runs, remote valve actuators, and other components that penetrate watertight bulkheads, decks, and compartments are inspected frequently and properly maintained. Each may have a unique sealing method involving glands with packing assemblies, penetration seals, or other methods. Frequent inspection and proper maintenance of these various fittings and assemblies will assist in minimizing the possibility of progressive flooding."⁴
