December 10, 2025

MIR-25-45

## Contact of Bulk Carrier *Algoma Discovery* with BNSF Allouez Taconite Facility

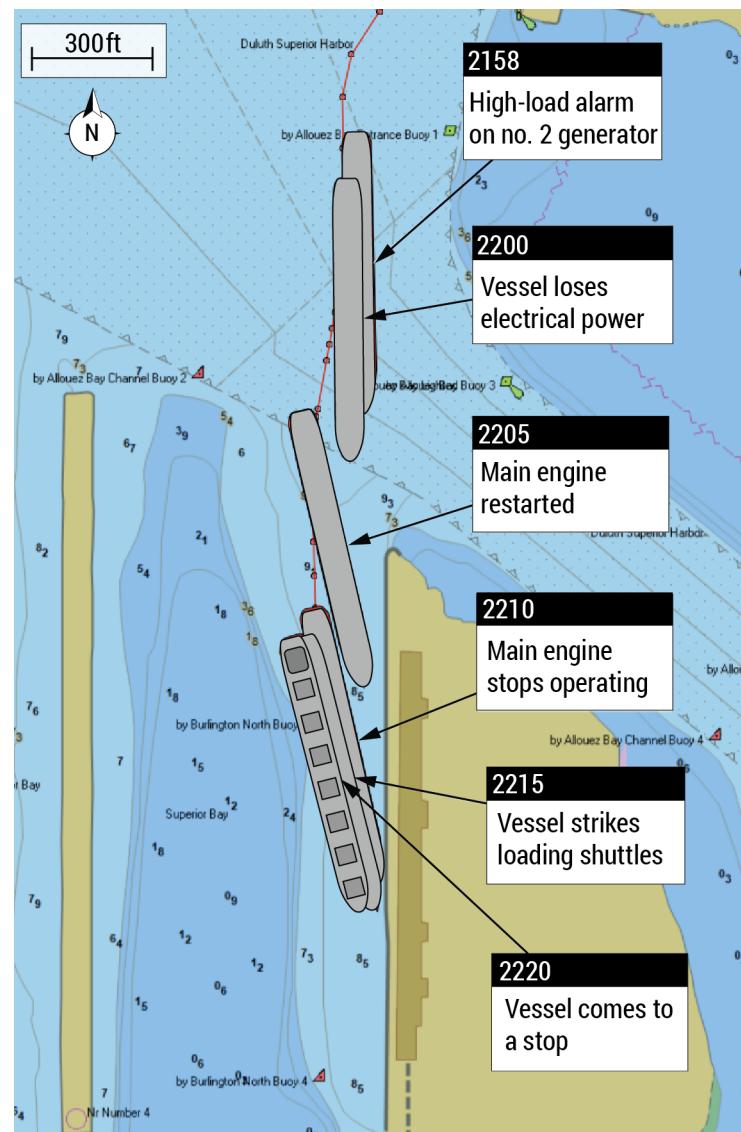
Once power and propulsion were restored, the master proceeded to give engine commands to maneuver the vessel toward the dock. As the vessel continued toward the dock, the main engine stopped operating a second time following a low control air alarm about 2210 (see figure 3). The chief engineer tried to restart the main engine again, but after several attempts, it would not

**Figure 3.** Trackline of *Algoma Discovery* as it approached the dock, from the time of the high-load alarm about 2158 to the time it came to a stop, about 2215, after striking the loading shuttles. (Background source: National Oceanic and Atmospheric Administration Electronic Navigation Chart US5DLHCG as viewed on MadeSmart automatic identification system.)

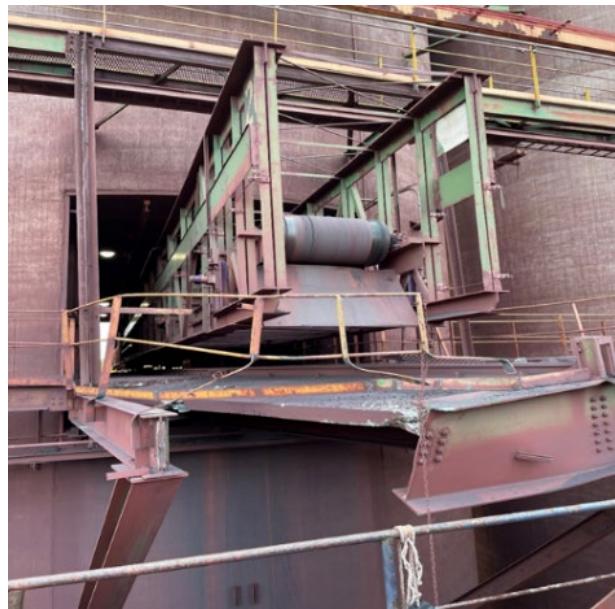
A postcasualty survey of the BNSF Allouez Taconite Facility identified that five loading shuttles (nos. 24, 26, 28, 32, and 35) sustained impact/crushing damage (see figure 4). Damage to the facility was estimated at \$950,000.

**Figure 4.** Damage to one of the loading shuttles at the BNSF Allouez Taconite Facility following the casualty. (Source: Coast Guard)

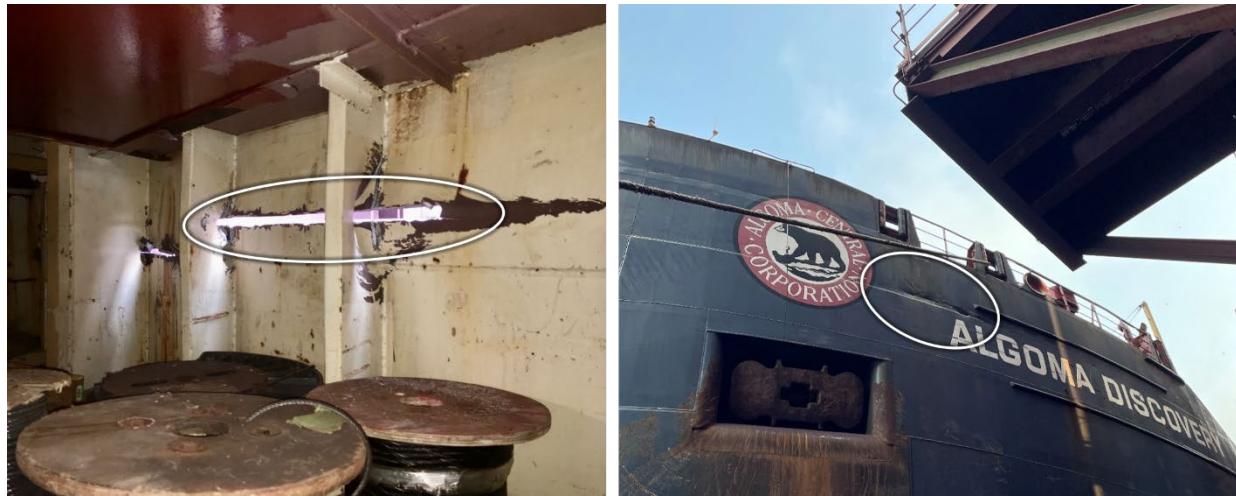
The *Algoma Discovery* sustained hull damage above the main deck on the port side of the bow, estimated at \$130,000 (see figure 5).

**Figure 5.** Left to right: Damage (circled) to the *Algoma Discovery*, as seen from the interior and the exterior, following the casualty. (Source: Coast Guard)

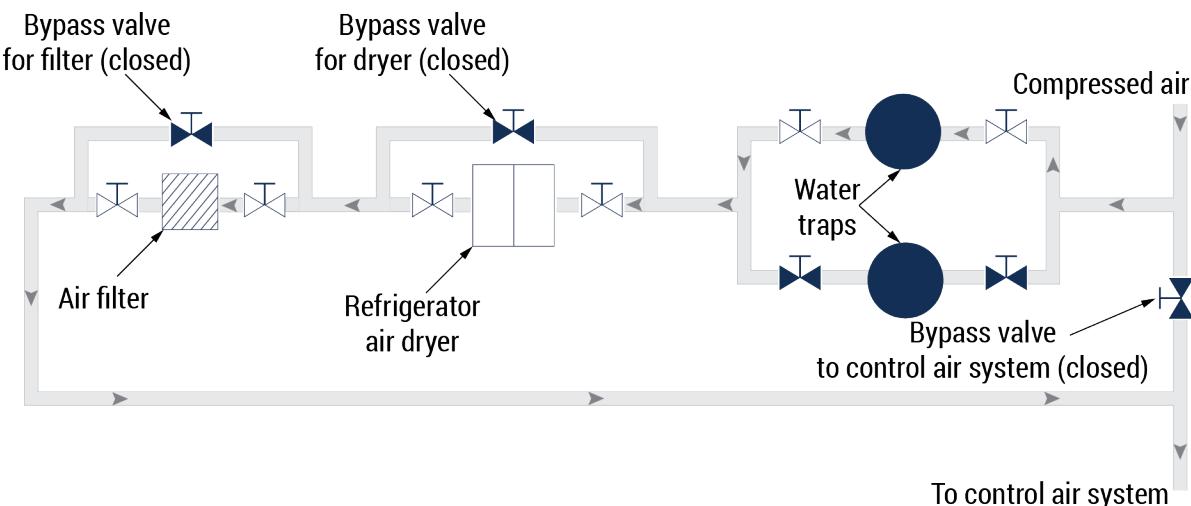
To bypass the entire air dryer system, the bypass valve to the control air system had to be opened (see figure 6). For compressed air to bypass the refrigerator air dryer but flow through the air filter and the water trap, the bypass valve for the refrigerator air dryer had to be opened.

**Figure 6.** Typical flow of compressed air through the water traps, refrigerator air dryer, and air filter before reaching the control air system. (Background source: Algoma Central Corporation)

The operating company's postcasualty investigation found that the main engine stopped a second time because the refrigerator air dryer had likely shut down after the loss of power—the company identified a fan motor failure alarm—and thus prevented the supply of compressed air to the main engine control air system.
