MIR-25-46

# Sinking of Barge PTC 706 and Subsequent Breakup of *Chad Pregracke* Tow

On March 16, 2024, about 0008 local time, the towing vessel *Chad Pregracke* was transiting southbound on the Lower Mississippi River pushing 34 loaded barges, near mile 260.6, about 5 miles east of New Roads, Louisiana, when a barge, the PTC 706, at the head of the tow rapidly sank, causing the tow to break apart (see figure 1 and figure 2).<sup>1</sup> Five barges in the tow were damaged. Damages were estimated at \$2 million. There were no injuries, and no pollution was reported.

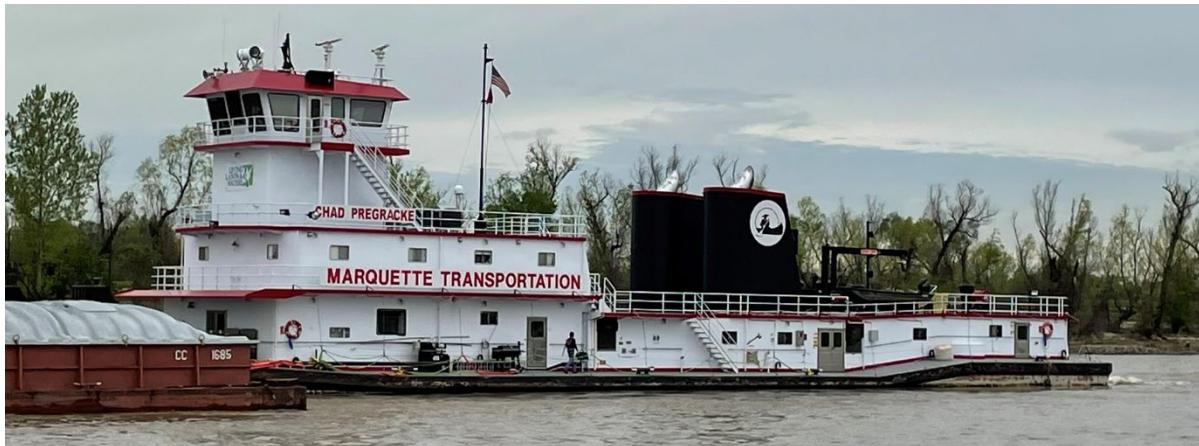
**Figure 1.** *Chad Pregracke* after the casualty.

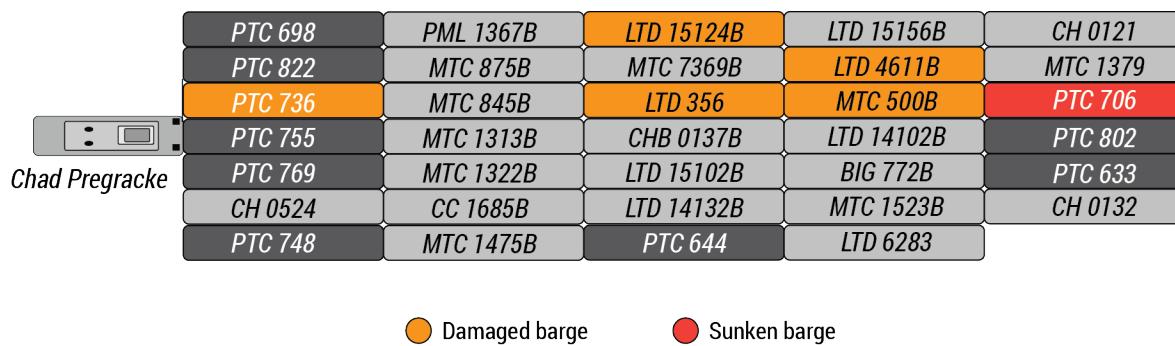
A marine survey company found damage to five barges, including flooding in various compartments, cargo loss and damage, and hull structure damage (see figure 5).

**Figure 5.** *Chad Pregracke* towing arrangement, showing the location of the damaged barges in orange and the sunken barge PTC 706 in red.

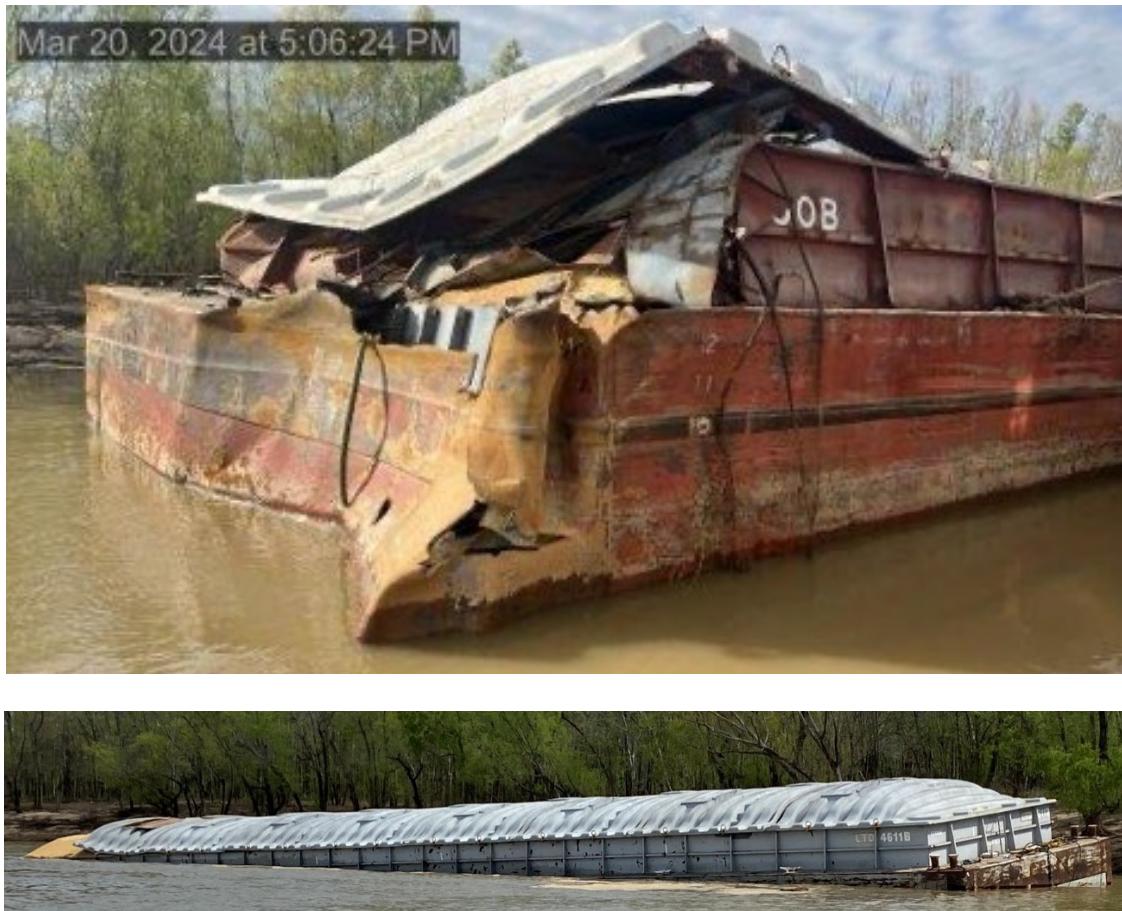
Of the damaged barges, three of them (*MTC 500B*, *LTD 356*, and *PTC 736*) were in the same string as the *PTC 706* (see figure 6). One of the other damaged barges (*LTD 4611B*) was located on the second string on the port side, second after the lead barge, and partially sank. The other damaged barge (*LTD 15124B*) was located on the outboard port string, third barge from the lead.

**Figure 6.** From top: Damage to the stern area of MTC 500B, the barge that was immediately aft of the PTC 706, and covered barge LTD 4611B partially sunken by its bow to port. (Source: Budwine and Associates, LLC)

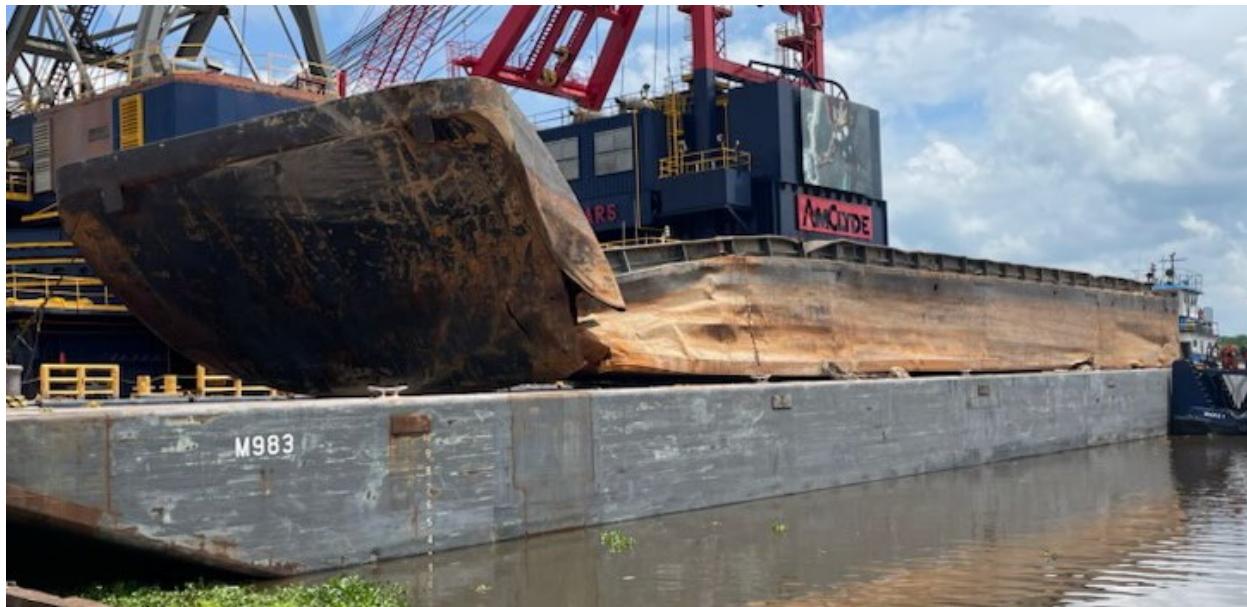
The PTC 706 was a constructive total loss. Investigators examined the PTC 706 at the recycling yard. The rake section was substantially damaged from contact with the river bottom (see figure 7). It was bent upward from near the watertight bulkhead between the rake void and the no. 1 wing tank. The port side of the barge in the vicinity of the watertight bulkhead between the rake void and the no. 1 wing tank exhibited substantial compressive forces and deformation to its plating.

**Figure 7.** Barge PTC 706 after arriving at the recycling yard in Houma, Louisiana, on April 22, 2024, with damaged rake. (Source: Modern American Recycling Services, Inc.)

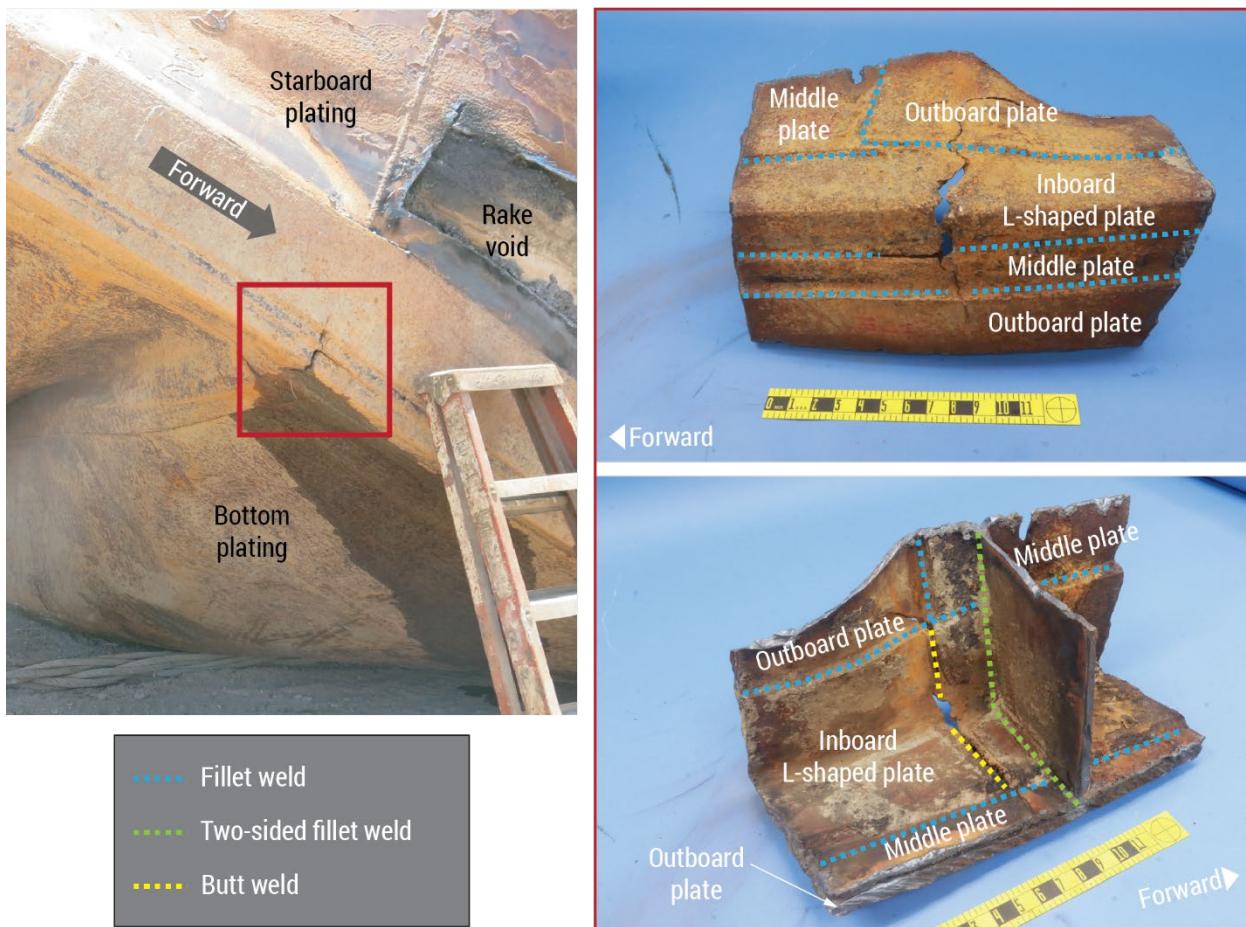
On the starboard side of PTC 706, at the bilge knuckle in the area between the rake void and wing tank no. 1, investigators found a hull fracture, dissimilar to any other damage observed.<sup>3</sup> This starboard side section of the bilge knuckle was cut out of the hull and sent to the National Transportation Safety Board (NTSB) Materials Laboratory for examination.

The NTSB found that the sectioned portion of the hull plating fractured initially along a 2.8-inch length of section of the vertical butt weld.<sup>4</sup> The butt weld exhibited a lack of penetration, with less than a third (0.162 inches) of the 0.5-inch plate thickness joined at the thinnest areas (see figure 8). This portion of the weld also exhibited large pores, some open to the surface, along with weld spatter and flash deposits in the welded areas between the plates.

**Figure 8.** Clockwise from left: PTC 706 starboard-side bilge knuckle before section was cut away on April 22, 2024. Bilge knuckle section cutaway with labeling. Interior of the cutaway section.

After the casualty, investigators found a hull fracture along a butt weld forward on the starboard-side bilge knuckle of the barge, between the rake void and wing tank no. 1, an area susceptible to extreme wear. The weld exhibited a lack of weld penetration, with large pores, weld splatter, and flash deposits in the unwelded areas between the plates. These characteristics would have left the weld unable to accommodate as much load as the plates it was joining. Once the porous area of this butt weld fractured, the resulting crack would have grown into the adjoining plates until it arrested. If the fracture existed before the barge sank, it would have provided an opening for water ingress. Thus, flooding, even at a slow rate, into the rake void or wing tank no. 1, would cause an increase in forward draft of the barge. Continuing to push a barge with an increased forward draft could lead to the bow being submerged. However, the rake area of the barge was severely damaged as a result of the sinking, and investigators could not determine whether the fracture existed before the casualty or was the result of the barge's contact with the river bottom. Therefore, the cause of the PTC 706 being down by the bow could not be definitively determined.
