December 12, 2025

MIR-25-47

Contact of Towing Vessel *Schweiger* with US Coast Guard Station Cape Disappointment Docks

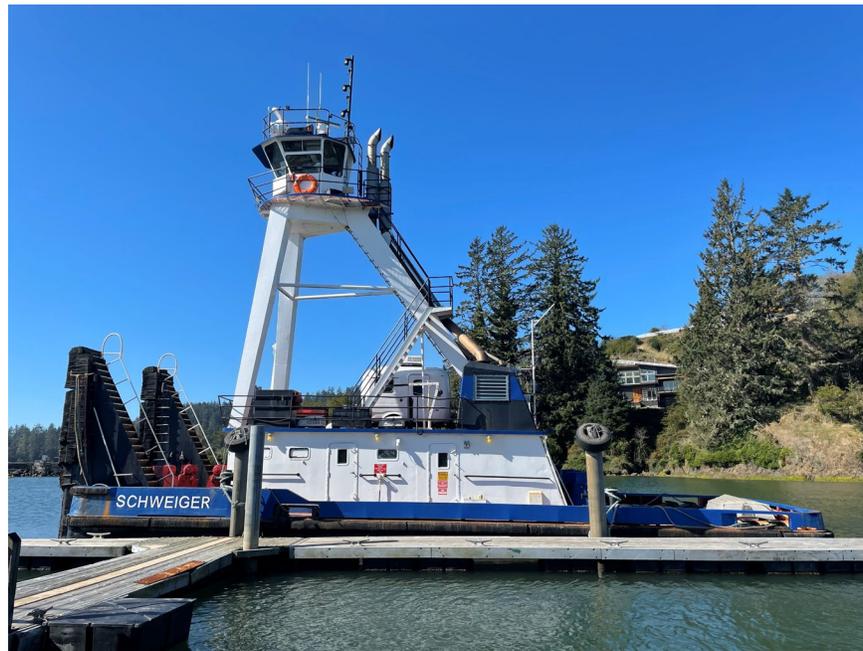
Figure 1. *Schweiger* moored at Port of Ilwaco, September 2024.

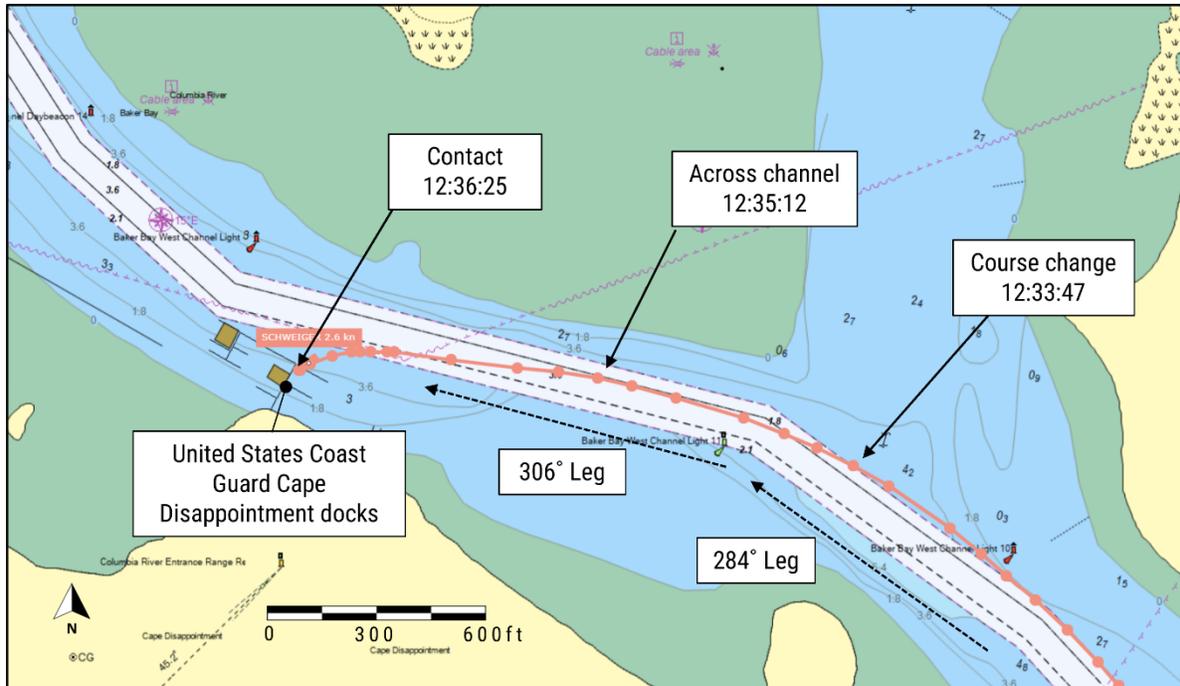
According to the vessel's automatic identification system (AIS) recorded track, at 1235:12, the *Schweiger's* course altered slightly to port toward the middle of the channel. Then, a little less than a minute later, the *Schweiger* veered to port as the vessel exited the marked channel toward the US Coast Guard Station Cape Disappointment dock.

At 1236:25, the *Schweiger* struck the dock's wave barrier while traveling at 7 knots (see figure 4). The tug broke through the wave barrier, damaging a floating dock and associated pilings, fuel system and electrical systems located behind the wave barrier. At the time, there were two, 47-foot-long Coast Guard motor lifeboats and a smaller 25-foot-long patrol boat moored to the floating dock that moved when the *Schweiger* struck the docks but were not damaged (see figure 5).

Figure 4. Trackline of the *Schweiger* as it transited the Baker Bay West Channel on September 11. (Background source: National Oceanic and Atmospheric Administration electronic navigation chart US5WA02, as viewed on Made Smart AIS)

The vessel's AIS track showed a deliberate course change from the 306° leg to the 284° leg on the red (right) side of the Baker Bay West Channel about 1233:47, indicating the captain was still alert at the time. At 1235:12, the *Schweiger* began moving to port and crossed the channel. At 1236, the rate of turn to port increased, resulting in the vessel contacting the Coast Guard docks about 30 seconds later. The captain reported that he fell asleep before the contact, which is supported by the vessel's AIS track showing the vessel moving across and then out of the channel. Therefore, the captain likely fell asleep about 1 to 3 minutes before the contact, sometime between 12:35:12 and 12:36:25 (see figure 4).

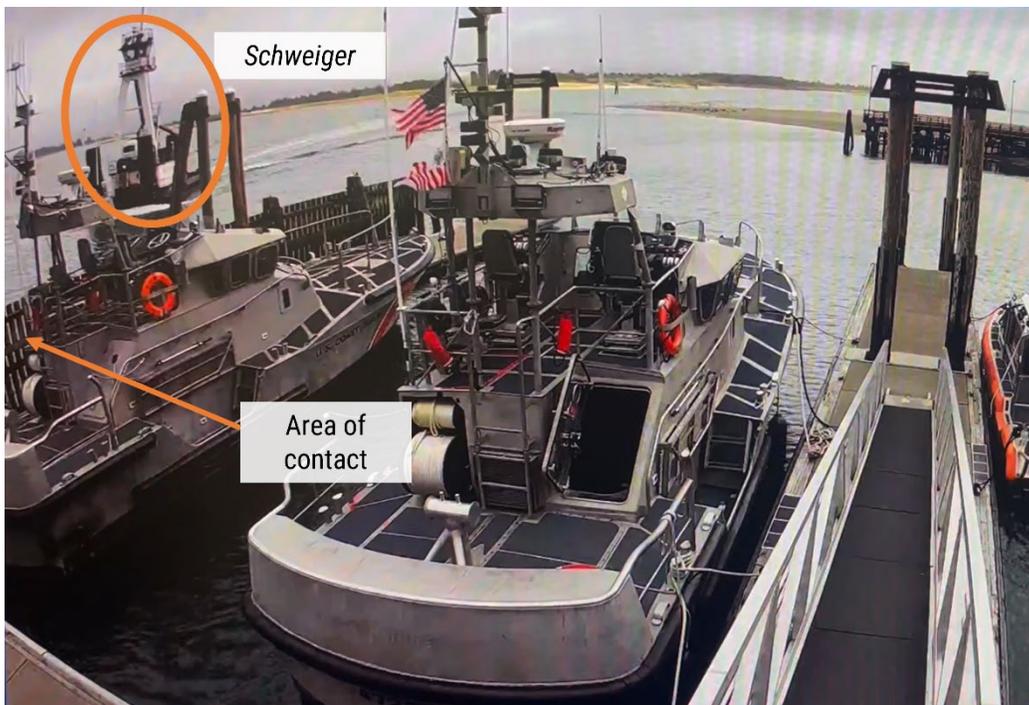
Figure 5. CCTV showing the *Schweiger* underway moments before contacting the wave barrier and floating dock. (Background source: Coast Guard)

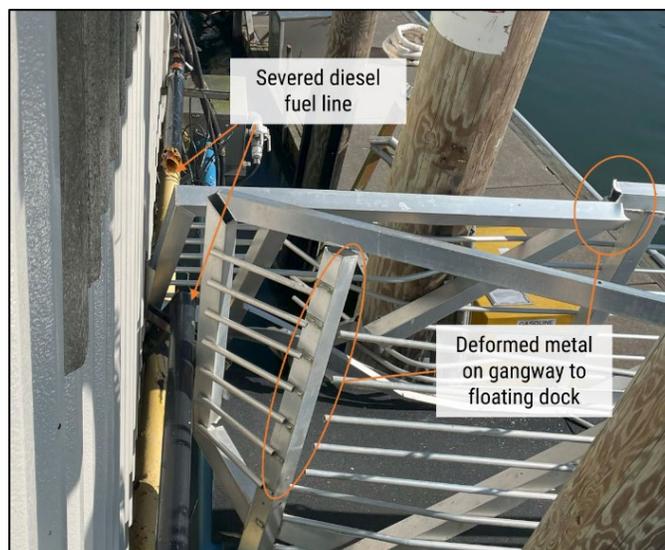
The *Schweiger* was undamaged. However, several components of the docking facility had damage—a 60-foot section of the wooden wave barrier was destroyed, multiple timber pilings shifted, and a concrete floating dock and metal gangway were damaged (see figure 6). Mechanical and electrical equipment located on the dock was also damaged. A diesel fuel piping system that ran from a shoreside pump room along the length of the upper pier was severed. (The fuel pipes were not pressurized at the time of the casualty.) About 20 gallons of residual fuel inside of the pipe leaked into the water and were then collected with containment booms and absorbent pads. None of the Coast Guard vessels moored at the docks at the time of the casualty were damaged.

Figure 6. Docking facility's severed diesel fuel line and deformed metal gangway leading from the fixed dock bridge to the floating dock.
