January 13, 2026

MIR-26-01

## Engine Room Fire on Towing Vessel *Thor*

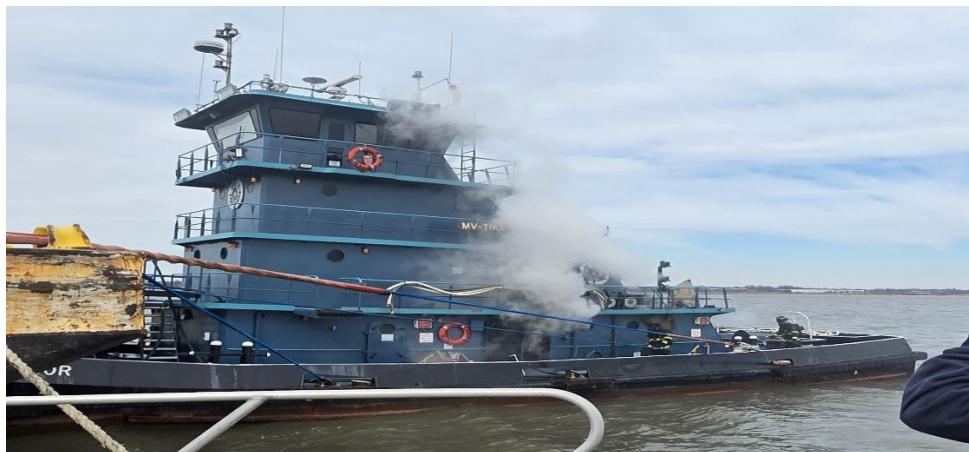
The Coast Guard, the Wilmington (Delaware) Fire Department, and Delaware State Police responded to the scene. Wilmington Fire Department's *Fire Boat 7* arrived on scene and deployed fire teams to extinguish the fire (see figure 3). The captain of the *Thor* boarded *Fire Boat 7*, briefed the on-scene commander of the fire's location, and provided a sketch of the engine room layout. The fire was under control by about 1200. Damage was estimated at about \$1.5 million.

**Figure 3.** Fire suppression on board the *Thor*. (Source: Wilmington Fire Department)

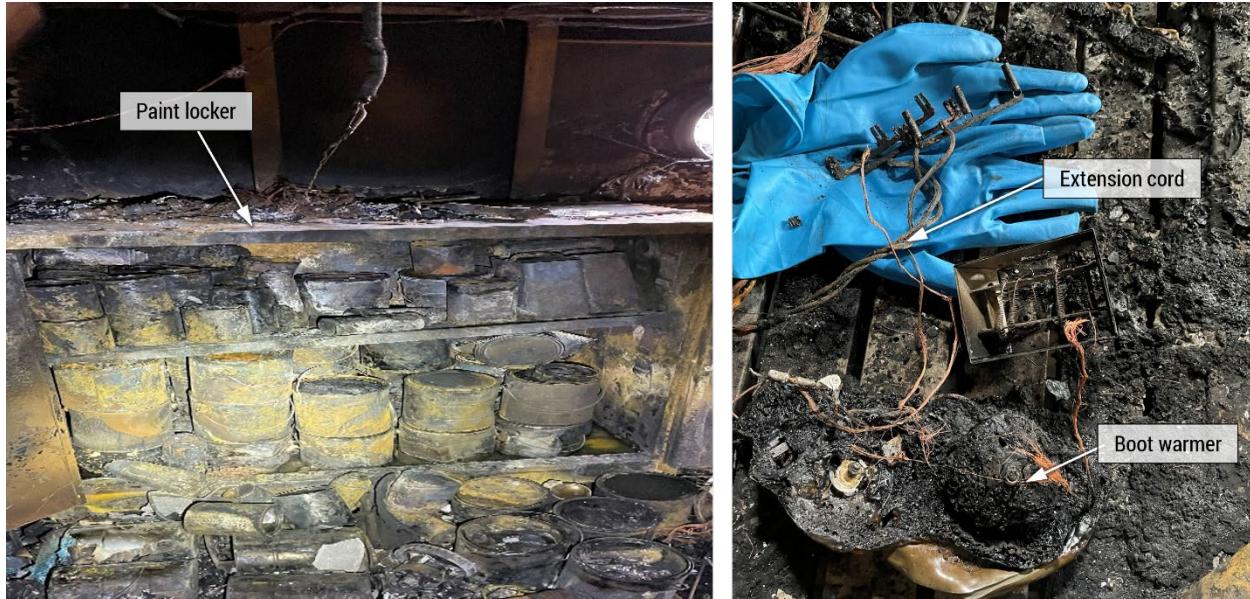
During the postcasualty examination, investigators found heavily oxidized paint cans in the paint locker (see figure 4). In the area around the paint locker, a three-prong extension cord with its insulation burned away was found with the remnants of the boot dryer. The control switch of the boot warmer was found to be in the "on" position. The associated electrical breaker powering the extension cord was found in the tripped position.

**Figure 4.** Paint locker located in the aft port corner of engine room.

Based on the fire damage patterns found within the engine room, investigators concluded that the fire most likely originated in the port corner of the upper level of the engine room, aft. However, due to the damage to that area of the engine room, ATF investigators could not determine the exact ignition source and ultimately classified the cause of the fire as "undetermined."

ATF investigators determined that the fire originated in the upper level of the engine room, portside aft. A paint locker was located in the area of origin, and various combustible materials were stored inside and outside of the locker. Interviews with the vessel's engineer revealed a boot warmer was plugged into an extension cord a few feet from the paint locker. The boot warmer was stacked on a plastic trash can. The remnants of the boot warmer's control switch showed it to be in the "on" position. After the accident, the extension cord's insulation and plug were found burned down to the copper wiring. Additionally, the 30-amp breaker associated with the receptacle that the extension cord was plugged into was found to be in the tripped position. A breaker can trip due to overloaded circuits, shorts, or electrical faults. An electrical fault—such as a loose, broken, or frayed wire—within the plug or nearby boot warmer could have created excessive resistive heating. Resistive heating within electrical conductors can produce sufficient heat to ignite nearby combustibles. However, due to the extent of the fire damage, the exact ignition source and cause of the fire could not be determined.

Once an ignition source was produced, combustible materials in and around the paint locker, including paint cans and a plastic trash can, near the fire's origin caught fire. After these combustible materials caught fire, they provided a path for the fire to expand to the port side of the engine room, aft.
