MIR-26-03

Flooding of Bulk Carrier *Cuyahoga*

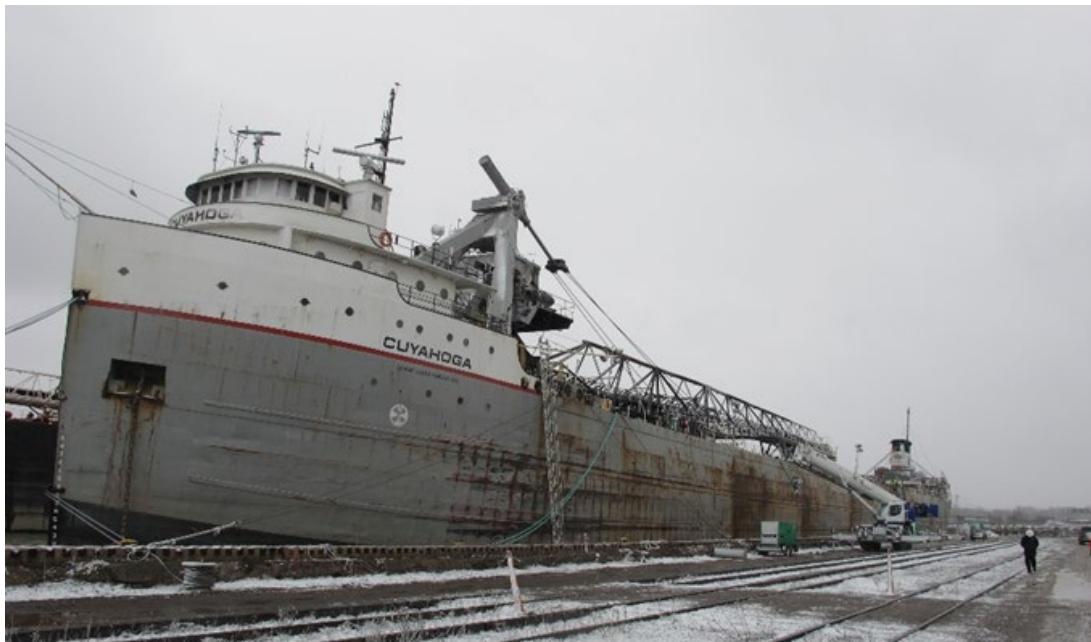
Figure 1. The *Cuyahoga* on March 20, 2024, before the flooding.

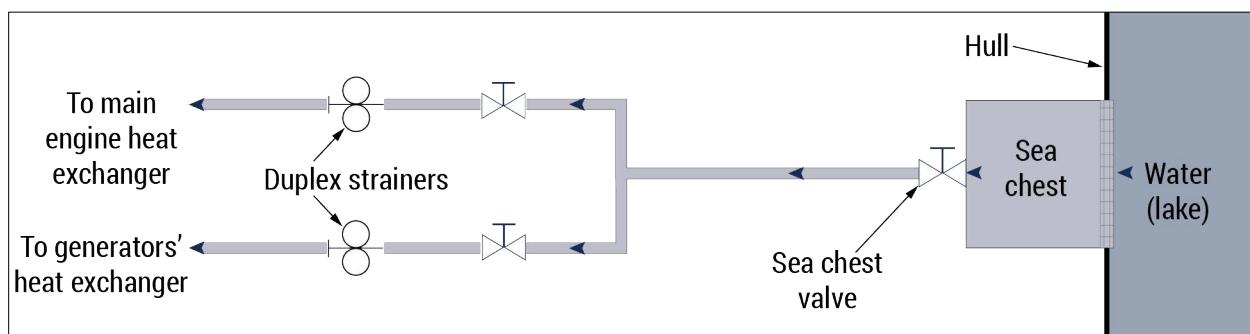
Per standard practice for layup of a Great Lakes vessel, the team opened the drains and removed the covers of the duplex strainers for the main engine and generator cooling water piping systems; the strainers were located on the lower level of the engineer room (see figure 3). Opening the strainer drains allowed the shipkeeper to see any ingress of water into the vessel, and removing the strainer covers helped keep the water from freezing and expanding, which would damage the housing of the strainer and the piping system. In addition, the team installed heat lamps—connected by extension cords to 120-volt electrical outlets located on the pier—by the sea chests to prevent ice formation within them. After this work was completed, the chief engineer and the team departed the vessel, and the vessel was considered in cold layup.

Figure 3. Simplified diagram representing the sea chest and inlet strainers for the main engine and generator cooling water systems (not to scale).

During the salvage of the *Cuyahoga*, divers confirmed that all of the sea chest valves, which isolated the vessel's sea chests from their respective downstream piping systems, were closed. As they investigated further, the divers discovered that lake water was entering the engine room through uncovered duplex strainers for the main engine and generator cooling system. These strainers were located downstream of the sea chest valve. Once the covers and drains to the duplex strainers were closed and secured, the water ingress ceased, and the vessel was able to be refloated. This indicates that although the sea chest valve supplying the main and generator engine cooling water systems was closed, lake water was still able to enter their piping (see figure 3). However, because the investigation into the flooding was limited and the vessel was scrapped, the exact cause of the water flowing in the system could not be determined. It is possible that the valve disk or the valve seat failed while the vessel was in cold layup, which would have allowed water to flow into the uncovered duplex strainers and out to the engine room.

The National Transportation Safety Board determines that the probable cause of the flooding of the bulk carrier *Cuyahoga* was water ingress in the engine room from main engine and generator water cooling systems' duplex strainers—which were uncovered while the vessel was in layup status—possibly due to the failure of the systems' closed sea chest valve.

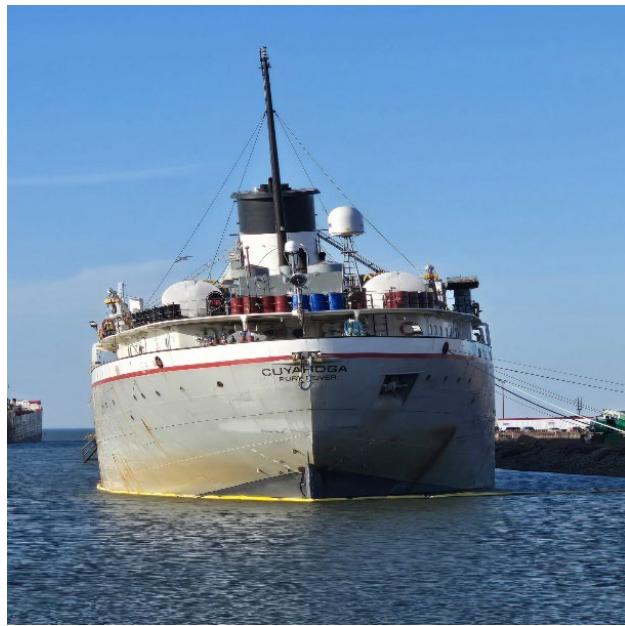
The owner of the vessel contacted the US Coast Guard to inform them of the situation. A pollution boom was deployed around the vessel, as per the vessel's pollution response plan, to contain any potential oil spill. The vessel continued to flood until it rested on the bottom while remaining moored to the pier (see figure 4). The vessel owner and the Coast Guard monitored the vessel for any changes in its condition.

Figure 4. The *Cuyahoga* heeling slightly to port after flooding. (Source: Coast Guard)

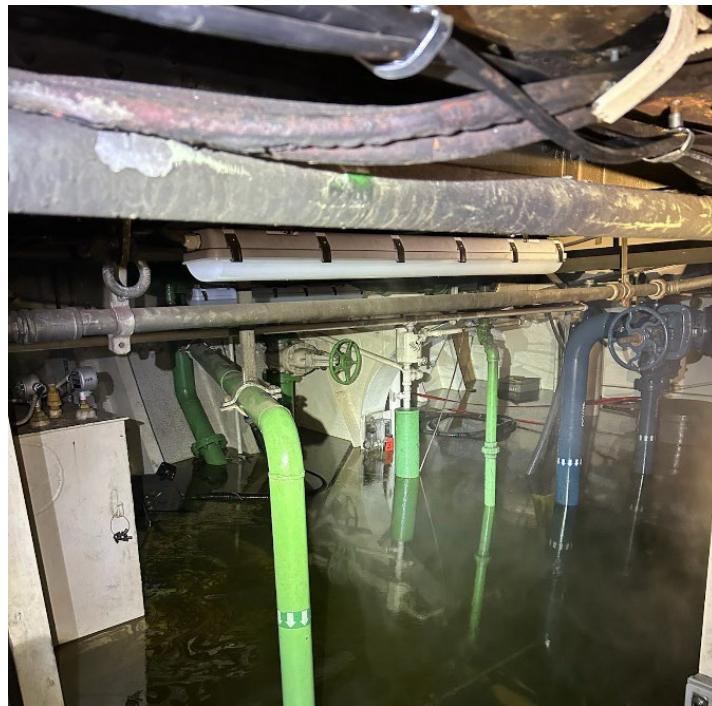
The *Cuyahoga* was salvaged between June 19 and 29, 2025 (there were no changes in its condition before salvage work began). During the salvage, divers checked the sea chest valves in the engine room to ensure that they were closed before dewatering the vessel (see figure 5). The divers reported that the handwheels to all the sea chest valves were in the closed position and could not be tightened further. Afterward, the divers determined that the water was entering the engine room through the uncovered duplex strainers and open strainer drains for the engine and generator cooling water systems (the covers had been removed and the drains opened as part of the winter layup process). The divers reinstalled the covers and closed the drains, and the water ingress stopped. Salvors used pumps to dewater the vessel, which was completed on July 1. No other investigation was conducted to determine how water was entering past the cooling water sea chest valve.

Figure 5. The engine room within the *Cuyahoga* following the water ingress. (Source: Coast Guard)
