February 4, 2026

MIR-26-04

Fire aboard Fishing Vessel *Spicy Lady*

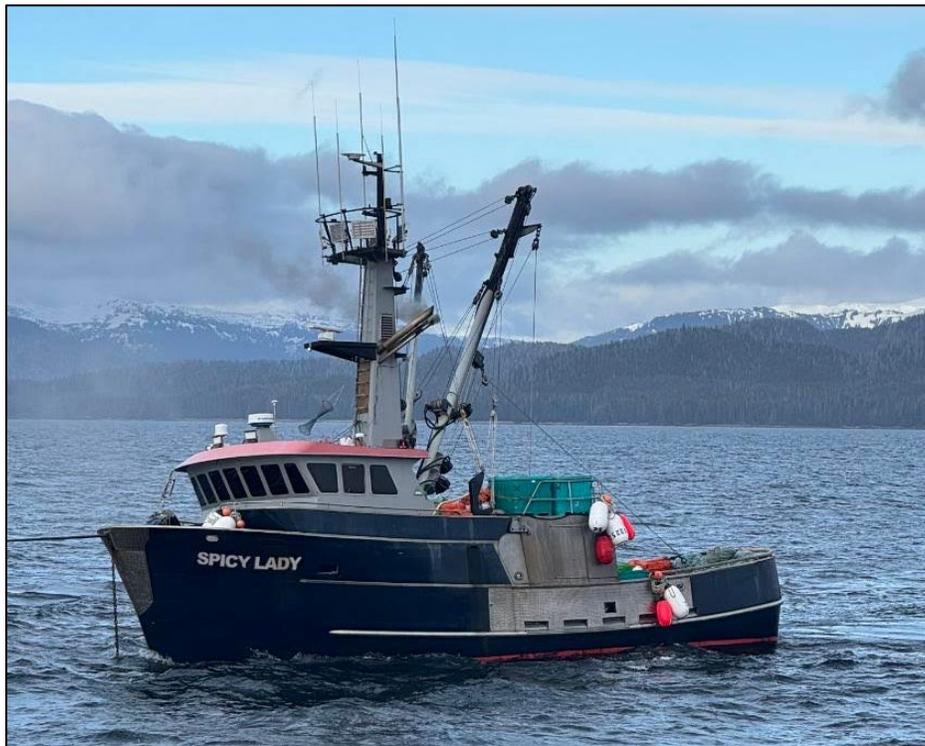
Figure 1. *Spicy Lady* being towed after the fire. (Source: *Spicy Lady* captain)

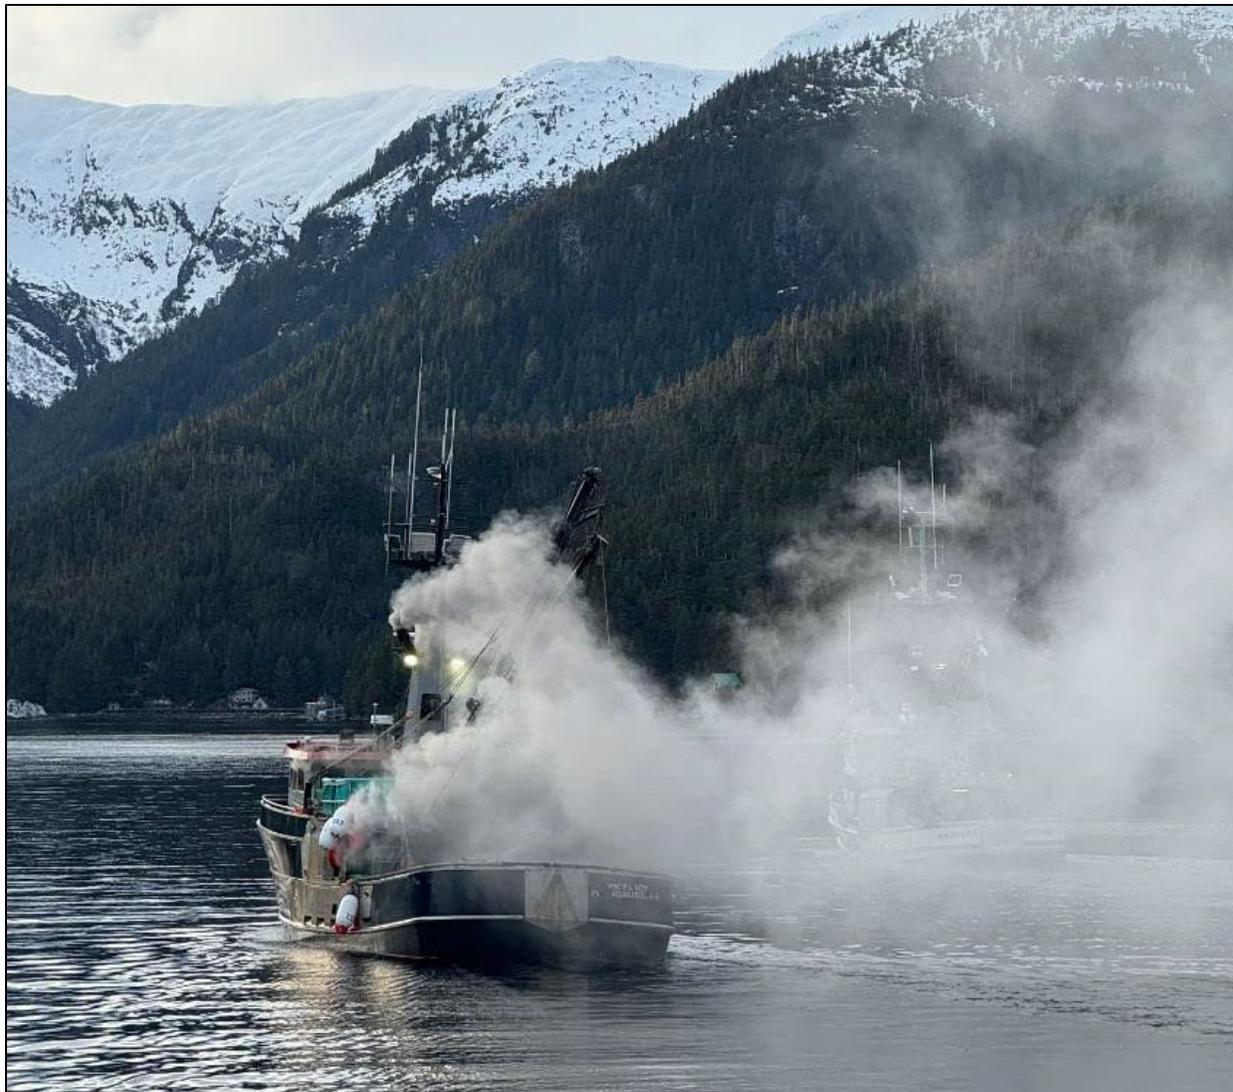
Figure 3. The *Spicy Lady* under tow by the *Angelette* after the crew evacuated to the *Angelette*. (Source: Wrangell Volunteer Fire Department)

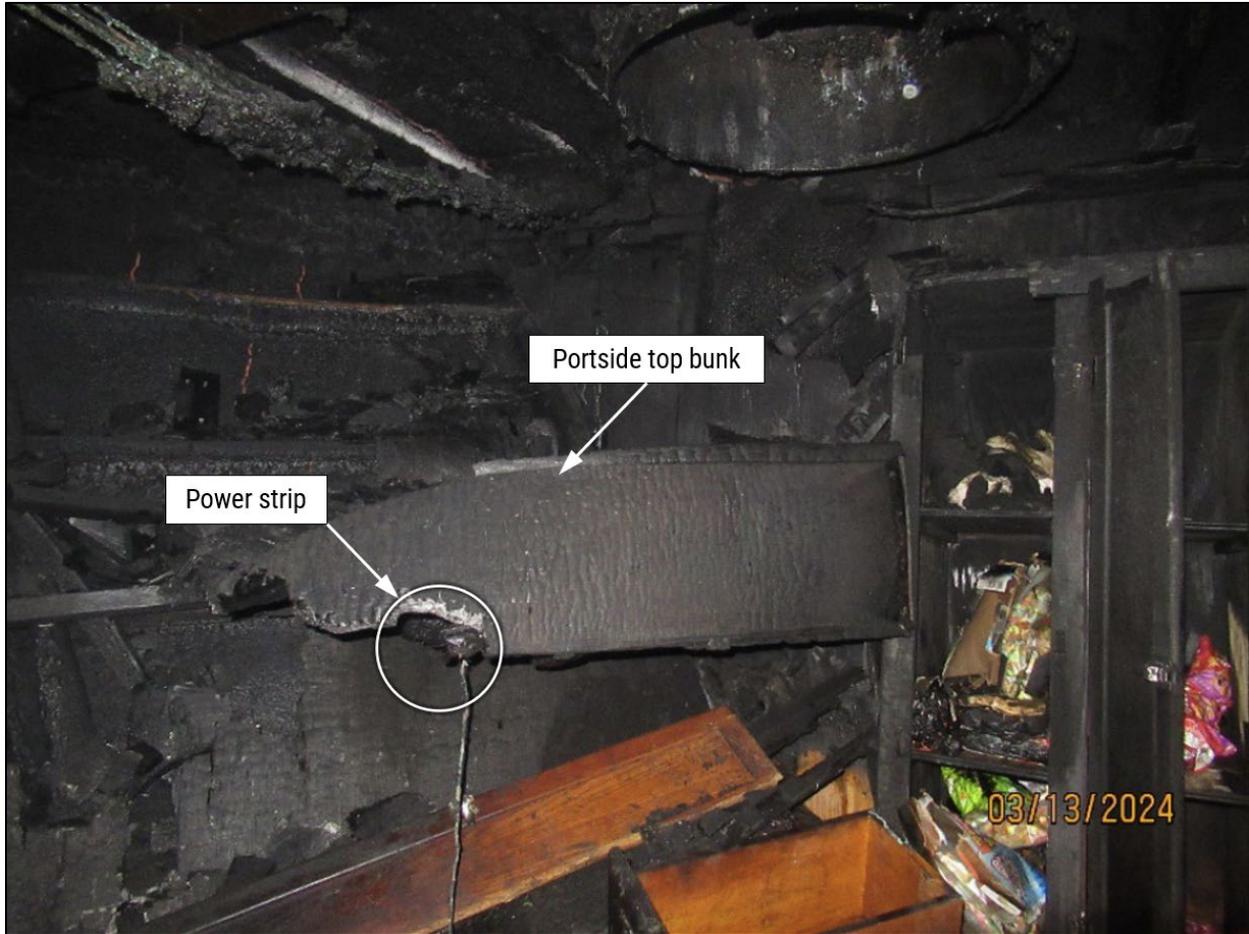
In the weeks following the fire, a damage survey of the *Spicy Lady* was completed on behalf of the vessel’s insurer. The survey report found that the forward berthing area was “completely destroyed by direct fire, high heat, and heavy soot and smoke,” and that the heaviest fire damage was on the port side of the space, aft (see figure 4). According to the survey report, the forward berthing area had two alternating current (AC) power outlets (one port and one starboard), one AC light switch mounted on the port side, and a 12-volt direct current (DC) reading light in each bunk. The surveyor found that the AC wire for the portside power outlet and light switch was bare and showed signs of corrosion and electrical arcing. The survey report showed the portside outlet had a power strip plugged into it.

Figure 4. Fire damage to the portside bunks in the forward berthing area. (Background source: Blomquist Marine Surveyors)

When the crew entered the cabin to investigate the smoke, they discovered a fire near the portside middle bunk in the forward crew berthing area. They found that the bunk mattress was burning, as was a “plastic tote” containing lithium-ion batteries for personal items, which may have been charging at the time. Post-fire photos showed that, compared to other areas of the vessel, the portside bunks in the forward berthing area were the most severely damaged and thus experienced the highest level of heat. Additionally, the responding firefighters and the marine surveyor’s report both concluded that the most severe smoke and fire damage was located in this area, and that this was the area of origin.

Possible ignition sources in the forward berthing area included electrical wiring, electrical components, and the lithium-ion batteries stored in the portside bunk (some of which the captain said were charging at the time). Although electrical arcing and corrosion were found to be present on the electrical wires in the berthing area post-fire, investigators were unable to determine when this occurred in the ignition sequence, and it is possible that the arcing and corrosion occurred after the initial fire or during firefighting efforts. Likewise, due to severe fire damage in the berthing area, and because the space was unoccupied when the fire started, investigators were unable to determine when the bag containing the lithium-ion batteries caught fire or what caused it to ignite. Therefore, an exact ignition source and sequence could not be determined.

The National Transportation Safety Board determines that the probable cause of the fire on board the fishing vessel *Spicy Lady* was an unknown source on a bunk in the forward berthing area.
