MIR-26-05

Contact of Tanker *Platanos* with Martinez Refining Company Wharf Pier

On October 14, 2024, about 0412 local time, the crude oil tanker *Platanos* was undocking from the Martinez Refining Company Wharf Pier, near Martinez, California, in the Carquinez Strait, when the vessel's port quarter made contact with a concrete dolphin and a fender support panel of the pier (see figure 1 and figure 2).¹ There were no injuries, and no pollution was reported. Damage to the vessel and pier was estimated at \$500,229.

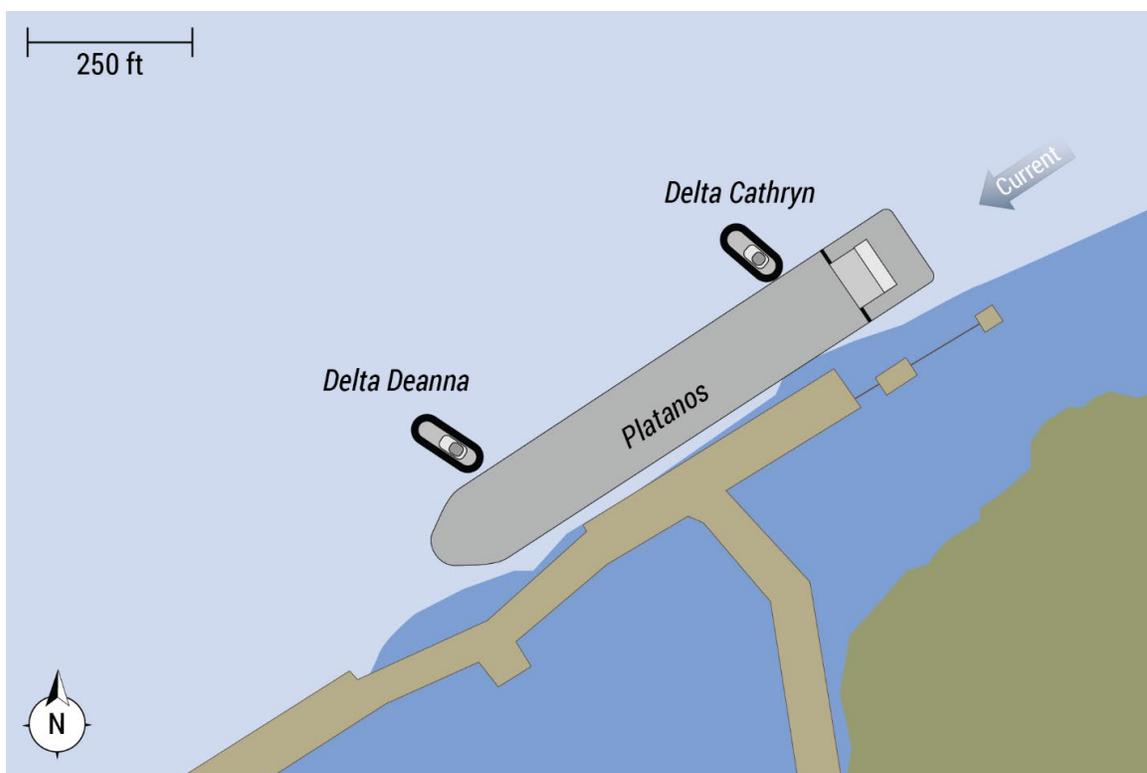
At 0357, the *Delta Deanna* was secured forward, and a minute later, the *Delta Cathryn* was secured aft. In his notebook and on the mooring plan diagram of the master/pilot exchange form, the pilot wrote down the placement and names of each tug on the starboard side of the ship. As was his common practice, he also wrote down the names and placement of each tug on a "radio card," or reference card, which he would have with him for quick reference from the bridge wing of the ship. At 0400, from the portside bridge wing, the pilot directed both tugs to push on the starboard side of the ship to hold it against the pier while the master ordered the *Platanos*'s mooring lines let go forward and aft (see figure 3).

Figure 3. Tug positions at 0400 for the undocking. (Scale approximate.) (Background source: *Platanos* electronic chart display and information system)

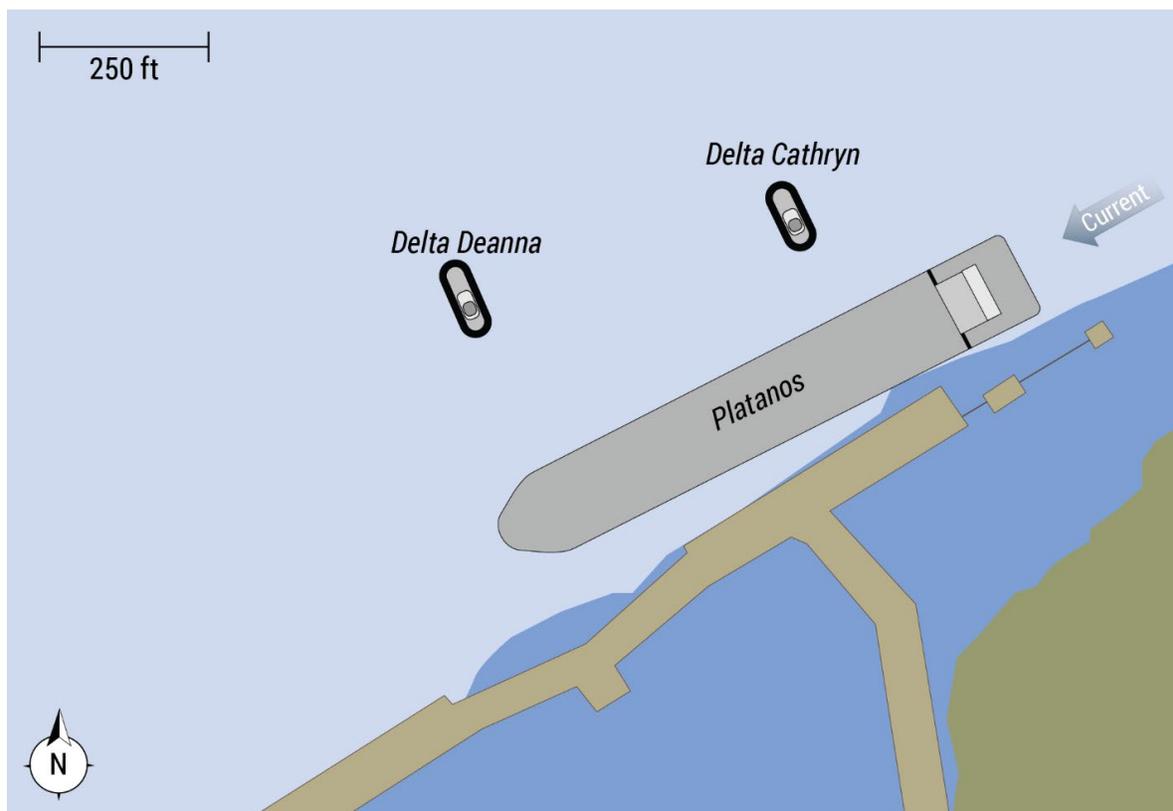
At 0411, the pilot then ordered the *Delta Cathryn* to stop, and seconds later, the pilot radioed the *Delta Deanna* and asked the operator to be on a 90° angle to the *Platanos* with the tug line. The *Delta Deanna* operator responded that he was "pretty darn close" (see figure 4). The pilot replied, "You are at a 45 [degrees] and you should be forward of the line." (The captain of the *Delta Deanna* later said in a statement that he believed the pilot was looking at the *Delta Cathryn*, which was sitting idle on the quarter, holding position 45° away forward with a slack line). Seconds afterward, the master announced to the pilot that the "aft is too close" (meaning the stern of the ship was too close to the pier). The pilot ordered the main propulsion of the *Platanos* stopped.

Figure 4. Tug positions at 0411:13. (Scale approximate.) (Background source: *Platanos* electronic chart display and information system)

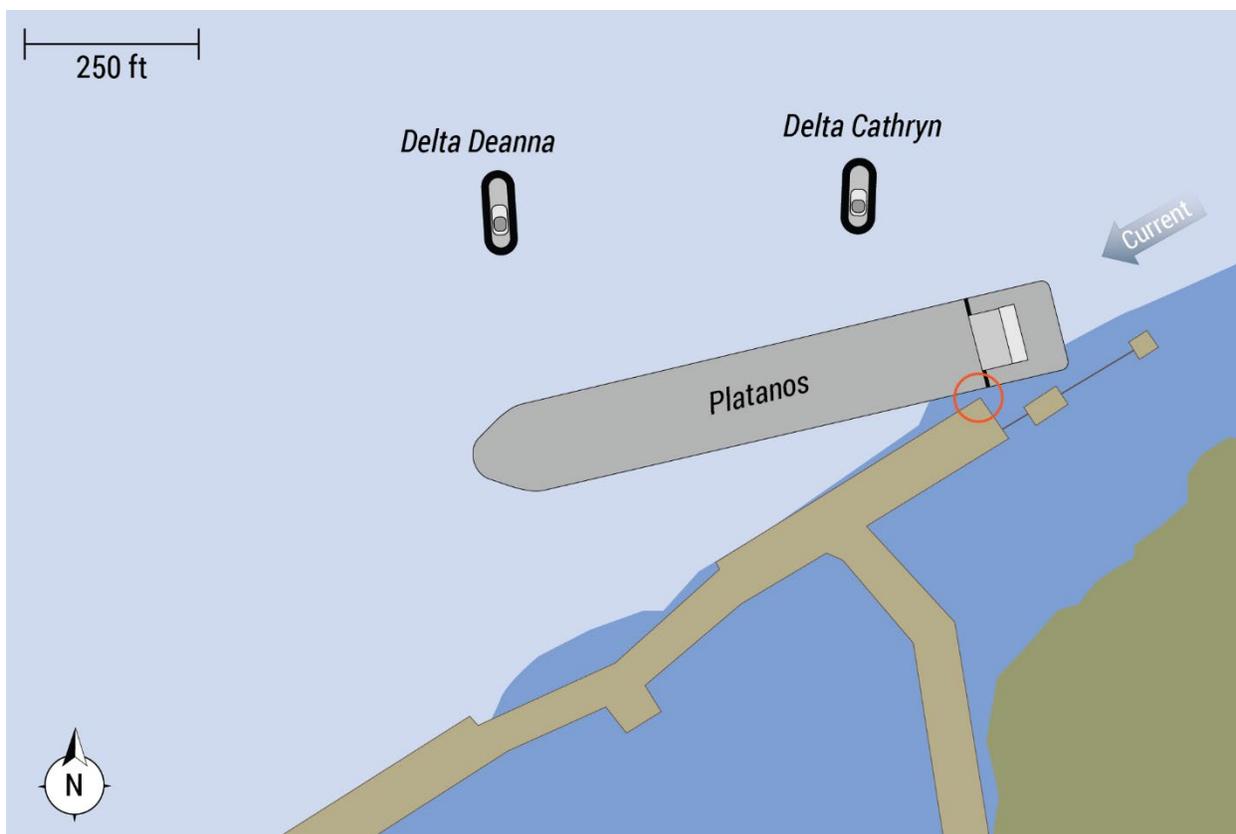
At 0411:23, the pilot ordered the *Delta Deanna* to pull “full away” and ordered the rudder hard to port. Seconds later, at 0411:50, based on the *Platanos*’s voyage data recorder data, an impact sound could be heard as the vessel contacted the northeastern corner of the pier (see figure 5).

Figure 5. Tug positions at 0411:54, with location of contact circled (Scale approximate). (Background source: *Platanos* electronic chart display and information system)

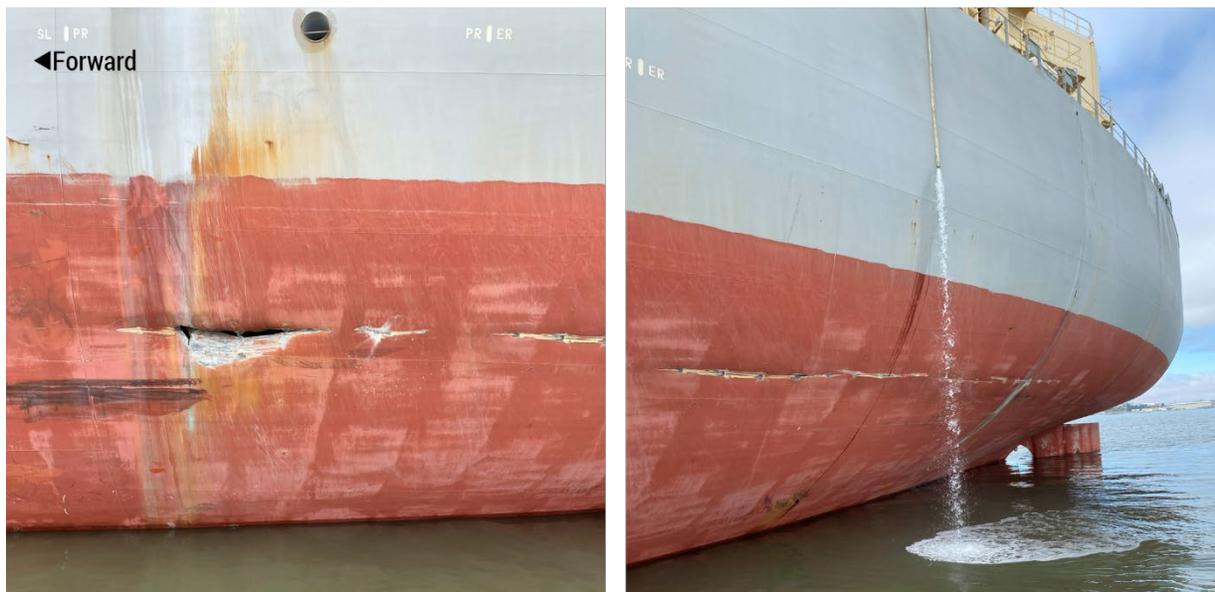
The contact resulted in a penetration of the shell plating into a pump room void space of the *Platanos*’s hull, port side. There were numerous horizontal indentations, buckling, and cracks of the shell plating extending aft of the hull penetration at the same height (see figure 6). No damage below the waterline was found, and there was no flooding to any of the ship’s internal spaces. Repairs to the ship were estimated to cost \$390,229.

Figure 6. Left to right: Hull penetration to the *Platanos*, port side aft, on October 14, 2024. Indentation, buckling, and cracks on the *Platanos*, port side aft. (Background source: Coast Guard).

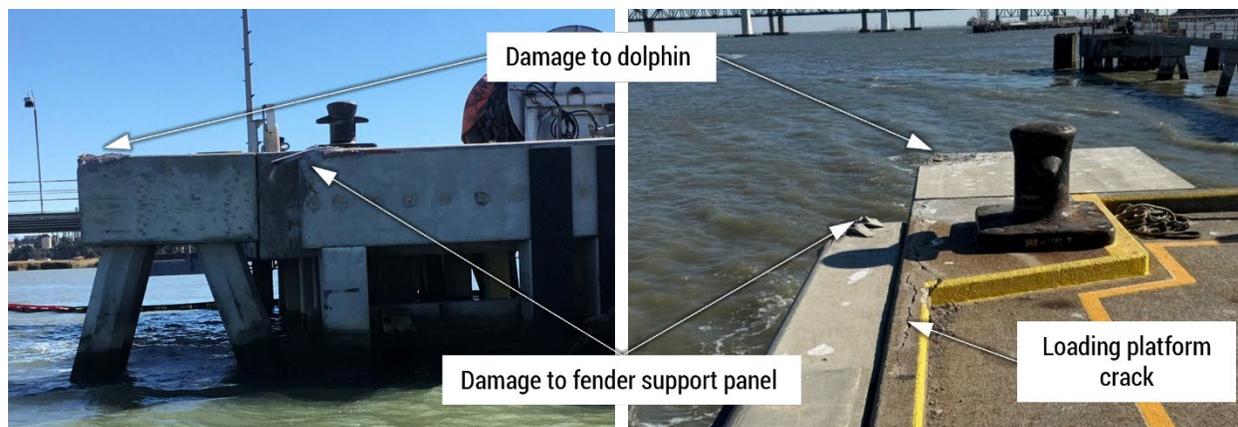
The Martinez Refining Company Wharf pier (berth no. 1) sustained impact damage—consisting of concrete spalling and cracks—to the northeastern face of the dolphin and fender support panel (see figure 7). Repairs to the berth were initially estimated to cost up to \$110,000.

Figure 7. Left to right: Northeastern end of the Martinez Refining Wharf Pier berth no. 1 showing damage to the dolphin, fender support panel, and loading platform. Damage as viewed from the loading platform. (Background source: SGH)
