March 10, 2026

MIR-26-07

## Grounding of Fishing Vessel *Eileen Rita*

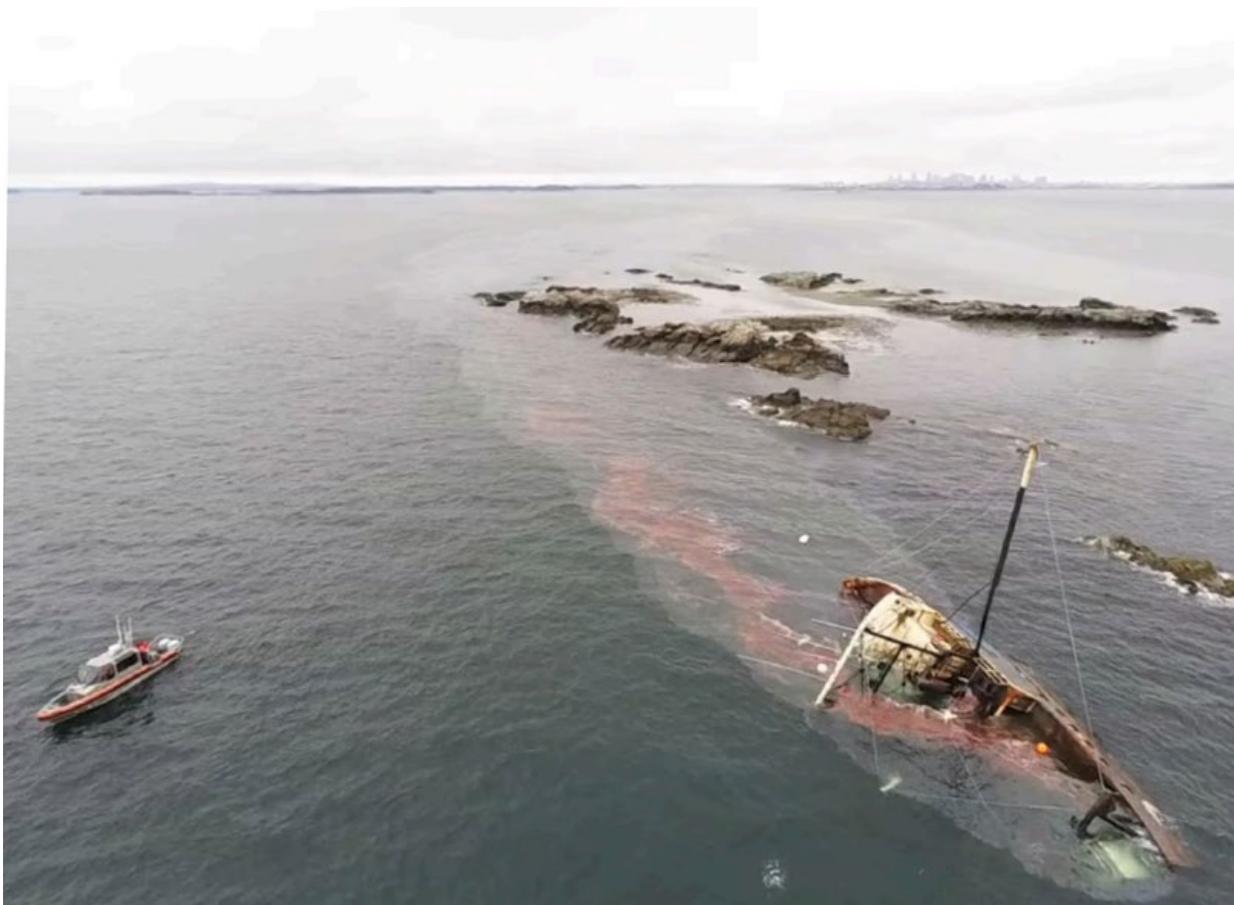
In the hours after the grounding, a Coast Guard helicopter crew observed a diesel sheen coming from the *Eileen Rita*. Responding vessels from the Coast Guard and a salvage company also reported observing a diesel sheen coming from the *Eileen Rita* (see figure 3).

**Figure 3.** *Eileen Rita* and diesel sheen observed by Coast Guard overflight the morning of the grounding near Green Island, Massachusetts. (Source: Coast Guard)

In the days after the grounding, the *Eileen Rita* came off the rocks and eventually sank. At the time of the grounding, the *Eileen Rita* had an estimated 4,000 gallons of diesel fuel and 50 gallons of lube oil on board. The *Eileen Rita* was later salvaged but was deemed a constructive total loss valued at \$720,000.

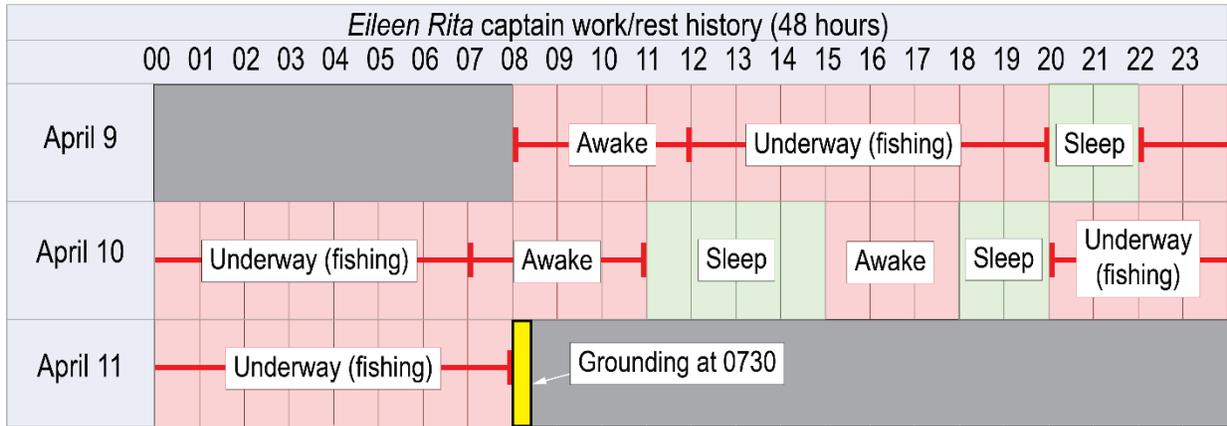
In the 48 hours before the grounding, between April 9 and April 11, the captain reported making three separate fishing trips on the *Eileen Rita*, totaling 29 hours of fishing. During this time, the captain reported getting a total of 8 hours of sleep, which were broken up into two 2-hour segments and one 4-hour segment, each occurring at different times (see figure 4). After the grounding, the captain told investigators, "I didn't realize how tired I was ... until it was too late." The captain estimated that he had fallen asleep about 10 minutes before the grounding.

**Figure 4.** *Eileen Rita* captain's work/rest history for 48 hours before the grounding.

The captain estimated that he had fallen asleep about 10 minutes before the grounding. In the 48 hours before the grounding, the captain accumulated a significant sleep debt, only getting a total of about 8 hours of sleep. Individuals typically require 7-8 hours of sleep every 24 hours to avoid the negative performance impacts of fatigue. Fatigue is the human body's desire for sleep and impacts all aspects of human performance. Even a deficit of as little as 2 hours can result in decreased attention, slower reaction time, reduced vigilance, and an inability to stay awake. Further, it is likely that the quality of sleep that the captain did receive was poor. The 8 hours of sleep that the captain reported were broken up, or fragmented, into one 4-hour and two 2-hour segments. Sleep is most restorative when individuals receive the maximum amount of uninterrupted sleep, typically occurring around the same time each day. The more sleep is fragmented, the more the restorative quality of sleep is diminished. As such, the captain was affected by fatigue the morning of the grounding due to an accumulated sleep debt and poor sleep quality in the previous 48 hours, causing him to fall asleep at the helm.
