MIR-26-08

Engine Room Fire aboard Cargo Vessel *Lem Verbena*

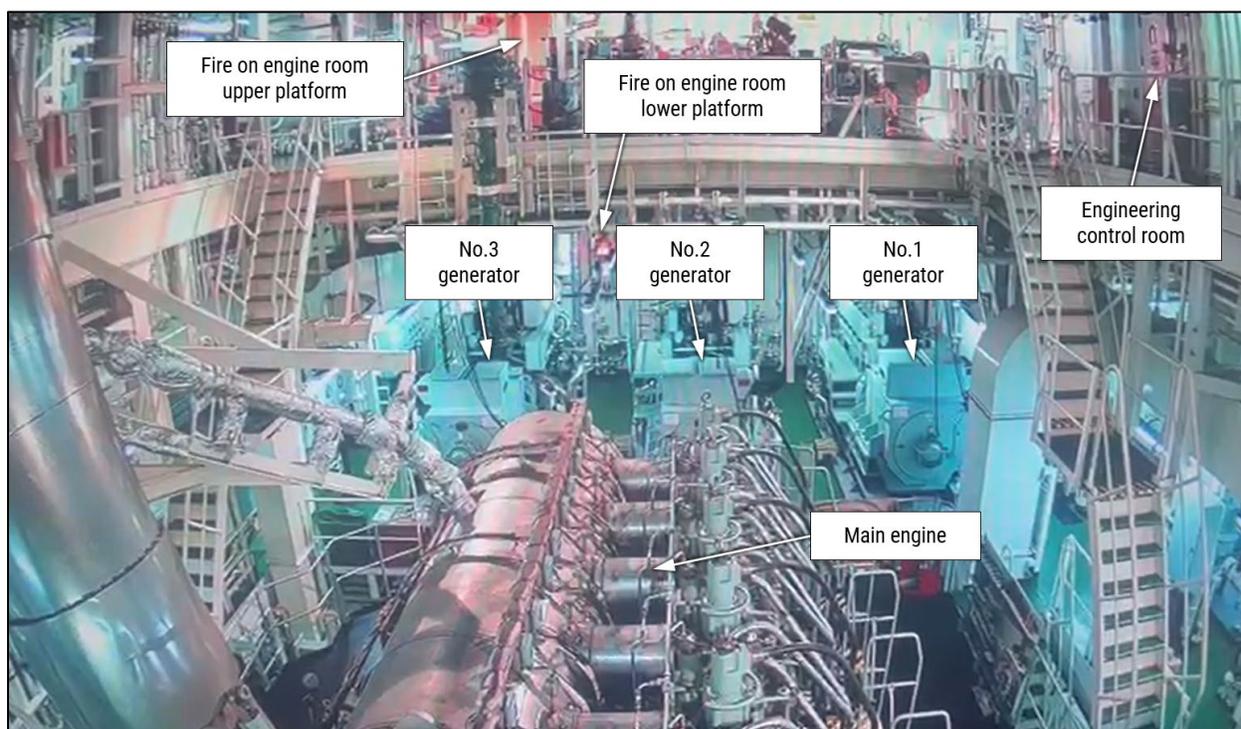
At 2322:41, a fire alarm activated in the ECR; the alarm indicated a fire in the “upper engine room” zone, where the boiler and the incinerator were located. At 2322:58, the vessel’s water mist system sensed smoke/heat in the upper engine room zone and automatically deployed in the space (see section 1.3.3). Upon activation of the fire alarm, the second engineer exited the ECR and observed ignited fuel “dropping down” from the engine room upper deck where the boiler burner unit was located, spreading the fire down to the engine room upper and lower platforms beneath it (see figure 3 and figure 4). The second engineer returned to the ECR and called the chief engineer.

Figure 3. CCTV screenshot from the *Lem Verbena* engine room (facing aft), showing the fire on the engine room upper platform (one deck below the boiler) and engine room lower platform. (Background source: Lemissoler Shipmanagement)

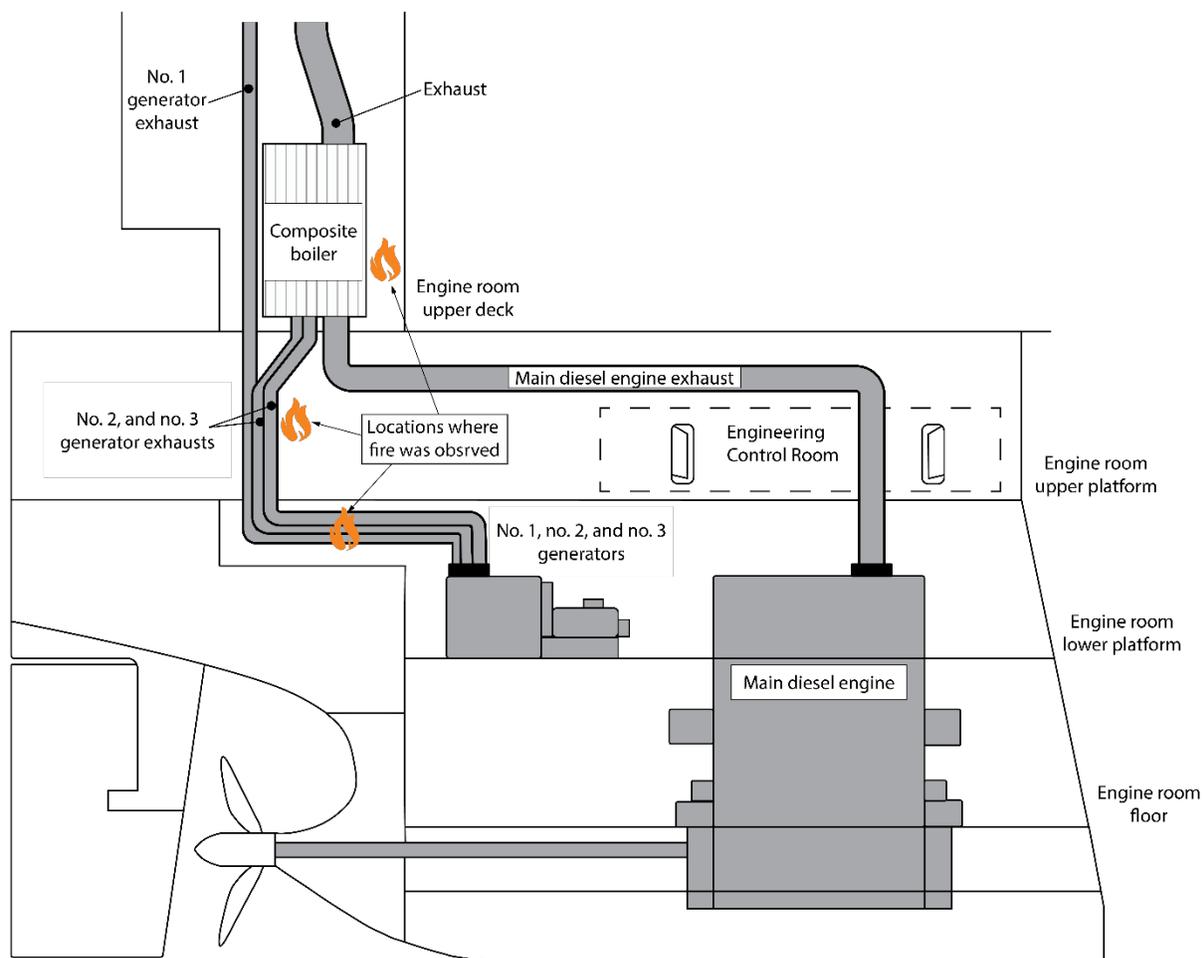
Figure 4. Simplified profile of the *Lem Verbena* engine room representing the arrangement of engine room spaces and exhaust components, and showing the location of initial fire near the boiler as well as the spread of the fire to lower decks. (Not to scale.)

Due to a lack of evidence, the exact ignition source and sequence (what caused the ignition and how the fire spread) could not be determined. However, post-fire damage assessments showed the most significant fire damage on the fuel-handling side of the burner unit and the immediately adjacent area. Significant fire damage was also found in the engine room upper platform, a deck below the boiler. Possible ignition sources in those areas included the boiler and burner unit,

which may have still been hot from a previous cycle (completed about 5 minutes before the fire), or the running no. 2 generator's exhaust, which ran into the boiler from directly below it. While the exhaust was covered with protective lagging, it is possible that the atomized fuel contacted an unprotected section of the exhaust pipe and ignited.

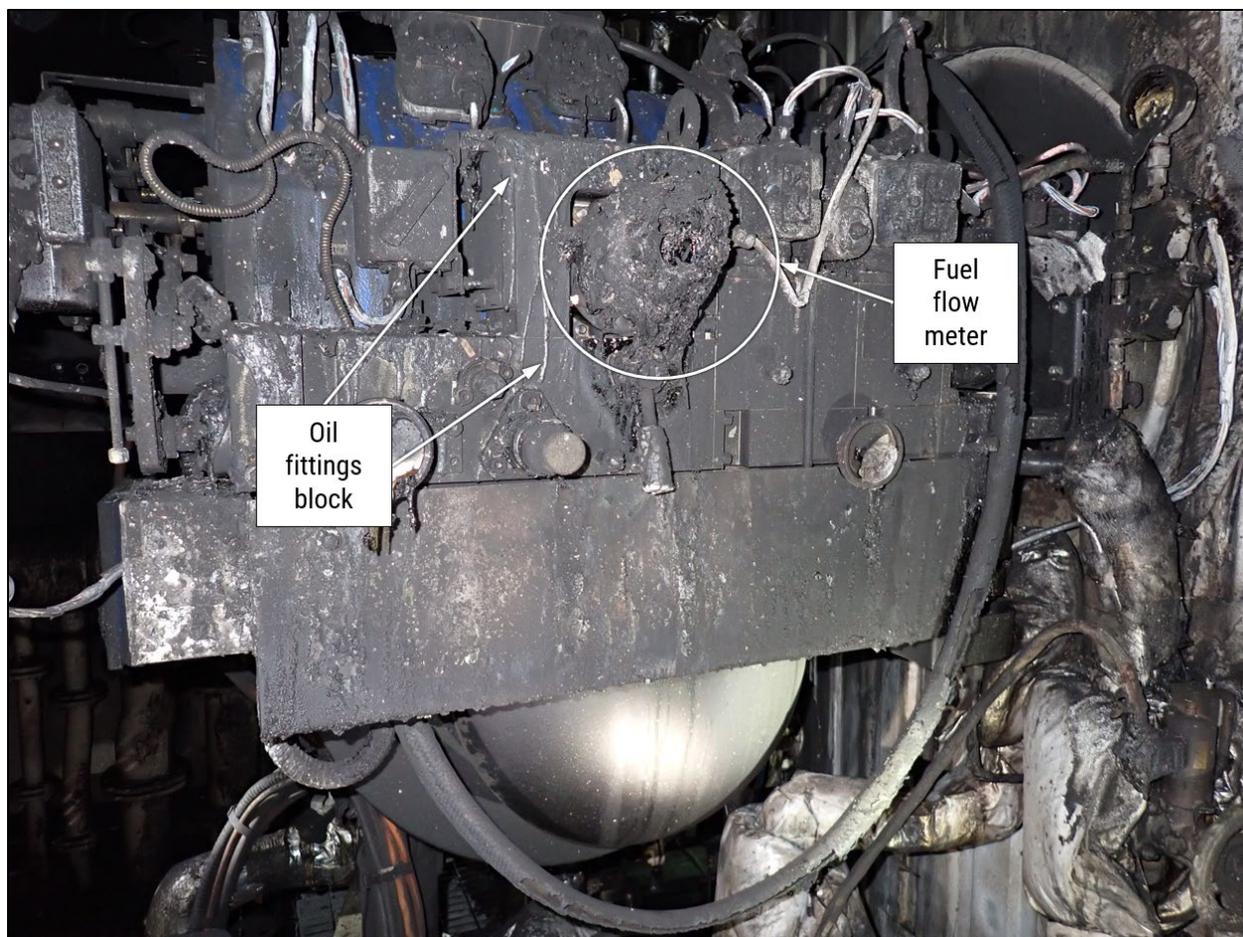
After the fire, a surveyor from the vessel's classification society completed a damage survey. The survey report noted extensive fire damage to the boiler's burner unit and adjacent burner control cabinet. The surrounding lights, electrical cabling, alarm light towers, piping and bulkhead insulation, fire alarm pull stations, general alarm horns, and fire doors in the engine room upper deck were also damaged by smoke and heat from the fire.

The surveyor observed the most severe fire damage on the fuel-handling side of the burner unit, which included the fuel flow meter and the oil fittings block (see figure 5). The other side of the burner unit was less severely damaged but showed heavy soot and signs of smoke damage. The engine room upper platform (a deck below the engine room upper deck, which contained the boiler) was also significantly damaged by the fire. A wooden supply shelf located directly below the burner unit through the metal grating of the engine room upper deck was destroyed by the fire, and fuel oil was observed on the deck below. Total damages were estimated at \$5.5 million.

Figure 5. The *Lem Verbena* boiler's burner unit after the fire. (Background source: US Coast Guard)

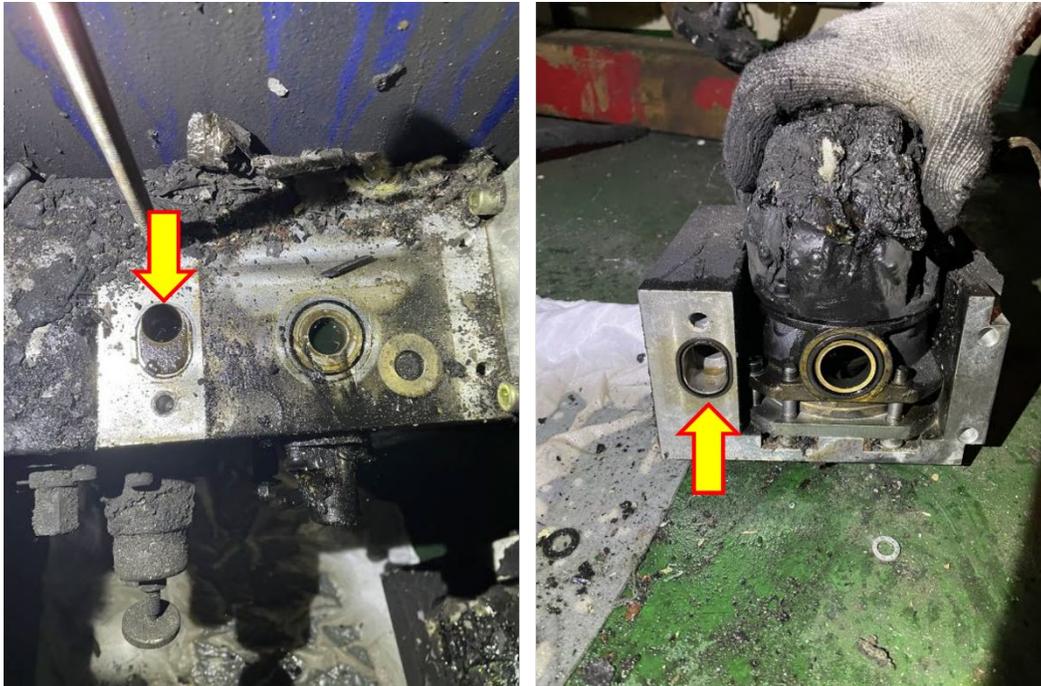
US Coast Guard investigators disassembled and examined the burner unit's oil fittings block around the fuel flow meter. The oil fittings block was comprised of three separate modules that provided a path for pressurized fuel from the fuel pump, through the fuel flow meter and other components, and into the igniter. Investigators found that an O-ring between two of the modules overlapped into the corresponding fuel port and became pinched between the two modules (see figure 7 and figure 8). When the fuel pump was running, fuel pressure at this location in the system was 3 bar, or about 43 pounds per square inch. Coast Guard investigators also found that the bolt securing the burner unit to the boiler combustion chamber was partially stripped, preventing the burner from being tightly secured to the boiler.

Figure 7. Left to right: Lower module of the oil fittings block showing overlap between the lower and upper module fuel ports as indicated by the arrow. Upper module of oil fittings block and fuel flow meter showing the pinched O-ring as indicated by the arrow. (Source: Lemissoler Shipmanagement)

After the fire, the *Lem Verbena* operating company and Coast Guard investigators found that an O-ring on the oil fittings block upper module of the boiler's burner unit had become pinched on the fuel port for the lower module. This O-ring was intended to provide a seal between the corresponding fuel ports on the lower and upper modules (when bolted together) to contain pressurized fuel as it moved through the system to the burner unit igniter. O-rings are designed to protect against leaks by lying flat and becoming compressed between two machinery surfaces that are secured together, typically containing a material under pressure. If any portion of the O-ring does not lay flat between the two surfaces, full compression of the O-ring cannot be achieved. This weakens the seal created by the O-ring and increases the likelihood of failure. In this case, a portion of the O-ring on the upper module overlapped into the fuel port on the lower module, preventing the O-ring from lying flat and providing an adequate seal. This was because the two modules' ports were not aligned radially and created an uneven clearance gap when the ports were bolted together. This gap could not be seen or detected when the ports were bolted together. (Investigators could not determine whether the block modules had been disassembled since they were manufactured or initially installed on the vessel.)

Additionally, because of a software settings error discovered on the boiler unit's SD card, the fuel pump did not shut down between cycles as intended and the pinched O-ring was exposed to constant pressure. The operating company found that the O-ring's exposure to hot, pressurized fuel caused accelerated degradation of the O-ring, ultimately causing the seal to fail. Over time, the pinched portion of the O-ring was weakened until its seal failed under the fuel pressure in the ports. Because the fuel pump remained running even if the boiler burner was not firing and, thus, the fuel system was always pressurized, pressurized fuel about 43 pounds per square inch would have atomized around the boiler and ignited on a nearby hot surface, causing the fire.

The National Transportation Safety Board determines that the probable cause of the fire on the bulk carrier *Lem Verbena* was the failure of an O-ring seal on the composite boiler burner unit oil fittings block due to the radial misalignment of the two fuel ports on the block modules, causing pressurized diesel fuel to atomize and ignite on a nearby hot surface.

In the months after the fire, the *Lem Verbena* operating company replaced the burner unit with the same model that was destroyed by the fire. When installing the new burner unit, the new unit's SD card was inoperable, so the service technician used the undamaged SD card from the previous burner unit that was involved in the fire (the boiler's SD card stored operational data and contained software controlling the operation of the boiler and burner unit). During initial testing, the MGO fuel pump did not turn off when the burner unit shut down between cycles. (According to the burner unit manufacturer, as designed, the fuel pump should only run when the burner unit was running, and the pump should turn off when the burner unit was off in between cycles.) To correct this issue, the service technician modified the software configuration file on the SD card so that the MGO fuel pump stopped when the burner was off.

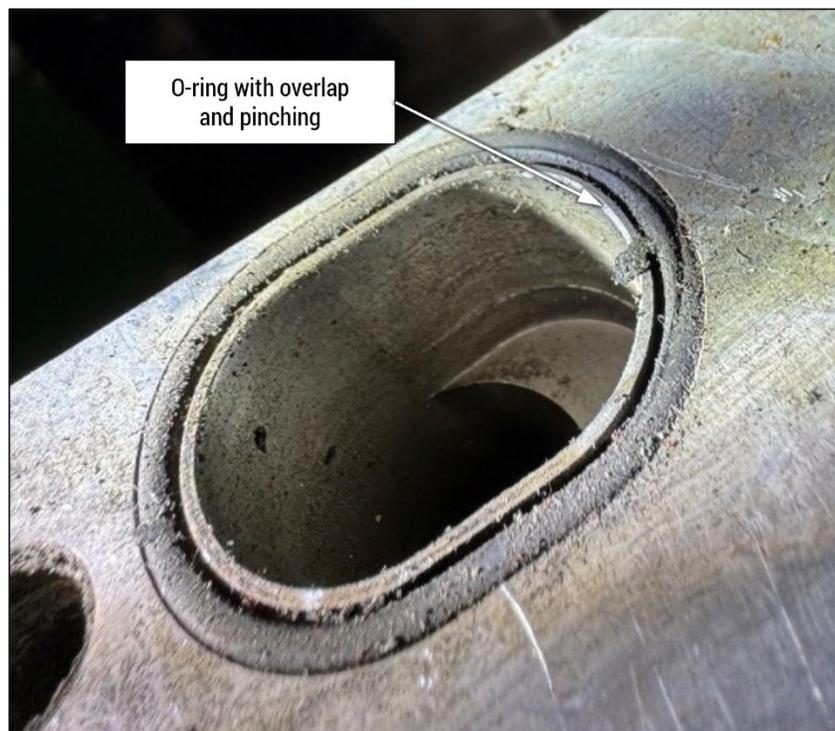
Figure 8. Close-up view of O-ring on upper module of burner unit oil fittings block. (Background source: Coast Guard)

The operating company determined that the pinched O-ring was subject to accelerated degradation due to a combination of becoming pinched between the two modules and continuous exposure to hot, pressurized fuel in the system because of a software settings error on the system's SD card. The company concluded that the fire started from an "exploding leakage" from the weak point in the system created by the degraded and pinched O-ring. Investigators could not determine whether the block modules had been disassembled since they were manufactured or initially installed on the vessel.
