MIR-26-09

Engine Room Flooding aboard Sailing School Vessel *Oliver Hazard Perry*

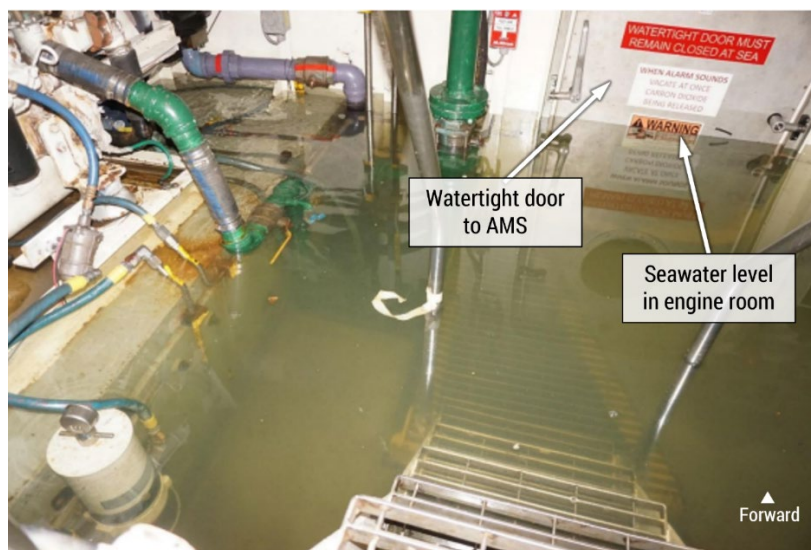
About 0810, local firefighters arrived at the vessel and worked with the bosun to set marks to monitor the water levels in the engine room and AMS (see figure 3). After monitoring for about 30 minutes, they determined that seawater was entering the vessel at a rate of about 1 inch per hour in the engine room and rising about a half inch per hour in the AMS. After the water level reached about 3 feet in the engine room, the level in the AMS increased to about 2 inches per hour.

Figure 3. Seawater level in engine room of the *Oliver Hazard Perry* on May 11, 2025. (Background source: Coast Guard)

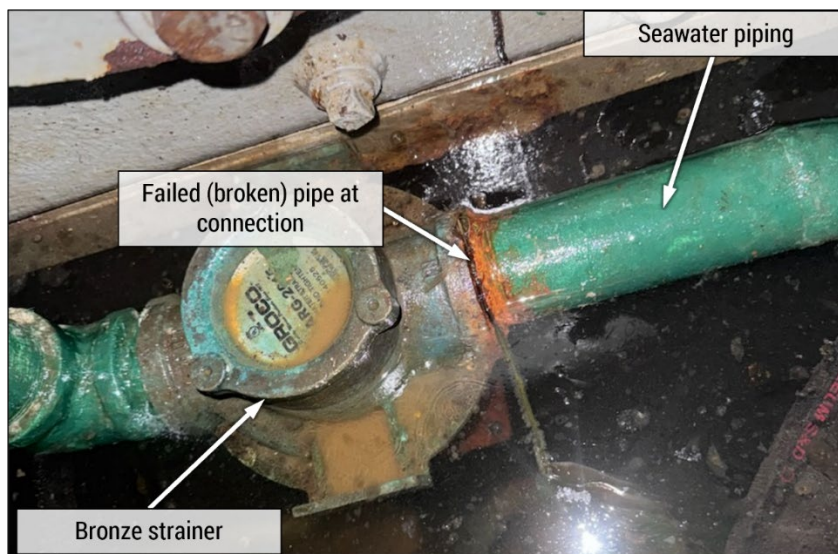
The marine surveyor determined the cause of the flooding was due to a failed (broken) seawater cooling supply pipe for the portside generator (see figure 4). The threaded portion of the 2-inch steel pipe was corroded at the connection point with the bronze strainer. The marine surveyor could not determine how seawater leaked from the engine room into the AMS but reported that it could have entered the AMS through fittings in the watertight bulkhead and/or from the hinged watertight door.

Figure 4. Broken pipe at connection between seawater supply pipe and strainer. (Background source: Coast Guard)

After the casualty, a marine surveyor examined the vessel's engine spaces and determined the cause of the flooding was the failed (broken) seawater supply pipe for the port generator, likely due to corrosion. The failure was located at the threaded connection between a steel pipe and the inlet to a bronze strainer housing. When a steel pipe is threaded, the pipe's outer surface is cut and results in a reduction of wall thickness. The reduced wall thickness makes this section of a pipe more prone to corrosion and possible failure, as the pipe wall is thinner, and therefore, less degradation is necessary for a piping failure to occur. Typical causes of corrosion may include vibration or galvanic action between dissimilar metals.⁵ About a year before the casualty, components in the starboard generator's seawater cooling piping system had been replaced due to corrosion. Based on the condition of the starboard generator's seawater cooling piping system, it is likely that the portside generator's seawater cooling system was similarly corroded and in need of replacement.

On May 15, a temporary sealing plate was installed over the port generator's seawater piping system with a rubber gasket to stop the water ingress until further repairs could be made. The captain told investigators that the vessel owner/operator was considering the installation of an alarm annunciator in the accommodation spaces to announce alarms for the bilge system. At the time of publication of this report, repairs were still ongoing.
