MIR-26-10

Breakaway of Barges *MPC 907* and *MPC 644* and Subsequent Contact with Mooring Cells

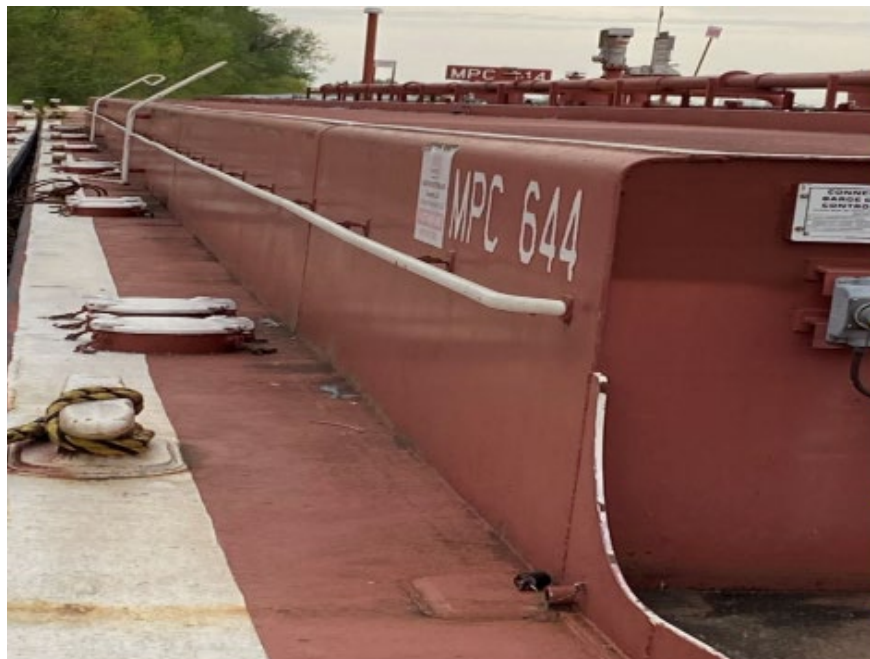
Figure 1. Barge *MPC 644* at unknown date. (Source: Marathon Petroleum Company)

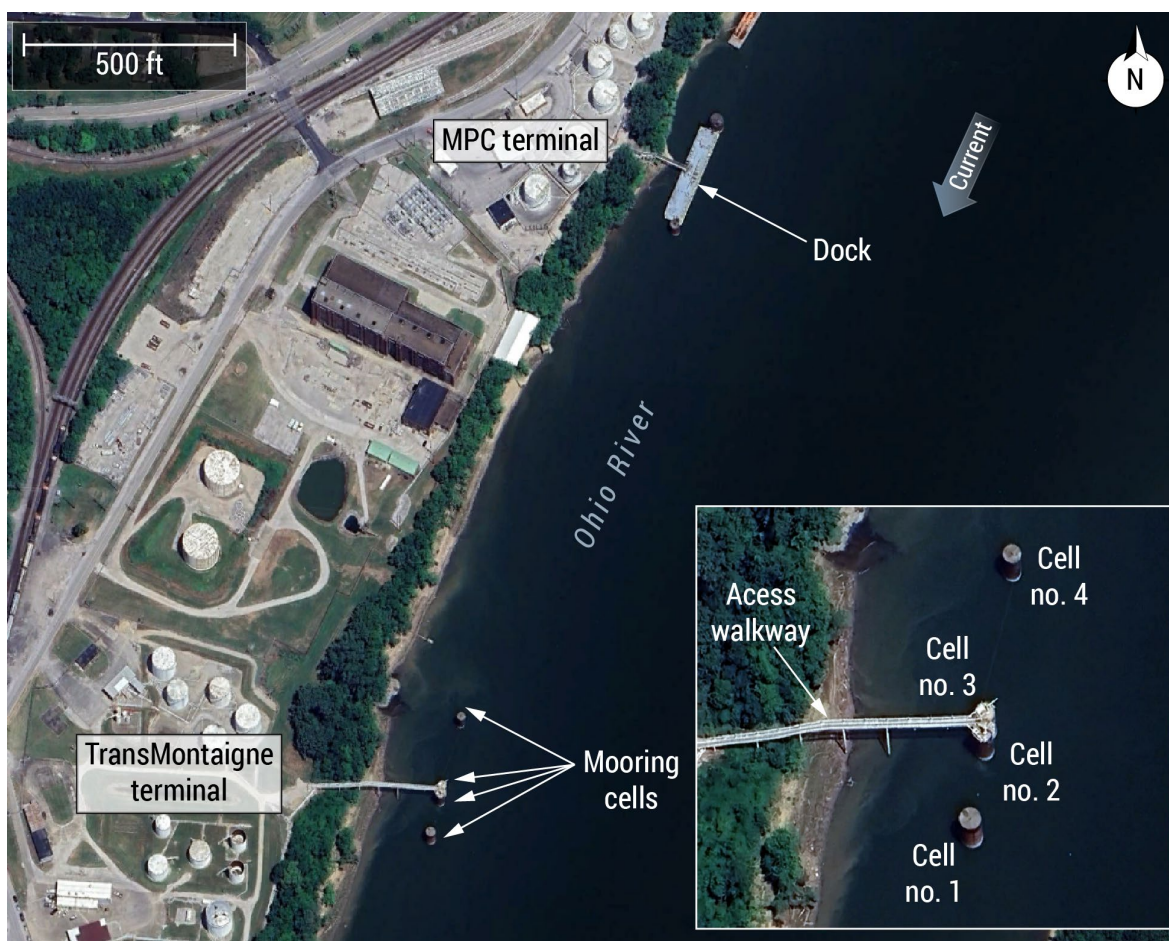
The TransMontaigne terminal—located at mile 794.1, about 1,500 feet downstream of the MPC terminal—reported damage to its dock structure, which consisted of four mooring cells and a steel access walkway running from shore to cell nos. 2 and 3 (see figure 3). Cell no. 4, located farthest upriver, was no longer present. A sonar survey found that the cell piling was fractured at the river bottom and laid in the downstream direction at a 90° angle to the original vertical location (see figure 4). Cell no. 3 sustained significant damage to the upstream piling structure and concrete cell cap. Cell no. 2 sustained fracture damage to its concrete cap. Supports and steps for a spiral access stairway attached to cell no. 2 were deformed. No damage to cell no. 1 was noted. The steel access walkway to the mooring cells and associated piping was distorted in the downstream direction. TransMontaigne estimated the physical damage to the dock structure would exceed \$2.5 million.

Figure 3. Mooring cells at TransMontaigne terminal before the barge breakaway and contact. (Background source: Google Earth)

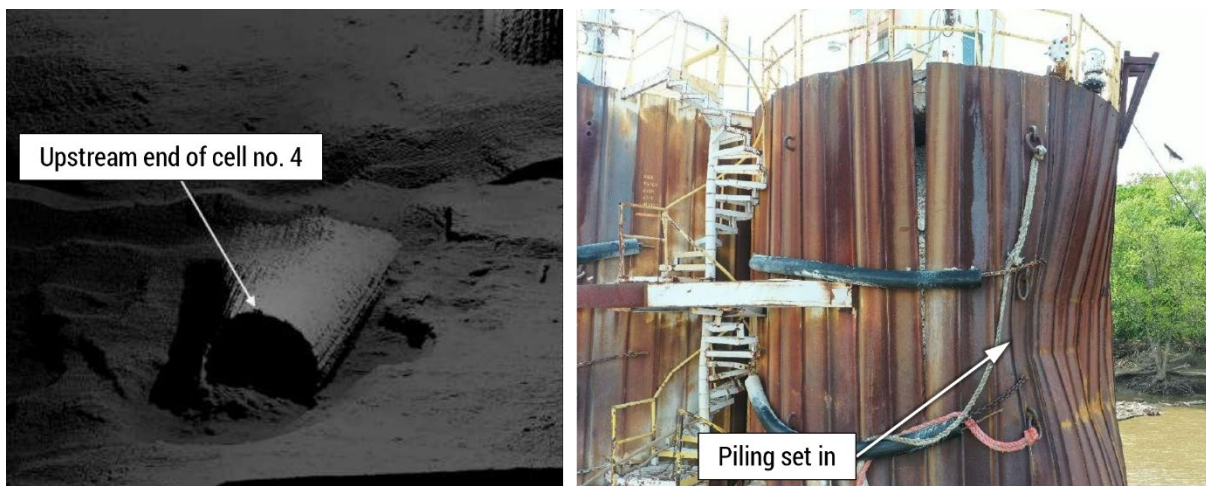
Figure 4. Left to right: Sonar image showing upstream end of cell no. 4 on the river bottom. Damage to mooring cell no. 3, with piling set in. (Background source: TransMontaigne)
