April 7, 2026

MIR-26-12

Fire aboard Pipelayer *Deep Energy*

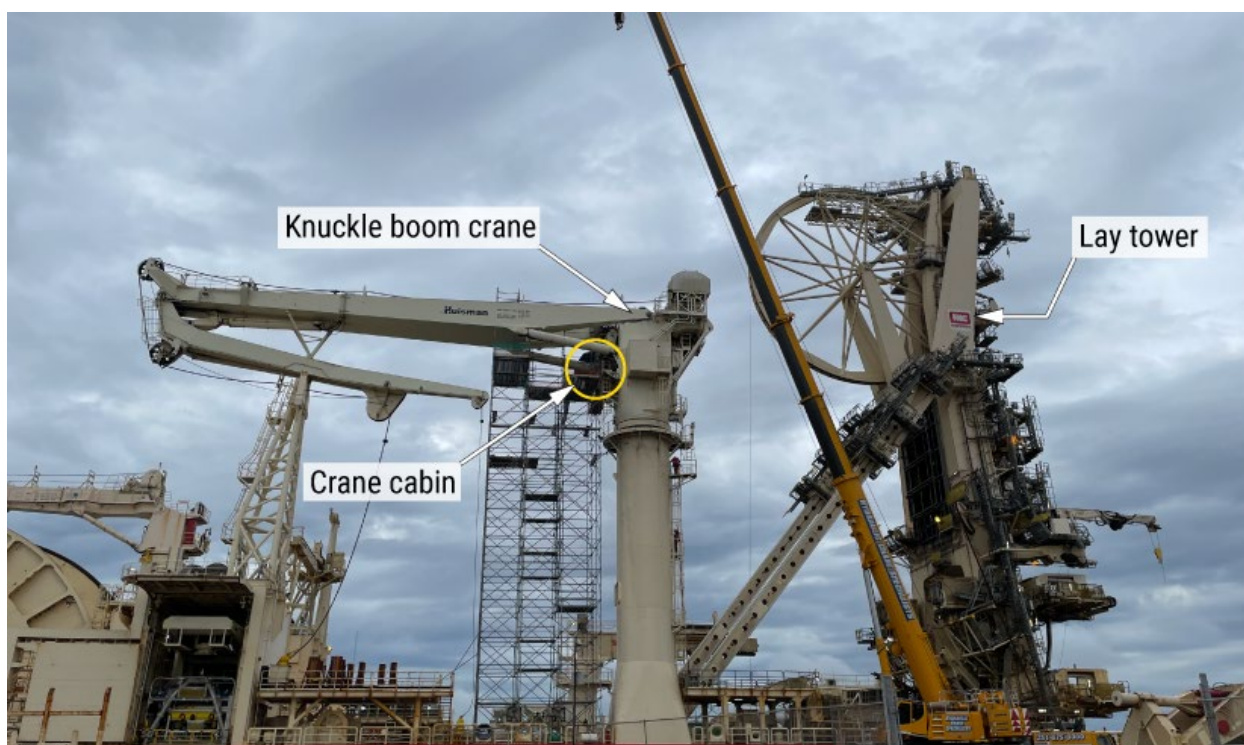
Figure 3. The knuckle boom crane from the port side of the vessel after the casualty.

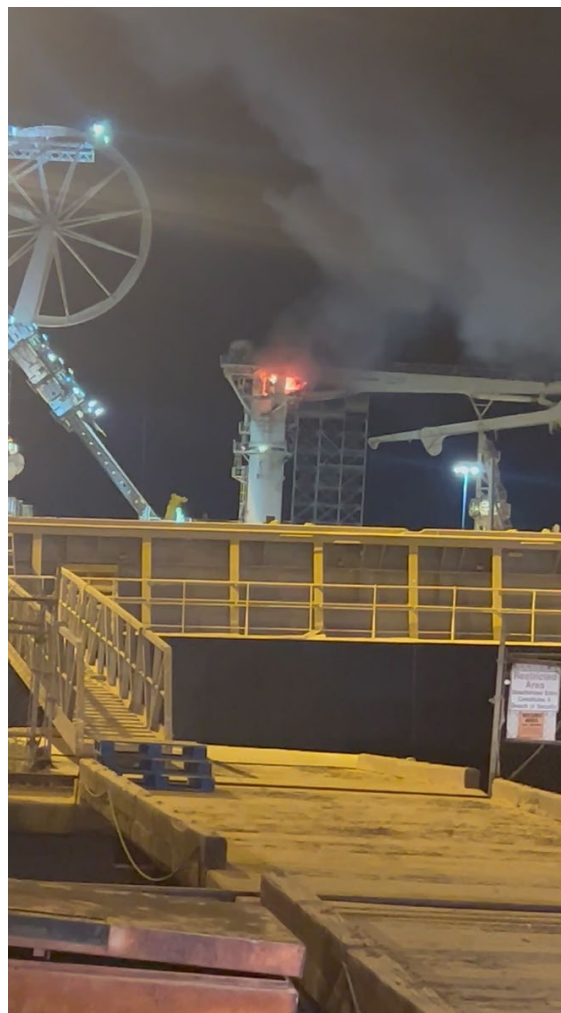
About 0401, the rigging superintendent accessed the crane cabin platform and confirmed that there was a fire within the crane cabin, on the starboard side by the entrance (see figure 4). He informed the senior chief mate of the fire and then retrieved the carbon dioxide fire extinguisher from inside the crane cabin. He emptied the extinguisher on the fire but was unable to extinguish it. The senior chief mate directed him to get down from the crane platform.

About 0408, after seeing the fire within the crane cabin break the glass of the structure and grow in intensity, the master directed the senior chief mate to again contact the Coast Guard and inform them that the vessel required assistance from the local fire department.

Figure 4. The crane cabin on fire, as seen from shore, after the fire broke the glass and before the arrival of the Mobile Fire Department. (Source: Unknown, via Coast Guard)

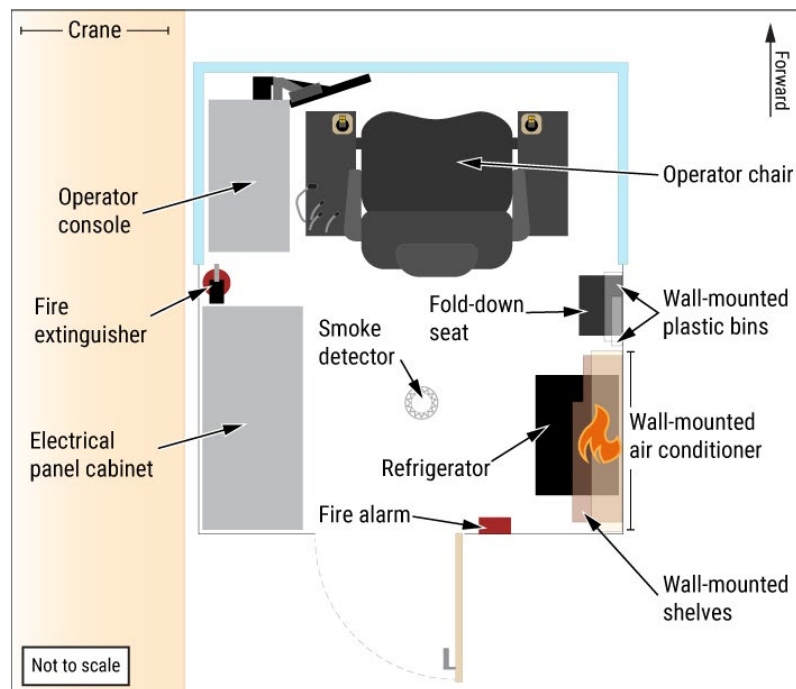
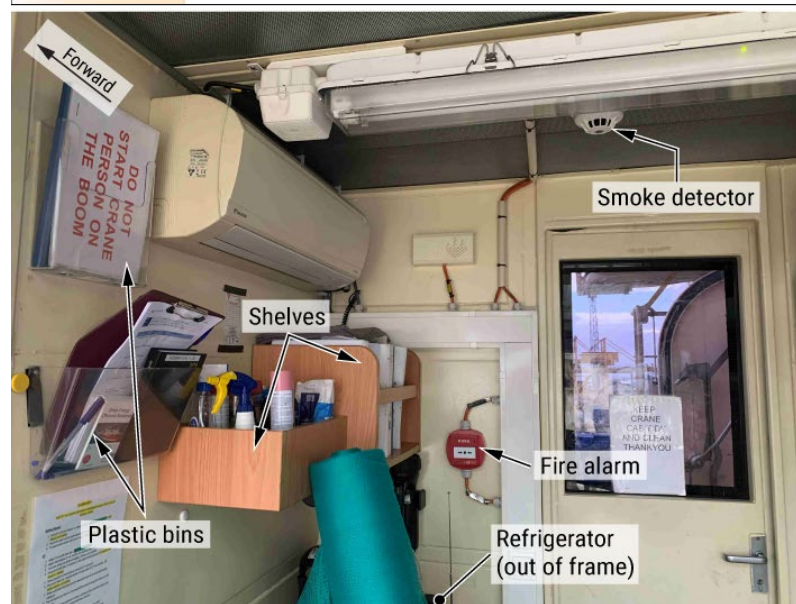
The crane operator said the crane cabin contained the electrical systems and controls to operate the crane, as well as a coffee maker, an electric tea kettle, and a compact refrigerator (see figure 5). The refrigerator was located on the deck, on the starboard side of the space by the door, and the coffee maker and the tea kettle were located above the refrigerator on a wooden shelf, which also housed plastic document binders. Plastic bins were also mounted on the wall, above the refrigerator. The refrigerator, which had been placed in the space about 6 months before the fire, was used by the crew to store water and milk. Information about the refrigerator's make, model, age, and country of manufacturing was not available.

Figure 5. Top: Plan view of the crane cabin room (not to scale and layout approximate). Below: An undated photograph from before the accident, showing the aft corner of the crane cabin room and the items mounted above and near the refrigerator.

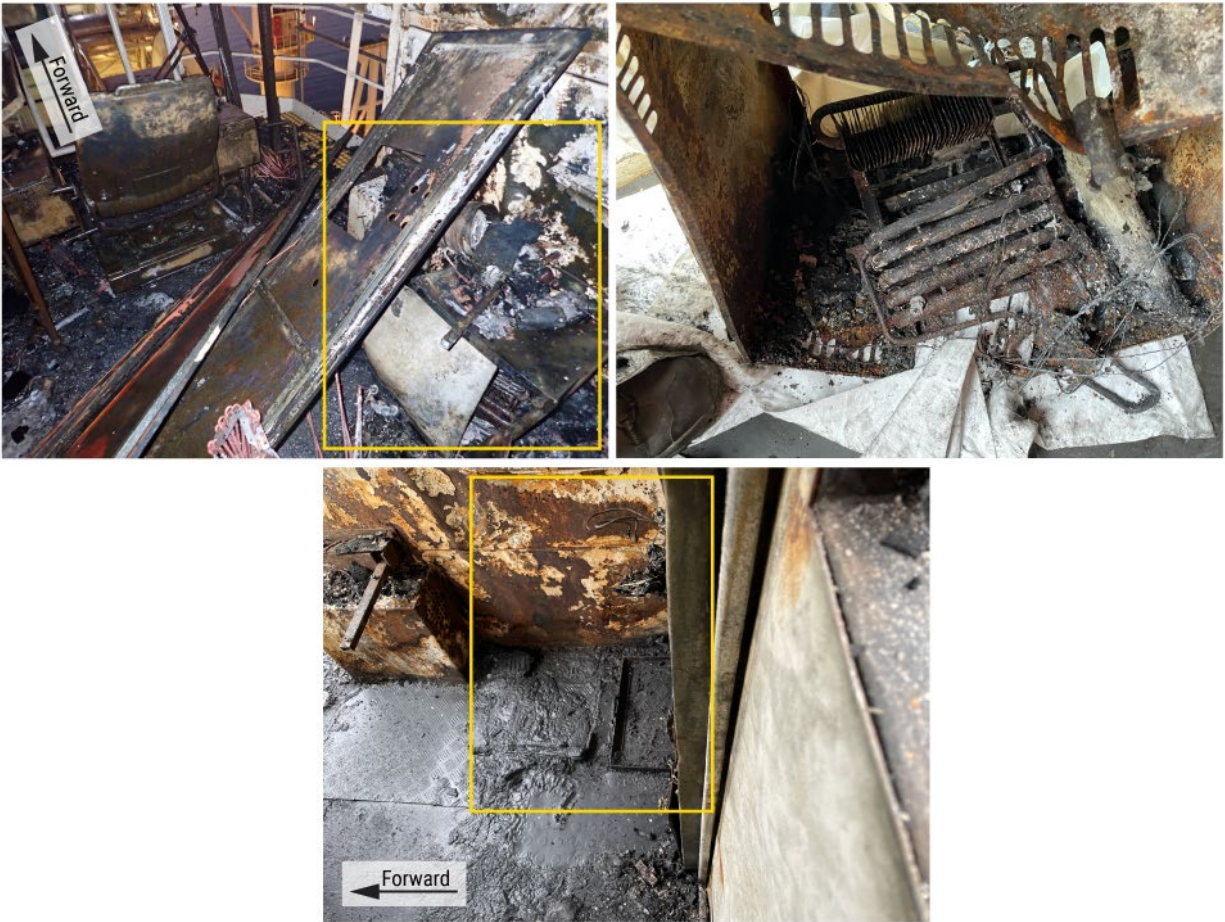
Investigators from the Coast Guard and National Transportation Safety Board, and a private fire investigator representing the vessel owner conducted a fire scene examination on board the *Deep Energy*. The interior of the crane cabin was found to be extensively damaged by the fire. The investigators found the remains of the coffee maker, electric tea kettle, and refrigerator on the starboard side of the crane cabin, next to the entrance (see figure 6).

After these items were removed, investigators discovered a fire pattern on the bulkhead, behind where the refrigerator, wall-mounted plastic bins and shelving had been installed, and in the same area where the rigging superintendent first saw flames. In addition to the fire pattern on the bulkhead, the investigators found fire damage to the metal deck-covering under the area where the refrigerator had been located.

Figure 6. *Top:* The crane cabin interior after the fire, with the location of the refrigerator and other objects outlined in yellow, and the burnt remains of the refrigerator. *Below:* The fire pattern on the bulkhead and damage to the deck underneath the removed refrigerator outlined in yellow. (Background source [*top left*]: Coast Guard)

A postcasualty investigation identified a fire pattern on the bulkhead on the starboard side of the crane cabin behind a compact refrigerator, indicating that this location was the likely origin of the fire. A failure of the refrigerator's hermetically sealed compressor or an electrical fault could have caused the fire. Additionally, there were two 110-volt electrical receptacles in the crane cabin, including the receptacle the refrigerator was plugged into, which were protected by a 15-amp breaker. If there had been an electrical fault—such as a loose, broken, or frayed wire, or broken receptacle hardware—within the receptacle, it could have created excessive resistance heating, which could have led to the ignition of nearby combustibles. However, because the vessel's breakers were opened as part of the response to the fire, it is unknown whether this breaker tripped. Due to the extent of the fire damage to the refrigerator and elsewhere within the crane cabin, the exact ignition source and cause of the fire could not be determined.

Once an ignition source was produced, combustible materials (including shelving and plastic bins) mounted on the bulkhead, above the fire's likely origin, ignited and provided a path for the fire to expand up the bulkhead to the rest of the crane cabin.
