April 22, 2026

MIR-26-13

Collision between Towing Vessel *Patrick J Studdert* and Bulk Carrier *Clara B* and Subsequent Sinking of *Patrick J Studdert*

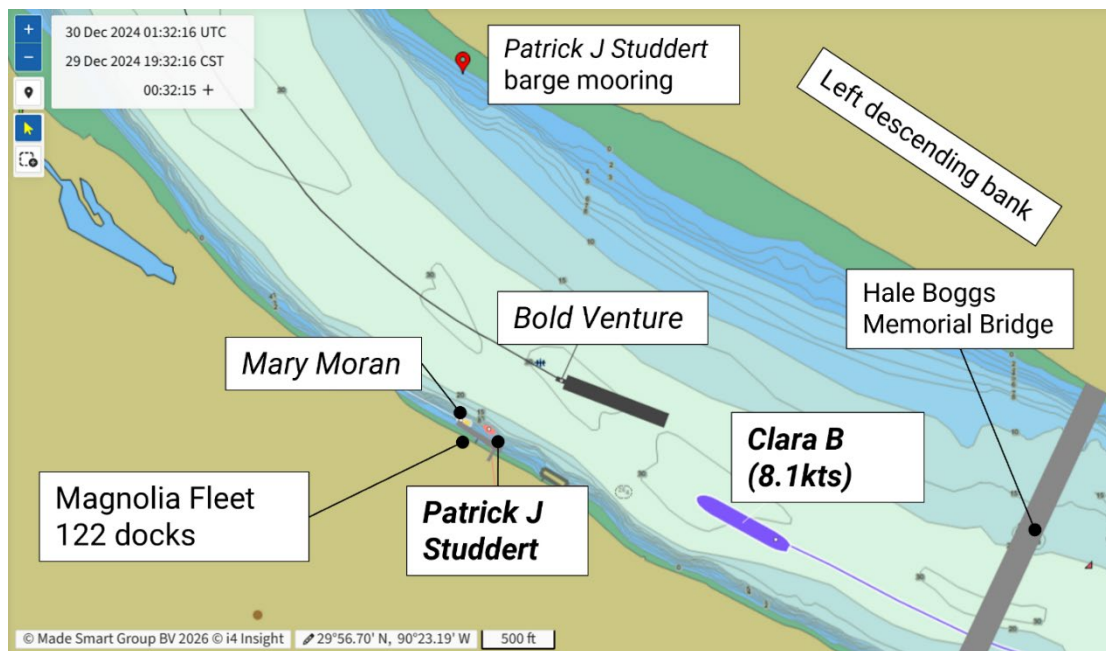
Figure 4. *Clara B* shown passing *Bold Venture* tow near Magnolia Fleet 122 docks as the *Patrick J Studdert* gets underway. (Background source: National Oceanic and Atmospheric Administration electronic navigation chart US5LU8AG, as viewed on Made Smart)

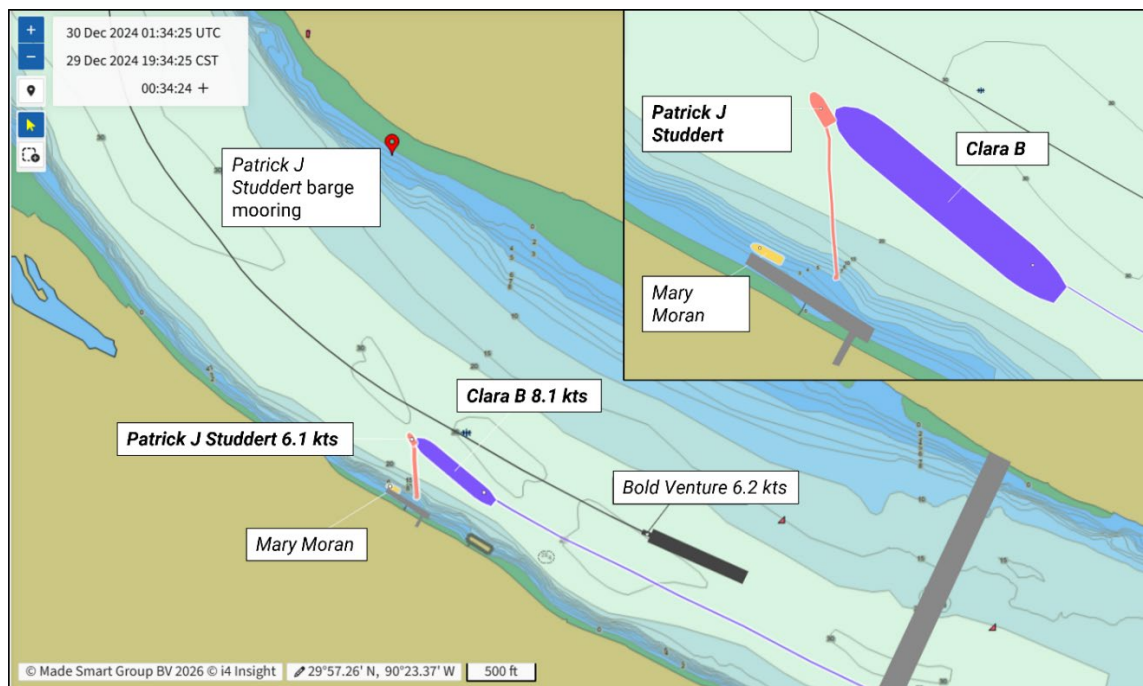
Figure 5. *Clara B* and *Patrick J Studdert* at the time of collision, 380 feet away from the docks. The *Patrick J Studdert*'s path is shown leading directly toward its mooring destination. (Background source: National Oceanic and Atmospheric Administration electronic navigation chart US5LU8AG, as viewed on Made Smart)

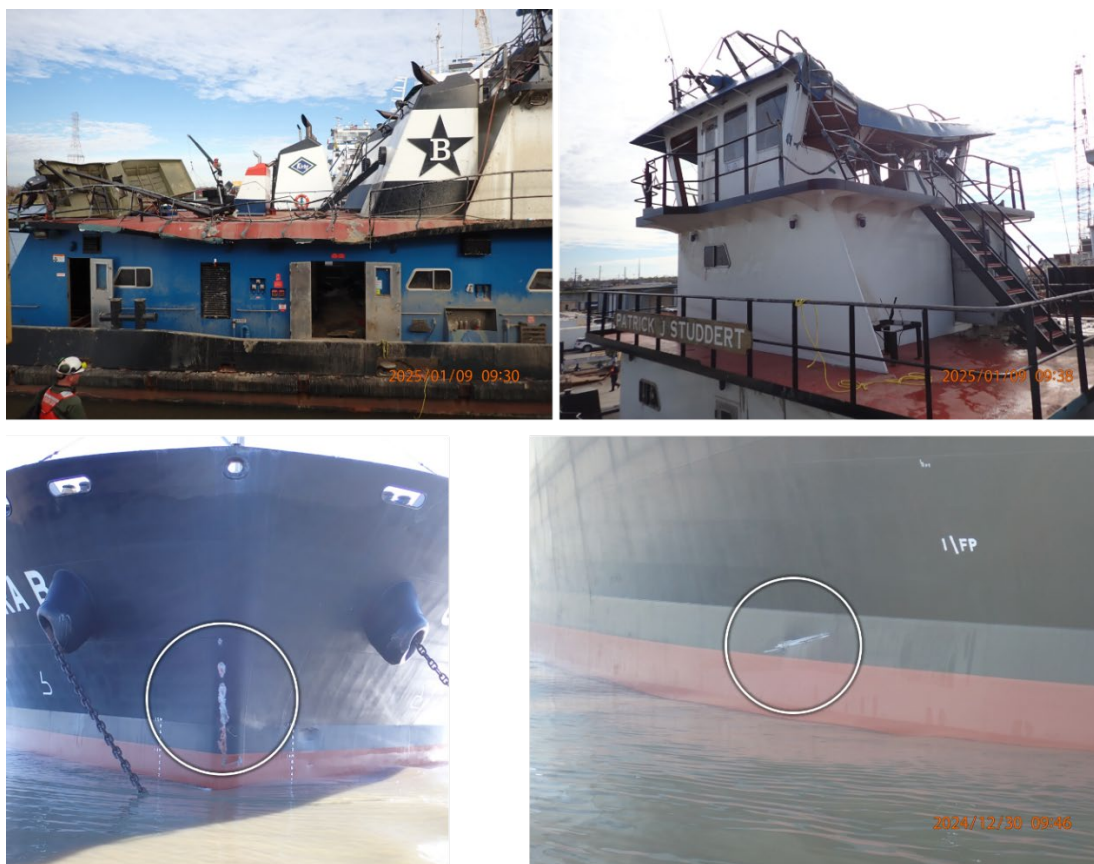
In addition to water damage, the vessel suffered structural damage to the upper decks and pilothouse (see figure 6). Salvors found no signs of a hull breach below the waterline. The vessel was considered a constructive total loss valued at \$2.3 million. Because the vessel sank, investigators could not confirm the channel settings or volume levels of the radios, nor the status of the radar.

The *Clara B* sustained minor damage on the stem and starboard side of the hull, estimated to cost \$250,000.

Figure 6. Clockwise from top left: Damage to the *Patrick J Studdert* on the starboard quarter, where the initial contact occurred, and deformed metal of the pilothouse. Damage (circled) to the *Clara B*'s starboard bow and stem. (Background source: Coast Guard)

The collision caused the *Patrick J Studdert* to roll toward the vessel's port quarter. The vessel began to flood and sank within a few minutes of the collision. After the vessel was salvaged, there were no signs of a hull breach below the waterline, indicating the water ingress was through a non-watertight opening above the main deck. Crewmembers stated that all main deck doors were secured, though the doors were weathertight, so water may still have been able to enter the vessel slowly through the doors even if they were secured. On the main deck, there were multiple air intakes and exhaust vents. Once the vessel heeled substantially, water would have readily entered the hull through one or more of these openings.
