April 30, 2026

MIR-26-15

Contact of *Mackenzie Rose* Tow with Norfolk and Portsmouth Belt Line Railroad Bridge

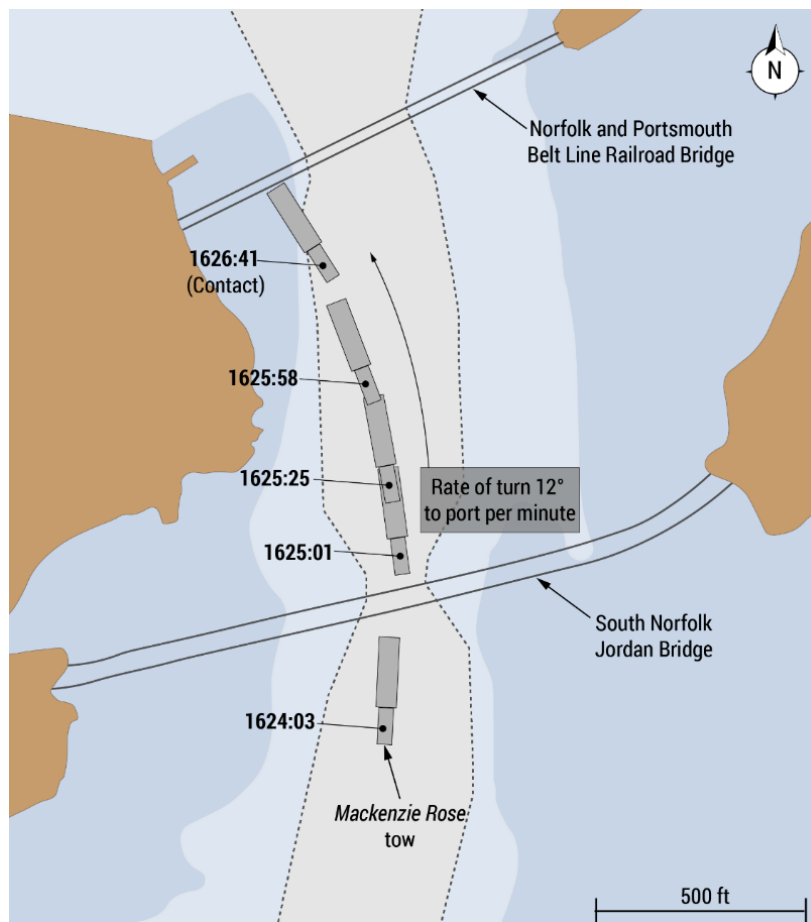
The tow continued to approach the bridge, and about 1625:25, the vessel's heading began swinging to port, with a rate of turn at 12° per minute (according to Rose Point data) (see figure 4). The mate told investigators that within a couple of minutes, when the tow was "getting too close to the bridge," he realized the autopilot "had switched" (turned off) without alarming.

Figure 4. *Mackenzie Rose* tow track as it transited through the South Norfolk Jordan Bridge and toward the Norfolk and Portsmouth Belt Line Railroad Bridge (tow not to scale). (Vessel position source: Rose Point data)

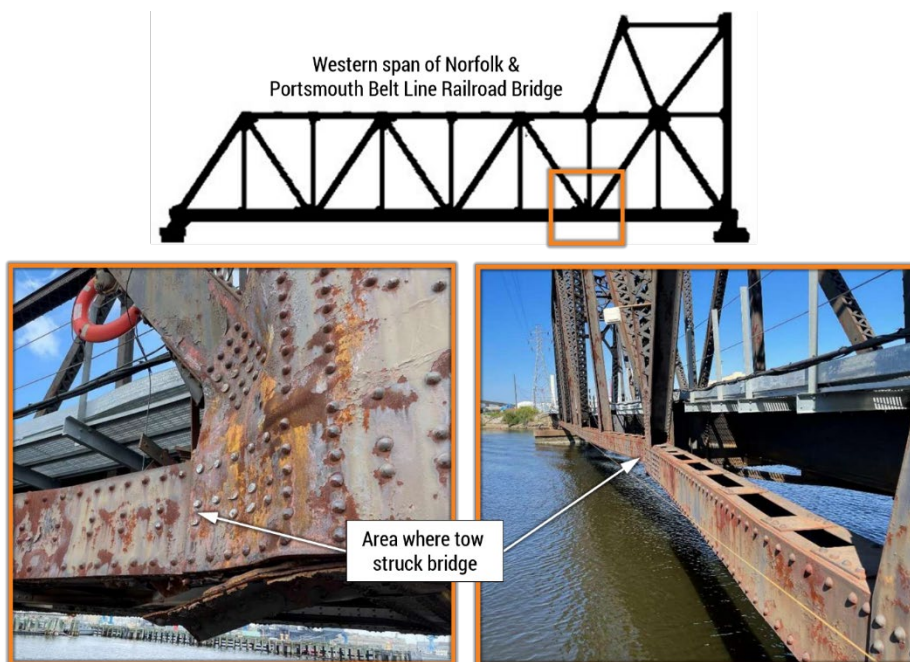
At 1626:41, the bow of the *Weeks 281* contacted the western portion of the Warren through-truss approach span of the Norfolk and Portsmouth Belt Line Railroad Bridge (see figure 5). The tow's speed over ground at the time of the contact was 4.8 knots. The bridge was not staffed by a local bridge operator at the time of the casualty.

Figure 5. Area of the bridge struck by the tow. (Background source: H&H, Norfolk and Portsmouth Belt Line Railroad Bridge)

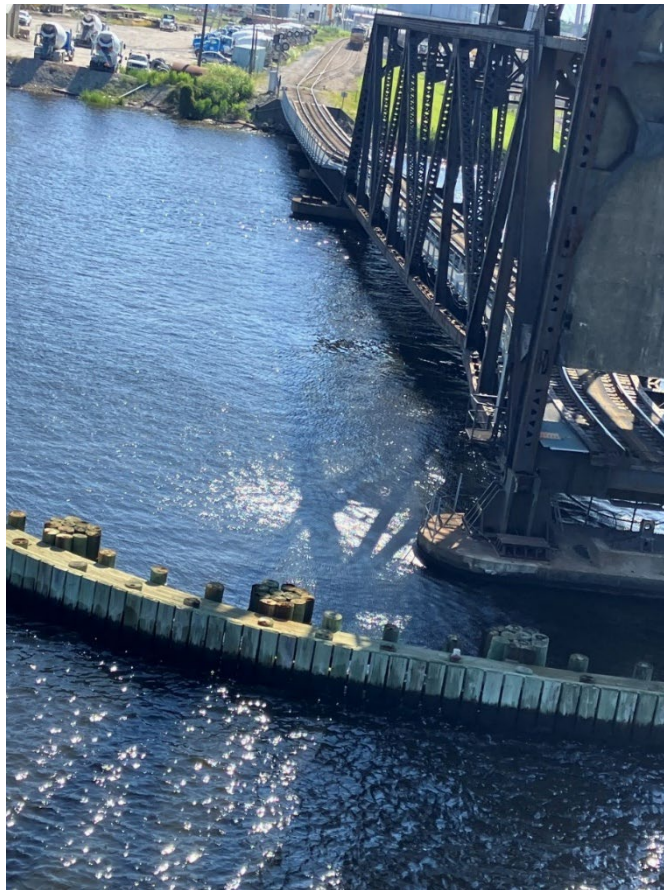
The vessel continued outbound with the mate navigating in NFU hand steering. The captain contacted the vessel operating company's port captain to inform him of the contact and that he wanted to call the US Coast Guard.⁴ The crew also told the port captain that there was no visible damage to the bridge, *Mackenzie Rose*, or barge *Weeks 281*, and sent photos of the barge and bridge to the port captain to review (see figure 6).

Figure 6. Photo of bridge taken by *Mackenzie Rose* crew after contact. (Source: *Mackenzie Rose* crew)

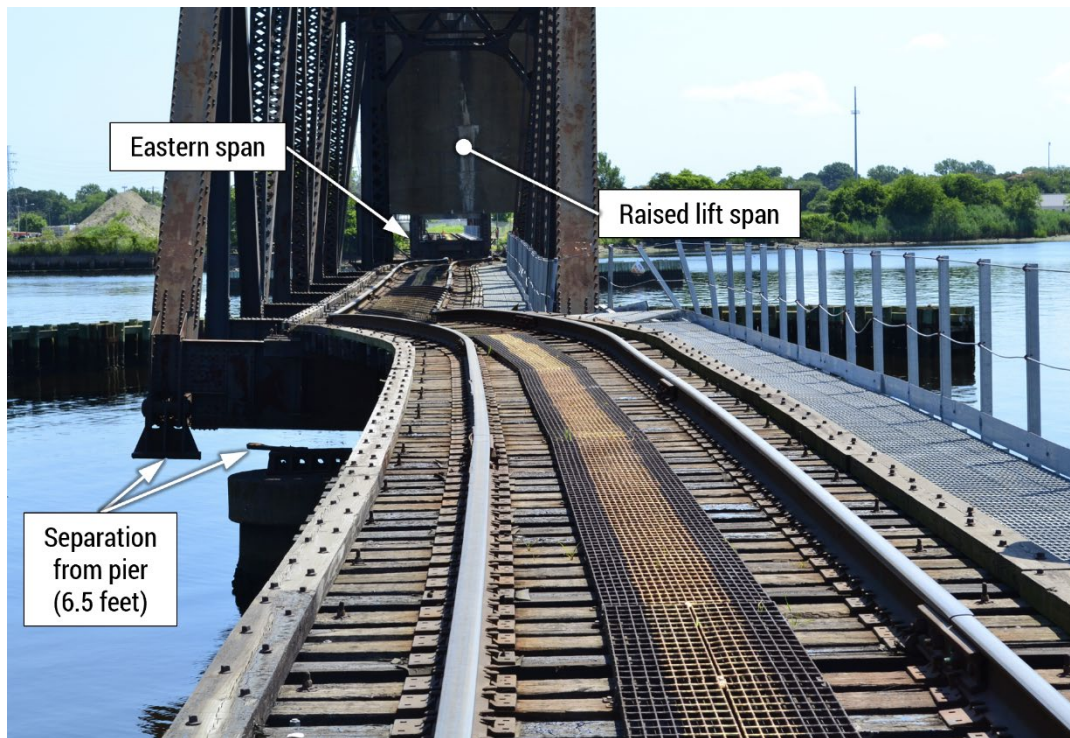
As a result of the contact, the western section of the Norfolk and Portsmouth Belt Line Railroad Bridge superstructure was sheered at the base of the pilings. The section was dislodged at the bearings and shifted north 6 feet 6 inches from bridge alignment (see figure 7 and figure 8). Bottom lateral bracings were buckled and ruptured at the point of contact, as well as gusset plate deformation and horizontal sweep damage. The lift bridge sustained damage to several members of the western structure to include buckling and extreme deformation in counterweight guide track, posts and top of posts being buckled, as well as bottom chord buckling and ruptured members, and rail decking and timber damage.

Figure 7. Norfolk and Portsmouth Belt Line Railroad Bridge in raised position after contact, looking east, showing rail and bridge structure misalignment. (Source: Coast Guard)

Costs to repair the bridge exceeded \$15.8 million and the bridge returned to service on November 6, 2024, with reduced-speed, manual operations. It returned to full-speed service with remote operation by the end of March 2025. No damage was reported to the *Mackenzie Rose* or barge *Weeks 281*.

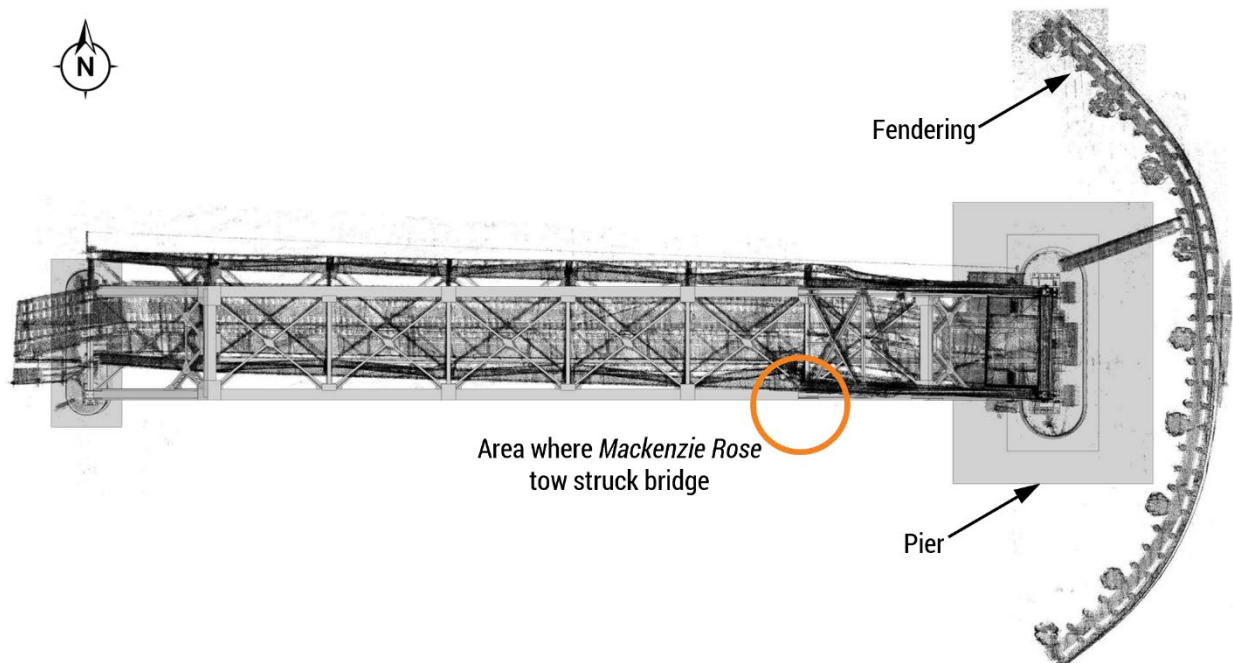
Figure 8. LiDAR image showing western span's misalignment compared to the designed alignment. The area where the tow struck the bridge is circled. (Background source: Norfolk and Portsmouth Belt Line Railroad Company)

The damage to the bridge was so severe that when a train crew stopped at the bridge 2 days later, it was evident they would not be able to lower the lift span and cross the bridge (the western end was displaced over 6 feet). Given how obvious the damage was, it was unlikely that a train would have crossed in the 2 days between the casualty and when the damage was discovered. However, the time immediately after a bridge is struck is typically used to examine the damage, alert authorities and users, perform an engineering exam, and begin stabilizing the bridge. Fortunately, in this case, the failure of the *Mackenzie Rose* operating company to report the casualty did not have repercussions. Regardless, marine casualties, such as bridge strikes, should be reported immediately to reduce possibility of negative outcomes.

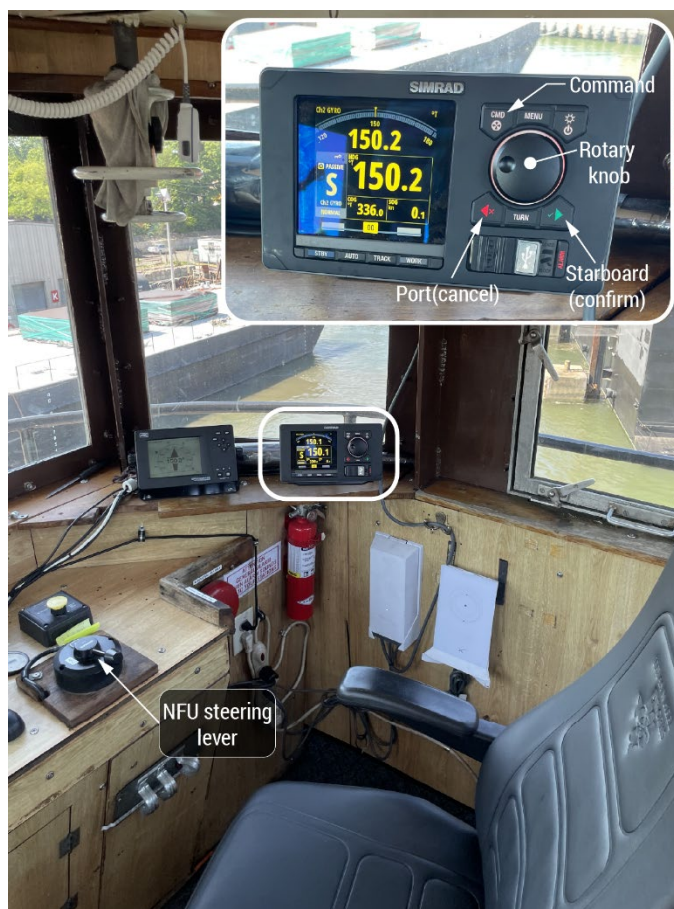
The *Mackenzie Rose*'s autopilot controller unit was installed on November 22, 2023, on the starboard side of the operating console in the upper wheelhouse (where the mate was conning the vessel at the time of the contact). A screen on the left side of the unit displayed the vessel's heading, ordered heading, course, speed, autopilot operating mode, and compass source (see figure 9). Four buttons below the screen allowed the user to select the autopilot mode (standby, auto, track, or work modes). The right side of the unit had other controls, including a rotary knob and buttons used to adjust vessel heading while the autopilot was active.

Figure 9. Starboard side of *Mackenzie Rose* upper wheelhouse with autopilot controller after the casualty.

After the casualty, National Transportation Safety Board and Coast Guard investigators examined the autopilot system and could not replicate the issue described by the mate or find any technical issues with the system. The vessel’s operating company also had technicians from the autopilot system manufacturer inspect the system; the technicians found no issues. The autopilot system manufacturer had not issued any service bulletins relating to the issue described by the mate.

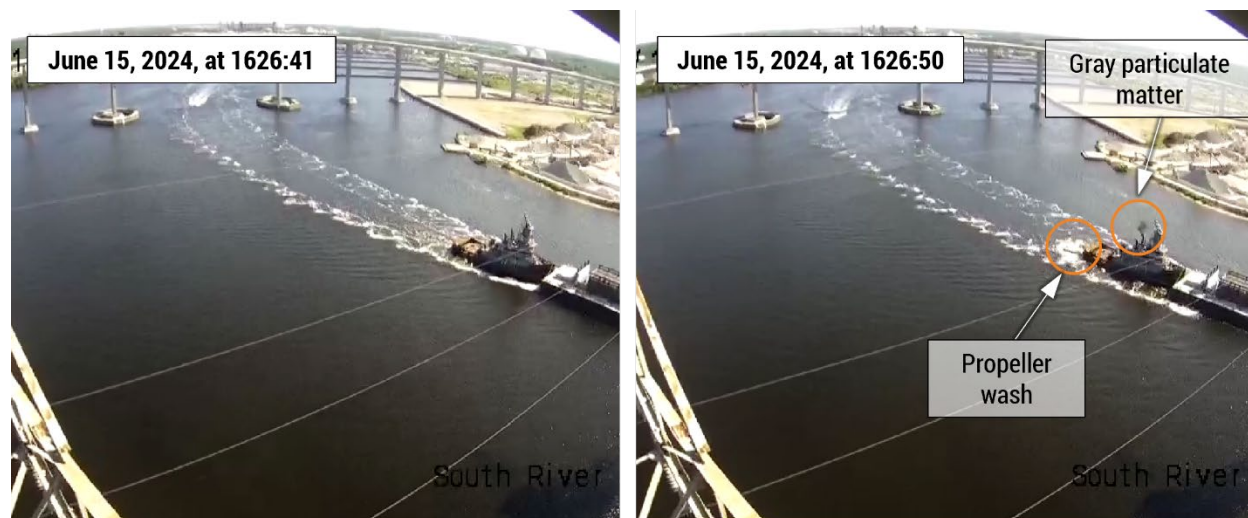
CCTV footage showed the *Mackenzie Rose* tow making contact with the bridge.⁶ The video showed the lift bridge superstructure shaking immediately after the contact, as well as the *Mackenzie Rose* tow continuing to push ahead on the bridge structure for 9 seconds following the initial contact. Forward thrust (propeller wash) was visible from the stern of the vessel during this timeframe. About 9 seconds after the contact, gray particulate matter was visible emanating from the main engine's exhaust stack.⁷ Shortly thereafter, the *Mackenzie Rose* tow was shown backing away from the bridge (see figure 11).

Figure 11. From left to right: CCTV footage of *Mackenzie Rose* tow at time of contact, and 9 seconds after the contact, showing propeller wash and gray exhaust particulate matter from vessel's exhaust stack. (Background source: Norfolk and Portsmouth Belt Line Railroad Bridge)

The mate also stated that he put the engines in full astern to attempt to stop the tow from contacting the bridge. However, CCTV footage showed propeller wash coming from the stern of the *Mackenzie Rose* immediately after it struck the bridge, indicating forward propulsion. There was no indication of a change in engine load—and thus a change from forward propulsion—until about 9 seconds after the contact. At that time, particulate matter, which typically results from high load demand on the engine, could be seen emanating from the main engine’s exhaust. Therefore, the

evidence does not support the mate's claim that he backed the vessel before the contact.
