MIR-26-16

# Flooding and Sinking of Fishing Vessel

## *North American*

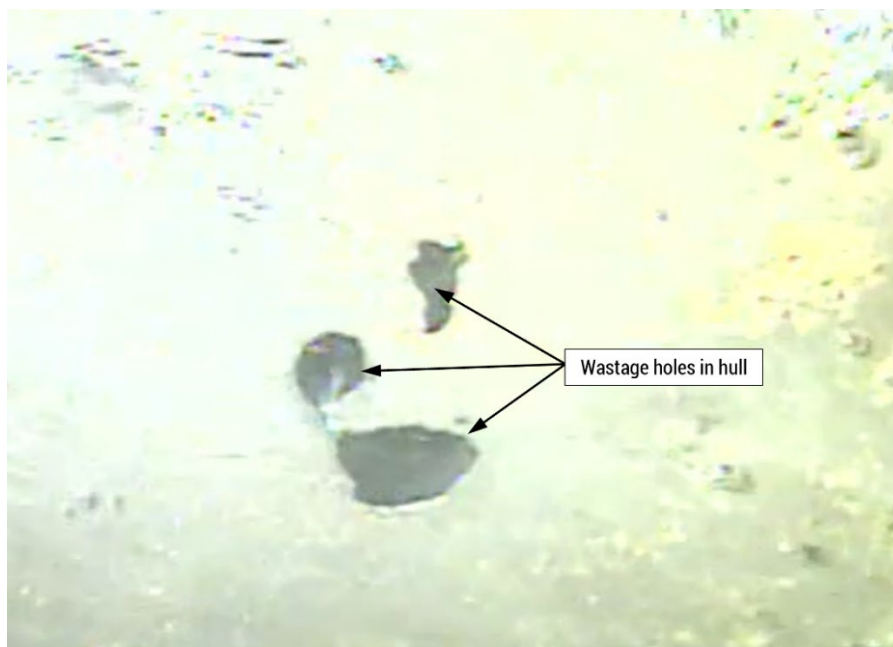
A dive survey was conducted after the sinking. The diver noted that there did not appear to be any issues with the rudder post or shaft, stern tube, or the cutlass bearing for the propeller shaft. He also checked all the sea chests and found no problems. While examining the hull, he found three wastage holes, "all smaller than a silver dollar," located 56 inches to the port of the keel and 99 inches aft of the outboard sea chest, placing them in the shaft alley (see figure 5).

**Figure 5.** Wastage holes discovered in hull during postcasualty survey. (Background source: Global Diving)

The paint on and around this area was found to be in excellent condition. No dishing or deflections were found in this area either. No witness marks or any type of damage from a potential grounding were found in this area or anywhere on the vessel ... .

A postcasualty dive survey found three wastage holes in the hull. The diver found no other potential sources of water ingress after examining the entire hull, the rudder, propeller, and all thru-hull fittings (including the stern tube). The crewmembers did not report striking any objects or grounding during their sea trial, and the dive survey confirmed that there were no signs of collision or grounding. Therefore, it is likely that the source of the flooding into the shaft alley, and subsequently the engine room, was the three holes in the hull, which were located beneath the shaft alley.

The vessel's owner had been aware of corrosion within the double bottom areas since 2020, when a hole in the hull was found during a survey. The owner conducted additional hull surveys in 2021 and 2023 in an attempt to identify and address any areas needing repair. The survey found potential areas of concern, but immediate repair of the areas was not deemed necessary. It is likely that localized corrosion within the shaft alley resulted in the holes identified postaccident, and that the holes manifested or worsened during the sea trial on May 13.
