Contact of *Rickey Hughes* Tow with the Vicksburg Highway 80 Bridge

On May 1, 2025, about 1454, the towing vessel *Rickey Hughes* was pushing 22 barges downbound on the Lower Mississippi River at mile 435.8 near Vicksburg, Mississippi, when the two lead barges on the starboard side of the tow contacted a fixed pier of the Vicksburg Highway 80 Bridge (see figure 1 and figure 2). As a result of the contact, seven barges broke away, six were recovered, and one sank. There were no injuries, and no pollution was reported. Damage to the barges was estimated at \$1.9 million.¹

¹ (a) In this report, all times are central daylight time, and all miles are statute miles. (b) Visit [nts.gov](https://www.nts.gov) to find additional information in the [public docket](#) for this NTSB investigation (case no. DCA25FM034).

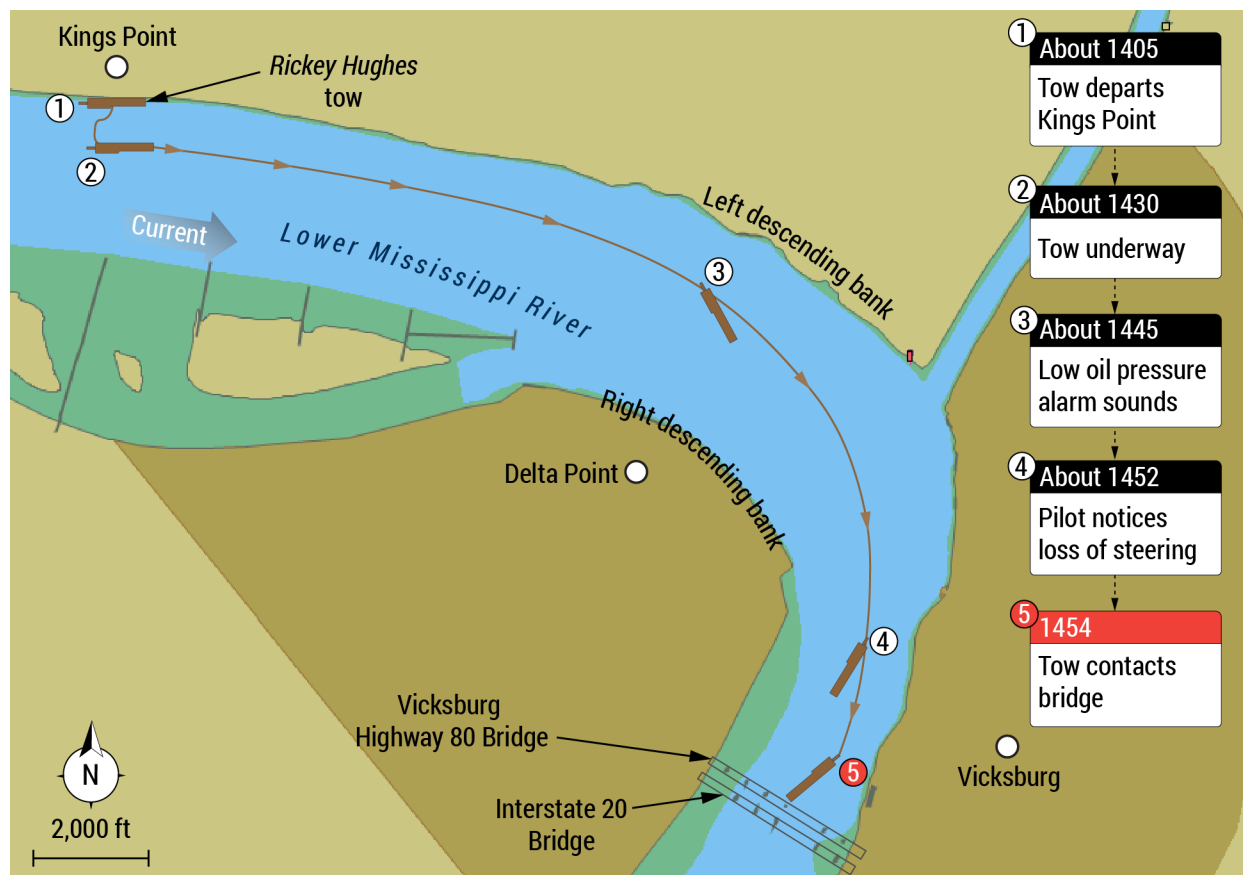
About 1454, about 9 minutes after the flanking rudder system low oil pressure alarm and about 2 minutes after the loss of the steering rudders, the two lead barges on the starboard string contacted the main span pier on the right descending bank side of the Vicksburg Highway 80 Bridge about 9 mph (see figure 5). Seven barges on the starboard side broke free from the tow, and crewmembers noticed several loose barges drifting downriver past the stern of the *Rickey Hughes* with the river current.

Figure 5. *Rickey Hughes* tow trackline as it approached the Vicksburg Highway 80 Bridge. (Background source: Army Corps of Engineers inland electronic navigation chart U35LM425 as viewed on Made Smart)

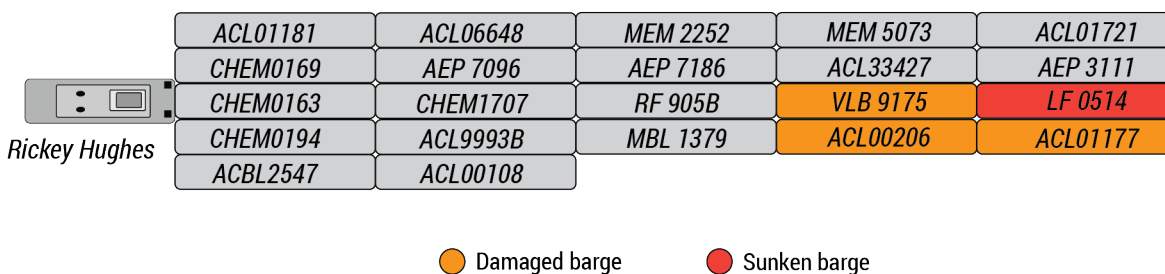
As a result of contacting a pier of the Vicksburg Highway 80 Bridge, the covered hopper barge *LF 0514*, which had been at the head of the tow and loaded with soybeans, sank. The value of the sunken barge was estimated at \$73,000 and the loss of its cargo was valued at \$610,000. Three other barges in the tow also sustained damage (see figure 6). The covered hopper barge *ACL01177*, loaded with soybeans, sustained damage to its bow (rake), and nos. 2, 3, and 4 wing tanks were taking on water. Damages to the covered hopper barge *ACL00206*, loaded with corn, resulted from flooding in the stern, which was pumped out and temporarily repaired after the casualty. The covered hopper barge *VLB 9175*, also loaded with corn, sustained damage to the box end, subsequently flooded, and could not be pumped out. The total estimated damage to the four barges was about \$1.9 million. There was no damage to the Vicksburg Highway 80 Bridge or the *Rickey Hughes*.

Figure 6. Barges that were damaged or sank as a result of the contact.

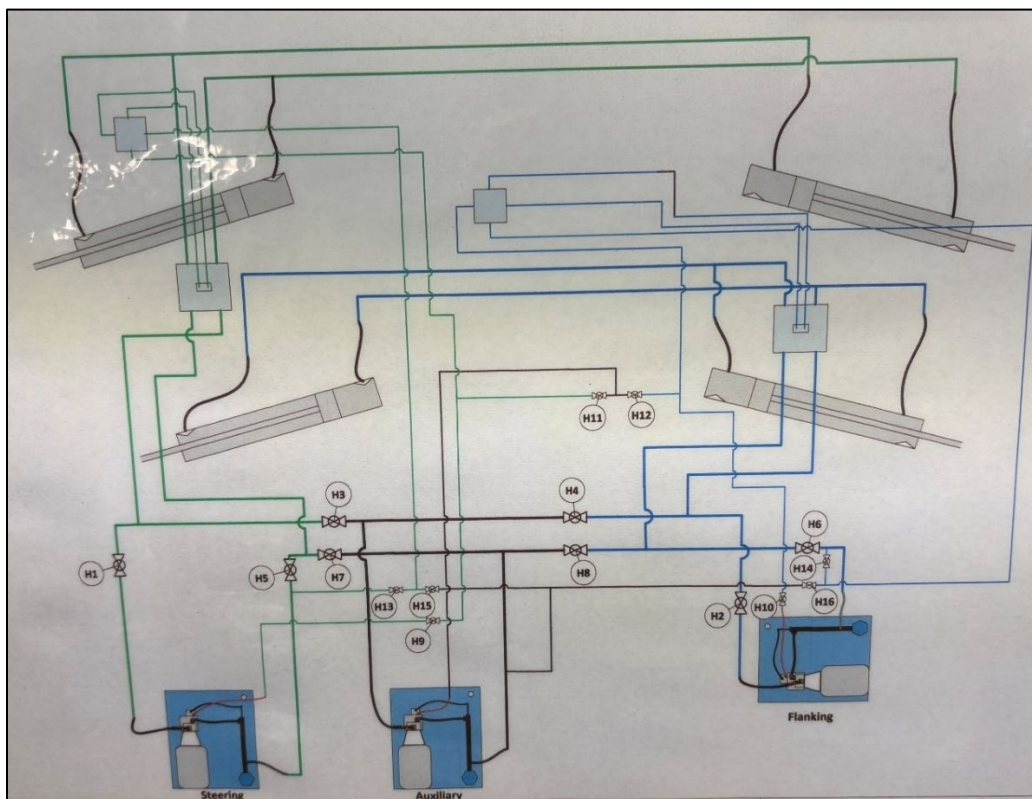
The hydraulic systems for the steering rudder system and the flanking rudder system each had their own hydraulic reservoir and hydraulic pump in the rudder room (see figure 7). There was a third reservoir and pump, referred to as the auxiliary system, also in the rudder room. By changing the position of several valves in the hydraulic piping, the auxiliary system pump could be used to provide hydraulic pressure to either the steering rudder system or the flanking rudder system.

Figure 7. Hydraulic diagram for steering rudder, flanking rudder, and auxiliary steering systems posted in the *Rickey Hughes'* rudder room.

Initially, the *Rickey Hughes* lost only hydraulic oil pressure for the flanking rudder system. A postcasualty investigation found that the loss of hydraulic oil pressure occurred because a motor-saving relay was improperly wired into the flanking system's hydraulic motor controller. This configuration caused the motor to prematurely trip and the system's hydraulic pump to stop for a short time before resetting and then starting again. As the *Rickey Hughes* and its tow were proceeding downbound, crewmembers in the pilothouse were steering the vessel using only the steering rudders. (According to the shoreside captain, the pilot was not flanking the bend immediately above the bridge and the transit would have primarily relied on the steering rudders.) There were no issues with the steering rudder system that was in use. Therefore, even without the flanking rudder system operational, the vessel likely could have successfully transited under the Vicksburg Highway 80 Bridge.

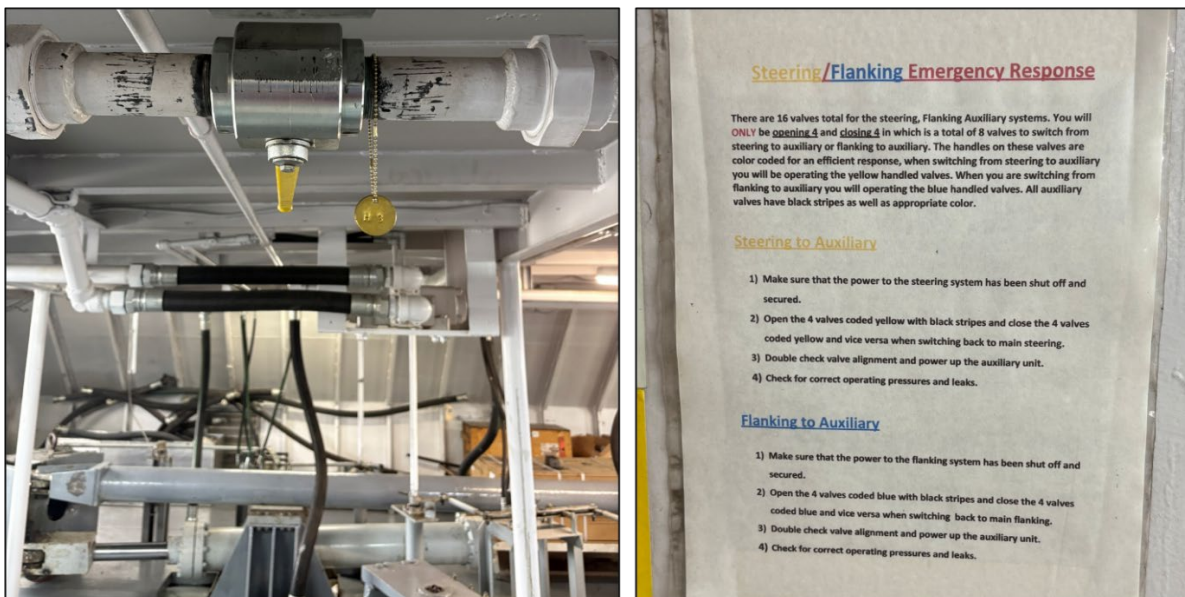
In the rudder room, the engineer began an emergency steering change over, switching over the valve alignment to change the flanking rudder hydraulic system to the auxiliary motor and pump, since the flanking pump would not restart (see section 1.3.2). After switching the third valve and starting the auxiliary pump motor, hydraulic oil erupted from the flanking rudder system's hydraulic reservoir tank through the fill cap, covering the engineer's face and body, as well as the deck, in oil. The engineer was wearing glasses, and they were also covered in oil. The engineer told investigators that he had difficulty seeing the valve tags with the valve numbers.

A "steering/flanking emergency response" document that provided procedures for changing the valves from the steering rudder system to the auxiliary pump system and from the flanking rudder system to auxiliary pump system was posted on the rudder room door (see figure 8). The valve handles were color coded: Yellow-handled valves were used to switch from steering to auxiliary, and blue-handled valves were used to switch from flanking to auxiliary. Each valve had a brass tag with the valve number stamped on it. Additionally, a piping diagram, a normal operation chart, and a valve designation sheet were posted on the electrical disconnect boxes and power panels for the steering pumps and auxiliary steering pumps.

Figure 8. Left to right: Yellow-handled valve in hydraulic system with “H3” valve tag. Posted steering/flanking emergency response document on rudder room door.

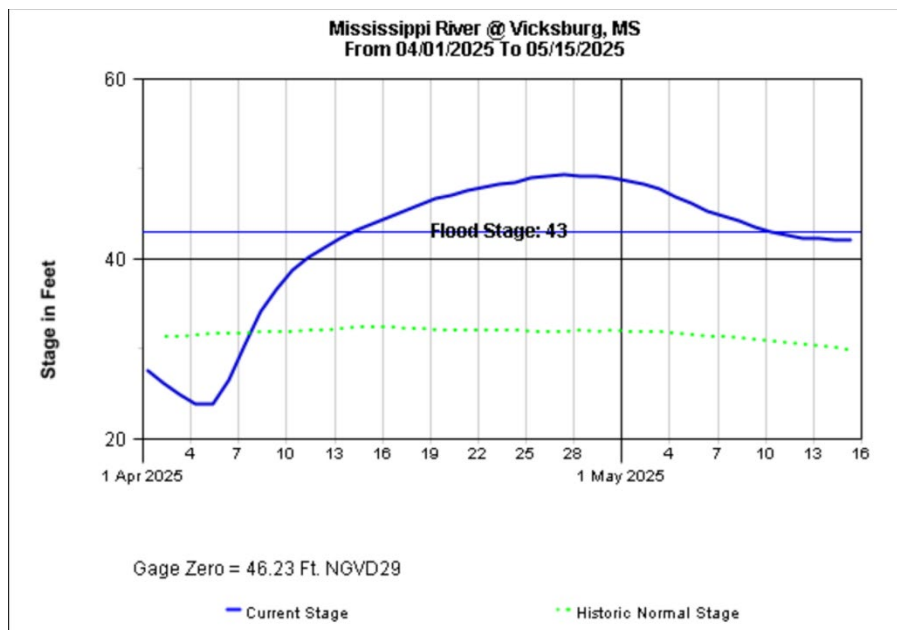
On April 27, the Mississippi River at Vicksburg was recorded having a high level of 49.3 feet. According to the National Weather Service, this was the highest peak at the Vicksburg gage since 2020. On May 1, the day of the casualty, the Vicksburg gage read 48.73 feet, 5.73 feet above major flood stage (see figure 9).

Figure 9. Mississippi River water level (in feet) at Vicksburg from April 1 to May 16. (Source: Army Corps of Engineers)
