Contact of *Josset* Tow with the Bayou Grosse Tête Bridge

On June 6, 2024, about 0512 local time, the towing vessel *Josset* was transiting the Morgan City-Port Allen Route of the Gulf Intracoastal Waterway, about 2.7 miles from Crescent, Louisiana, pushing three barges, when the lead barge struck the Bayou Grosse Tête Bridge (see figure 1 and figure 2).¹ There were no injuries, and no pollution was reported. Damage to the bridge was estimated at \$2.5 million.

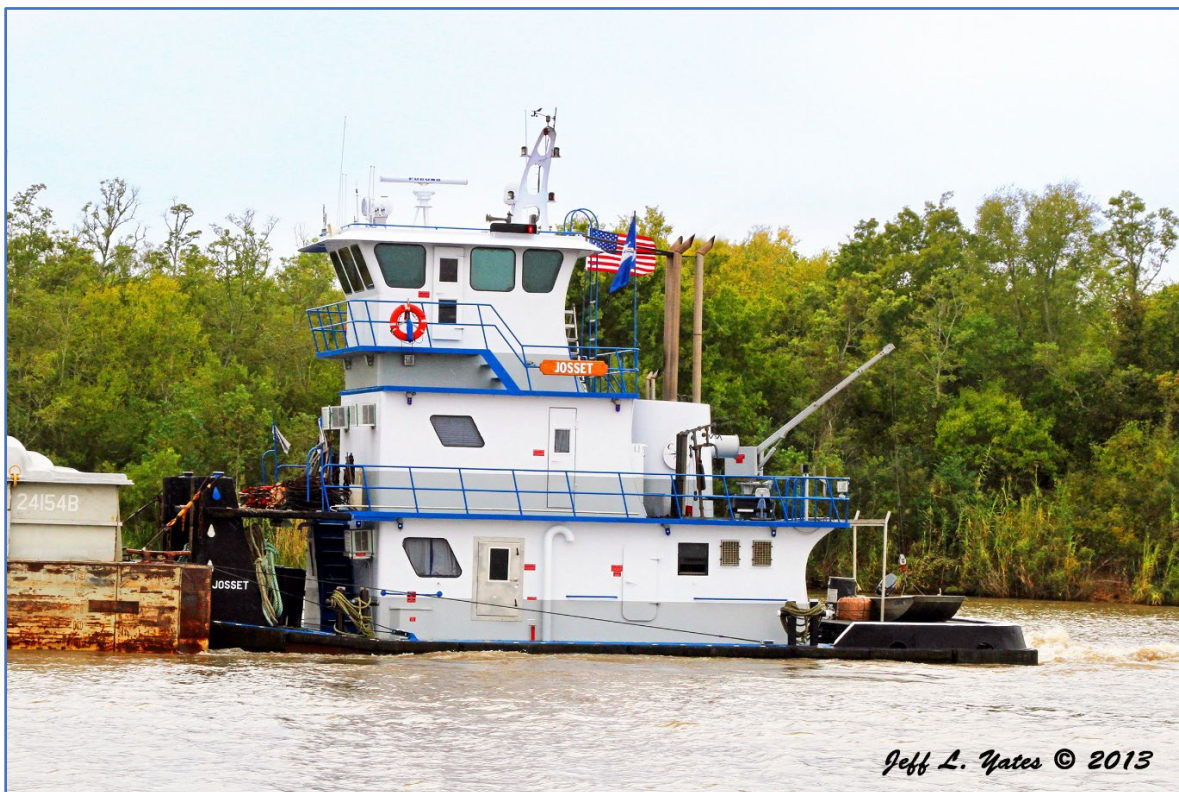
Figure 1. *Josset* underway in 2013. (Source: Captain Jeff L. Yates)

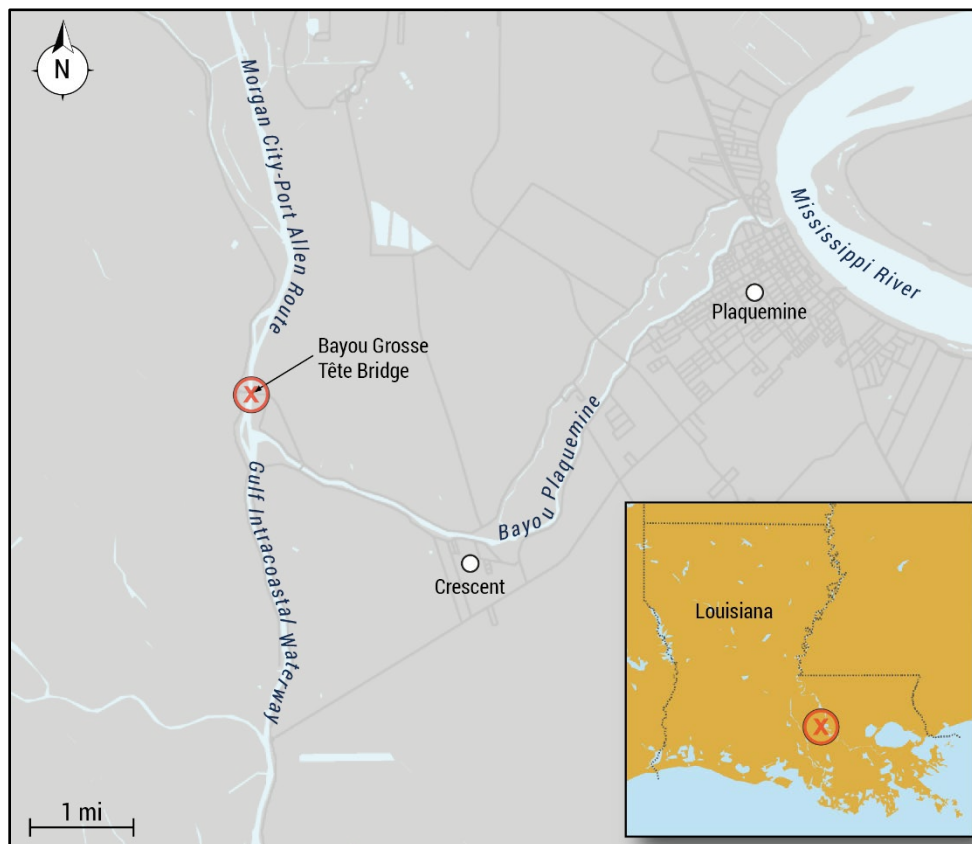
Figure 2. Area where the *Josset* tow contacted the Bayou Grosse Tête Bridge, as indicated by a circled X. (Background source: Google Maps)

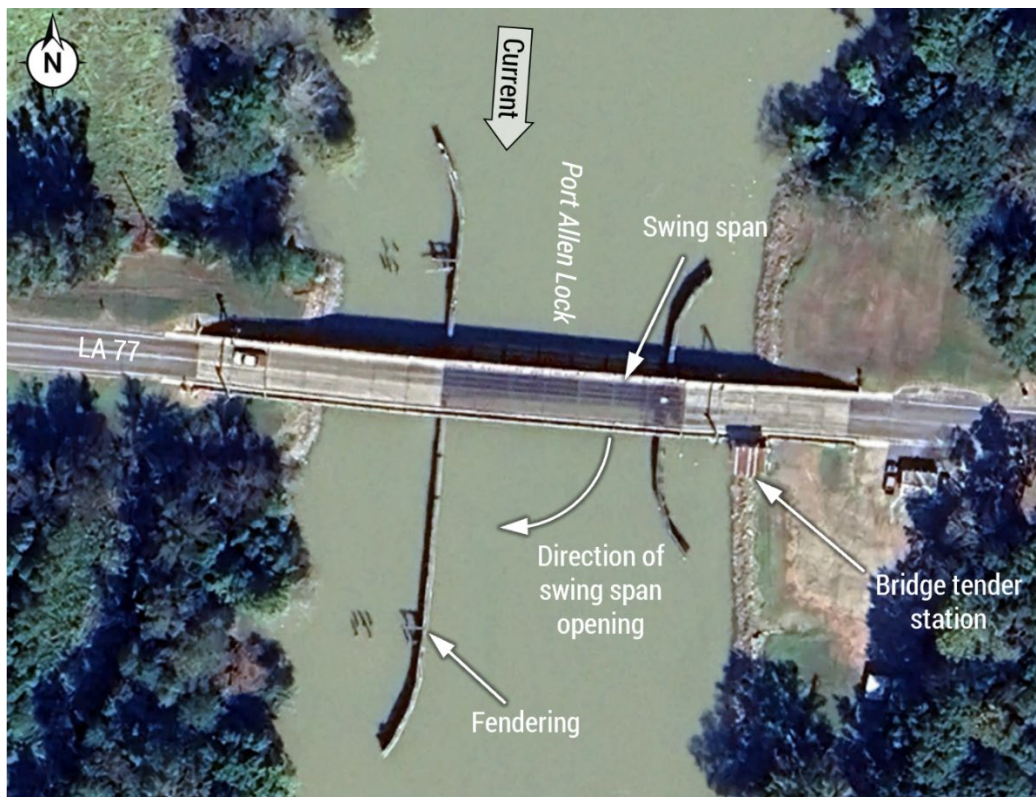
About 0452, with the pilot navigating the *Josset* in darkness, the tow approached the Bayou Grosse Tête Bridge at mile 47 (see figure 4).³ The bridge carried a two-lane highway (LA 77) over the Morgan City-Port Allen Route of the Gulf Intracoastal Waterway and saw an average of 5,000 vehicle trips a day. The bridge had a horizontal clearance of 125 feet and a vertical clearance of 2 feet.

Figure 4. Bayou Grosse Tête Bridge in October 2022. (Background source: Google Earth)

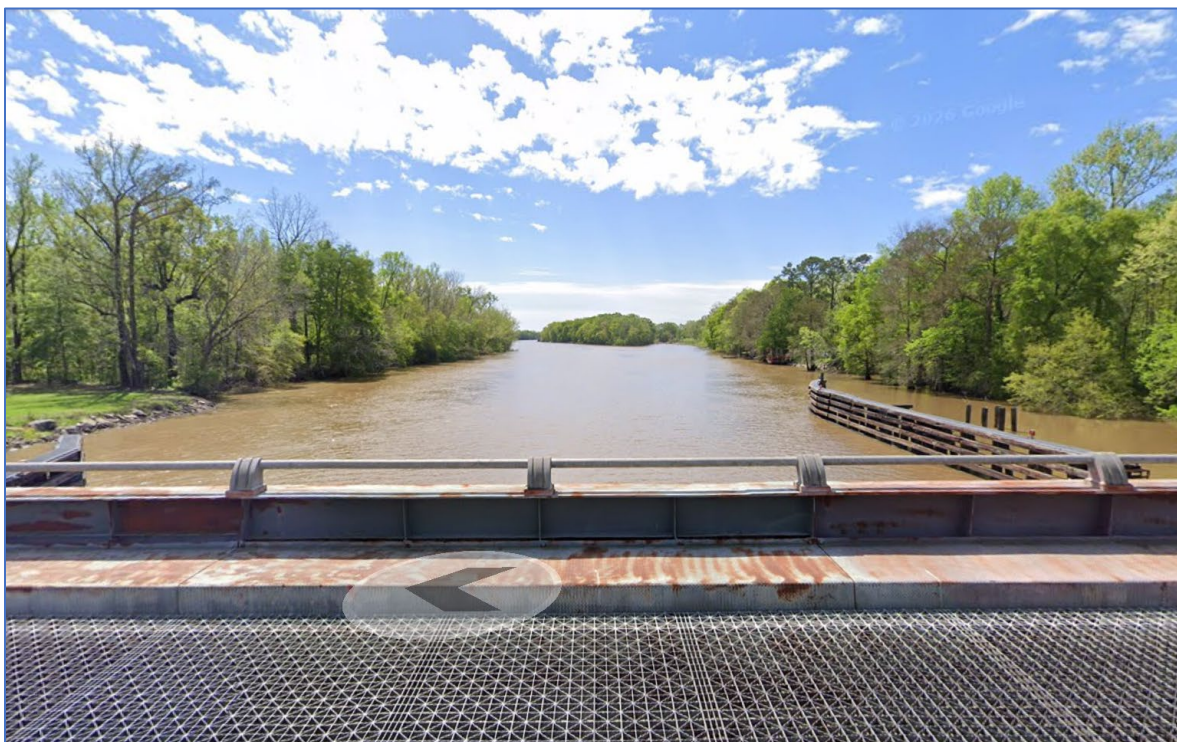
About a half mile south of the bridge, there was a bend in the waterway, where the *Josset* pilot had to avoid another tow, the *Tennessee Merchant* and barges, that was pushed up on the west bank (see figure 5). After passing the *Tennessee Merchant* tow, the lead barge was about 2,000 feet away from the bridge when the bridge came into the pilot's line of sight. The lead barge was empty and sitting high out of the water, somewhat obstructing the pilot's view. The pilot told investigators that he did not send a deckhand forward on the tow to act as a lookout since he had navigated Bayou Sorrell Lock without problems.

Figure 5. The Morgan City-Port Allen Route as seen from the Bayou Grosse Tête Bridge, looking south. The bend in the waterway is about 0.5 miles distant in the background. (Source: Google Maps)

There was a bend in the waterway about a half mile south of the bridge that would have obstructed the pilot's view of the bridge until the tow passed it. The *Josset* also had to avoid the *Tennessee Merchant* tow, which was pushed up on the west bank at that time. The tow was transiting in the early hours of the morning, in darkness, and the empty lead barge was high out of the water, further obstructing the pilot's view. Despite these obstructions, the pilot chose not to station a crewmember at the head of the tow to serve as a lookout. By the time the pilot was able to see the bridge and recognize the swing span was not open, the lead barge was nearing the bridge. The pilot began backing the tow as the bridge began to open toward the tow. However, the tow still had headway, resulting in the bow of the lead barge, *FMT 502*, striking the swing span as it was opening. Although not required, if the pilot had positioned one of the other crewmembers on the tow as a lookout, he likely would have been aware earlier that the bridge was not open as he expected and could have taken action to avoid striking the bridge.

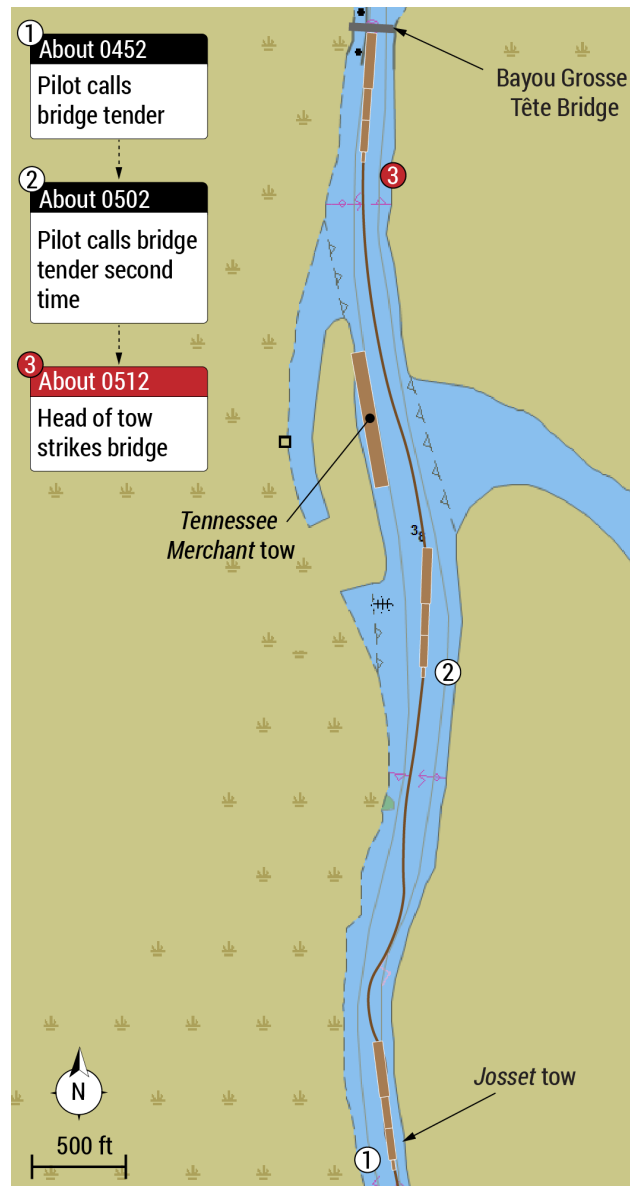
During the second call, the bridge tender had responded that he would start to open the bridge and for the vessel to proceed. After vehicles were stopped, it typically took about 3 minutes for the bridge to fully open from the closed position. When the lead barge reached the bridge, the pilot noted the bridge was not yet open and backed the tow. As he was backing down, the bridge started to open, with the lead barge, *FMT 502*, inside the fendering. Although the pilot was backing, the tow still had headway, and about 0512, the *FMT 502* struck the swing span (see figure 6). The bridge tender stated that he never signaled that the bridge was open and estimated the swing span was only a quarter of the way open upon impact.

Figure 6. Trackline of *Josset* tow as it approached the Bayou Grosse Tête Bridge. (Scale approximate.) (Background source: National Oceanic and Atmospheric Administration Electronic Navigation Chart US4LA1HI as viewed on Made Smart)
