MIR-26-19

Collapse of Emissions Control Barge *STAX 1* Capture and Control Articulated Arm

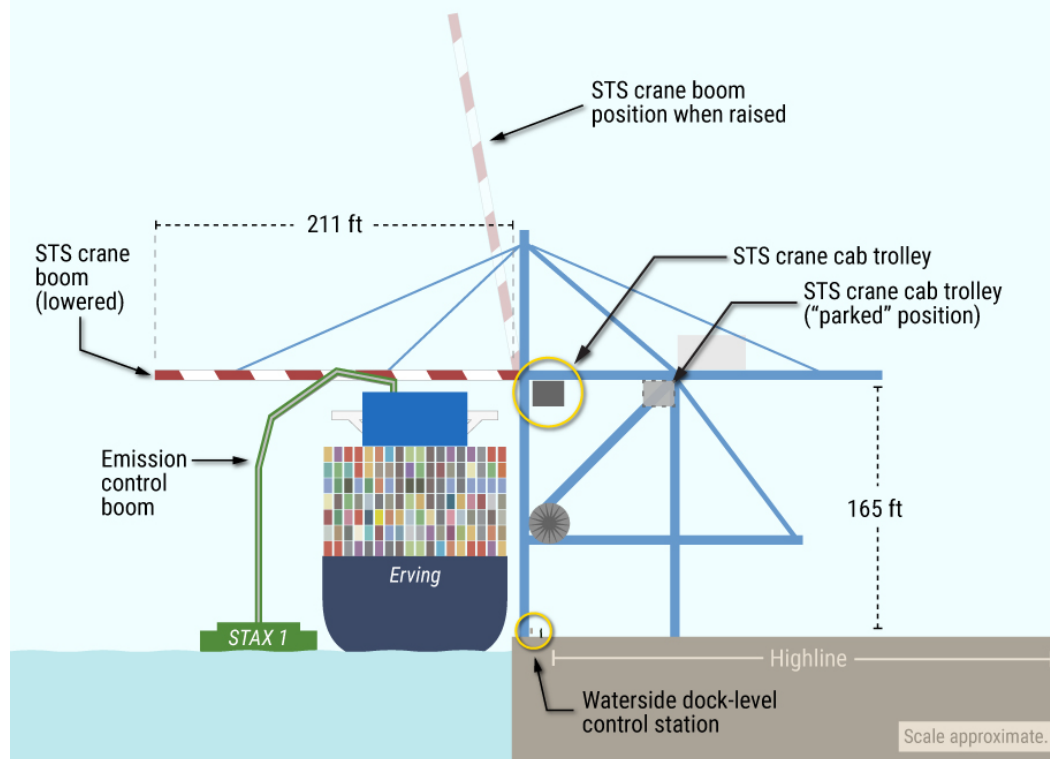
During this time, the *STAX 1* night-shift supervisor, two deckhands, and the trainee were still atop the *Erving’s* exhaust superstructure, making repairs to the exhaust ducting. The other *STAX 1* crewmember was aboard the barge in the control room. The night-shift supervisor and a deckhand noticed STS crane 16 boom begin to move toward them (see figure 5). The supervisor told his crew to move the exhaust ducting over the railing as he attempted to swing the emission capture boom aft, away from the path of the STS crane’s boom.

Figure 5. Diagram (looking toward the *Erving*'s bow) showing the position of the STS crane boom if it were raised versus its position at the time of the accident. (Scale approximate.)

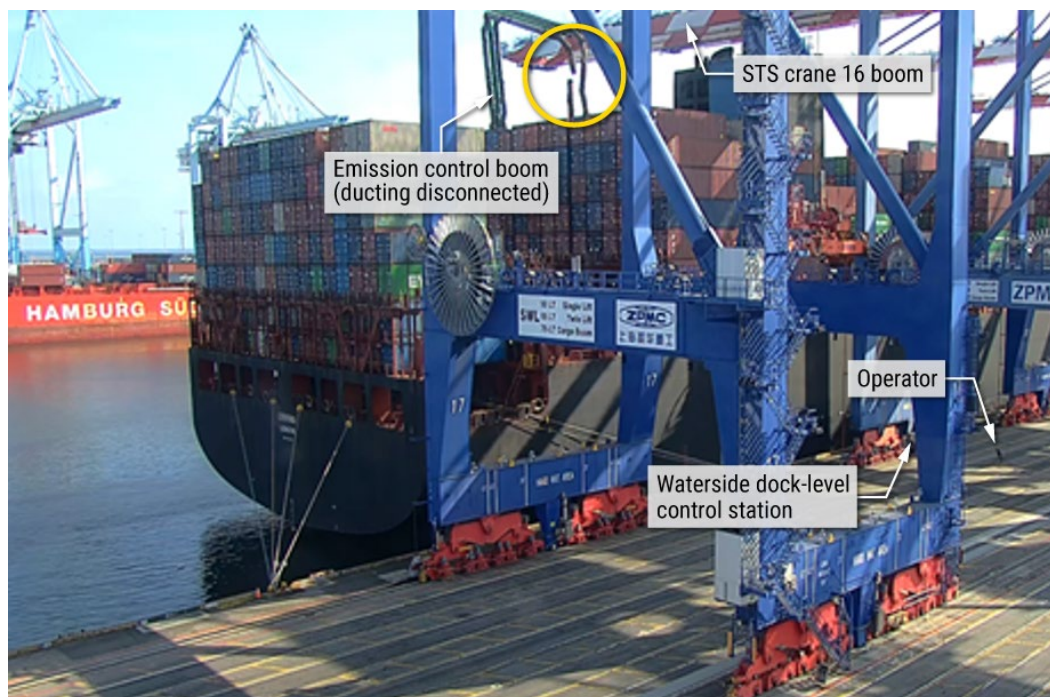
At 1649, while STS crane 16 was moving toward the stern of the vessel, the crane contacted the *STAX 1* emission capture boom (see figure 6). Sections of boom fell onto *STAX 1*, onto the *Erving*, and into the water. A portion of the emission capture boom landed on the *STAX 1* control room, injuring the crewmember inside. From the ground, crane operator 2 saw the *STAX 1* deckhand atop the *Erving*, recognized that the deckhand was signaling to stop, ran over to the waterside dock-level control station, and pressed the emergency stop button, which immediately stopped the crane.

Figure 6. STS crane 16 boom contacting the *STAX 1* emissions capture boom (circled) and crane operator 2 running toward the waterside dock-level control station. (Background source: FMS)

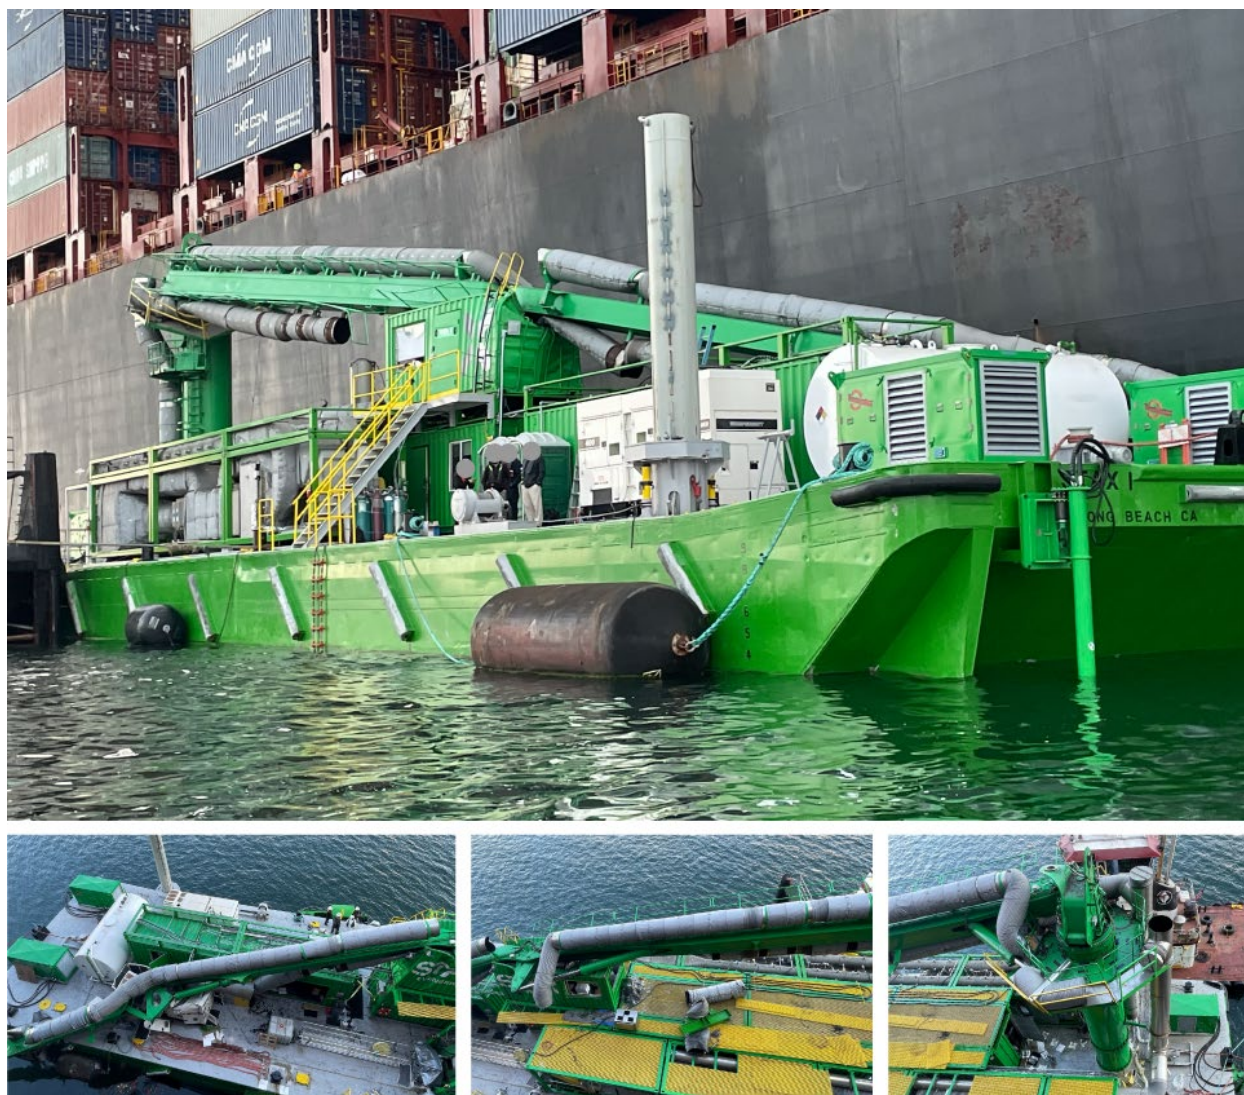
STS crane 16's contact with the *STAX 1*'s emission capture boom sheared the boom at the pedestal base (see figure 7). The boom crane, both exhaust scrubber systems, one generator along with other miscellaneous equipment as well as the vessel's emission system control-monitoring station room, and the crew restroom required significant repairs and replacement of components. Damage to the *STAX 1* was estimated at \$3.1 million.

Figure 7. Top: View from the starboard bow of the *STAX 1* showing the emission capture boom lying on top of the control room and across the deck. Bottom, from left: Top-down views of the *STAX 1* damage from stern to bow, as seen from the starboard side of the *Erving*. (Source: Coast Guard)

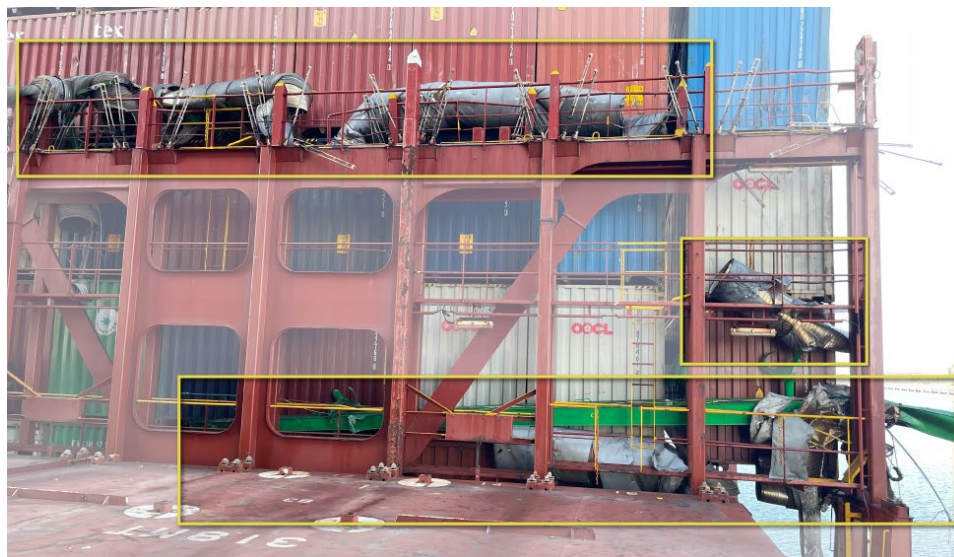
The *Erving* sustained damage to several handrails, ladders, crosswalks, platforms, and elevated walkways in container bays 75-83 (see figure 8). These components had to be replaced. Damage to the *Erving* totaled \$175,000.

Figure 8. Areas of *Erving* container bay 83 where sections of the *STAX 1* emission capture boom fell (outlined), causing damage.

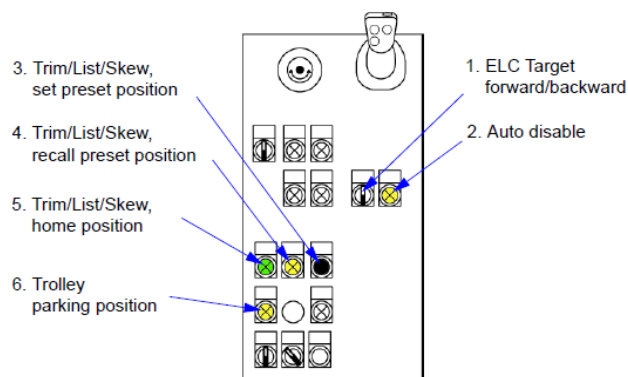
Figure 9. Crane trolley cab controls. (Source: FMS)

On June 2, after the casualty, an FMS crane technician tested STS crane 16 to troubleshoot crane operator 1’s inability to boom up the crane. The technician took control of the crane from the trolley cab, moved the cab about halfway out on the boom to verify operations, and returned the cab to the parked position. No issues were found. The technician determined the crane did not boom up because the trolley cab was not fully returned to the parked position to register contact with the proximity switch. According to the technician, as the trolley cab was being moved toward the parked position, the “control off button was pressed prior to getting a parking acknowledge light.” Therefore, the start interlocks were not meeting, thus preventing the boom from rising.

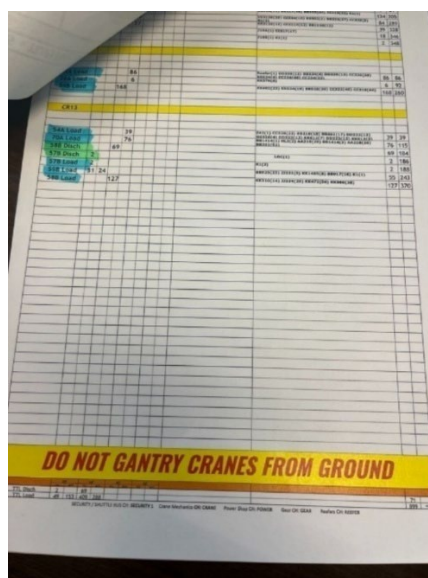
Figure 10. Example of revised FMS shift head sheet, showing the informational note added. (Source: FMS)

- Installed locks on all STS cranes' waterside dock-level control stations to limit crane gantrying from the ground. A mechanic and appropriate additional personnel were required to be present to access a control station to ensure safe movement of the STS cranes from the ground.
- Changed the cranes' control system program to inhibit gantry function from the ground station with the boom in the lowered position.
- Revised all shift head sheets provided to each STS crane operator so that they state, "DO NOT GANTRY CRANES FROM GROUND" (see figure 10).
