MIR-26-20

## Contact of *Myra Eckstein* Tow with Vicksburg Highway 80 Bridge

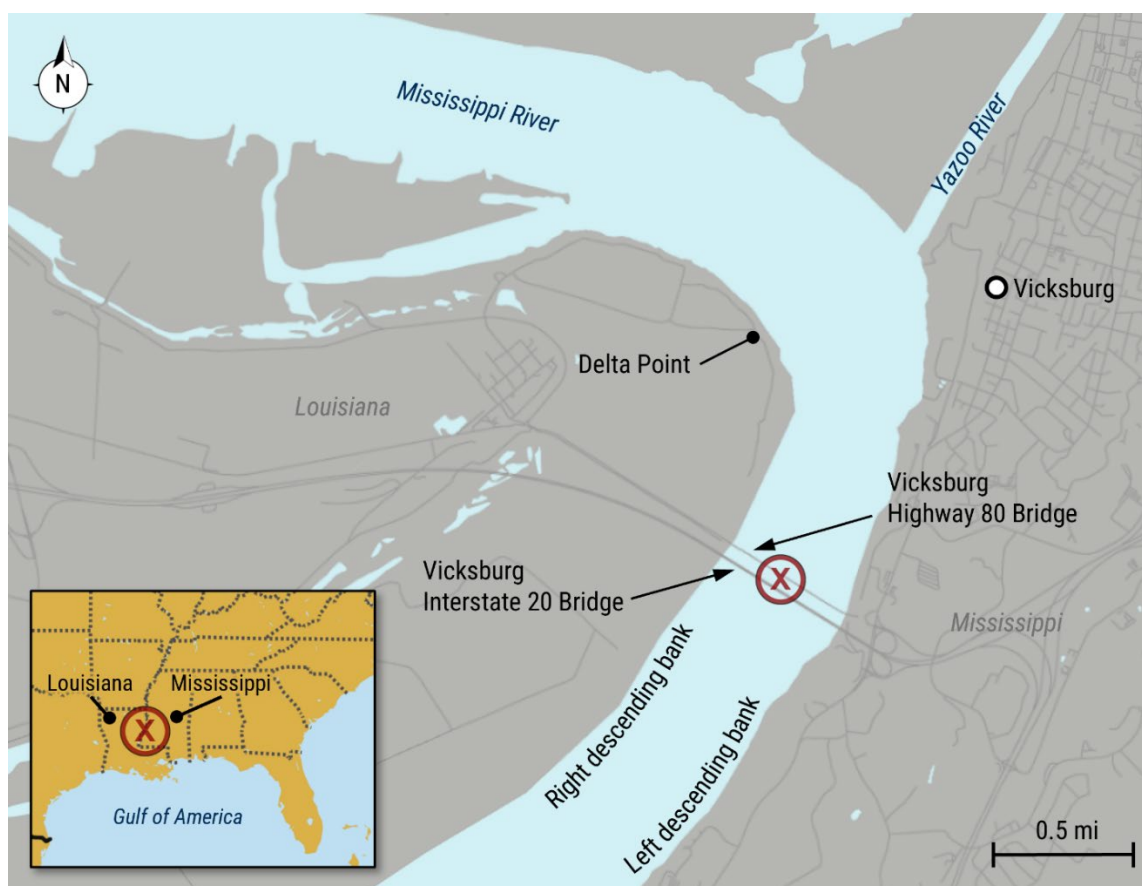
**Figure 2.** Area where the *Myra Eckstein* tow contacted the Vicksburg Highway 80 Bridge, as indicated by a circled X. (Background source: Google Maps)

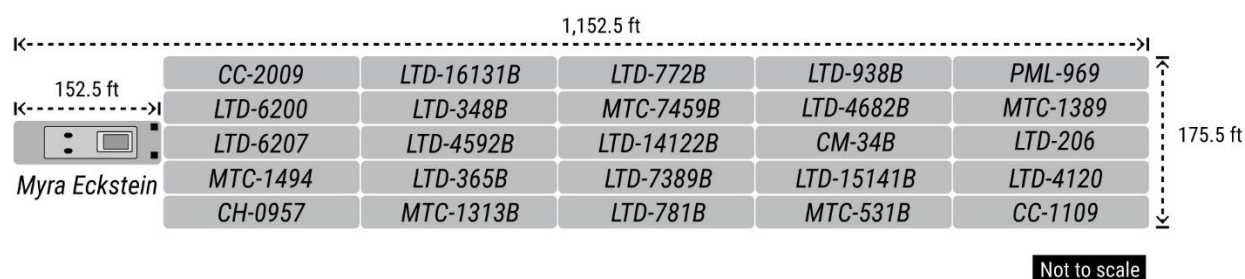
**Figure 3.** The *Myra Eckstein* tow configuration. (Background source: Marquette Transportation Company)

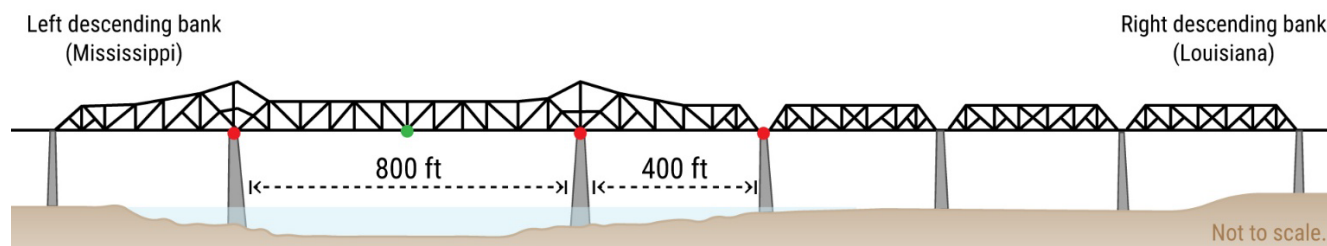
On May 5, the tow was approaching Vicksburg and two bridges: the Vicksburg Highway 80 Bridge and the Vicksburg Interstate 20 Bridge (see figure 2). The Vicksburg Highway 80 Bridge opened in 1930 and originally served as a highway and railroad crossing (see figure 4). The bridge had been closed to vehicular traffic for several years, serving solely as a railway bridge. Vehicular traffic was carried via the Vicksburg Interstate 20 Bridge, which was about 315 feet downstream from and ran parallel to the Vicksburg Highway 80 Bridge. The Coast Guard recorded 29 reportable contacts with the bridge between March 2010 and February 2024.<sup>4</sup>

**Figure 4.** The Vicksburg Highway 80 Bridge, as viewed looking downriver. (Background source: US Army Corps of Engineers)

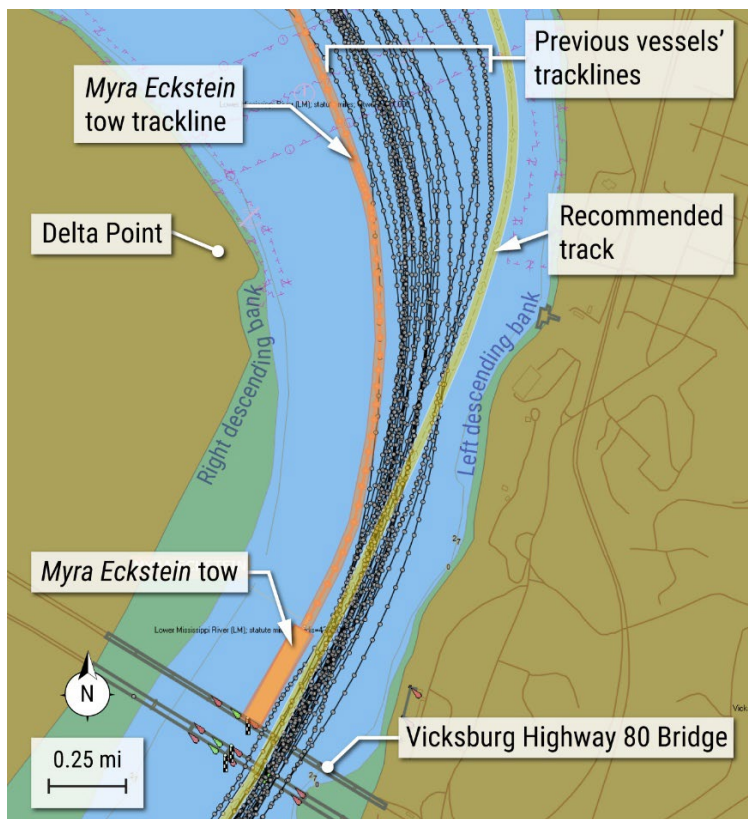
**Figure 5.** Trackline of the *Myra Eckstein* tow (highlighted orange) before and during the contact with the Vicksburg Highway 80 Bridge, the recommended track (highlighted yellow), and the tracklines of vessels (black) transiting downbound in daylight hours from 1000 on May 4, 2025, to 0958 on May 5, 2025. (Background source: Corps of Engineers Inland Electronic Navigation Chart U35LM425 as viewed on Made Smart)

The captain stated that he was following previous tows' tracklines around Delta Point and the approach to the Vicksburg Highway 80 Bridge. A review of other vessel tracklines from the 24 hours leading up to the casualty showed that the *Myra Eckstein's* trackline was closer to the right descending bank than all other downbound vessels. This left the tow more susceptible to eddies that formed along the right descending bank near Delta Point. The captain reported that he was unable to correct the heading of the tow in the current despite his maneuvering actions. He

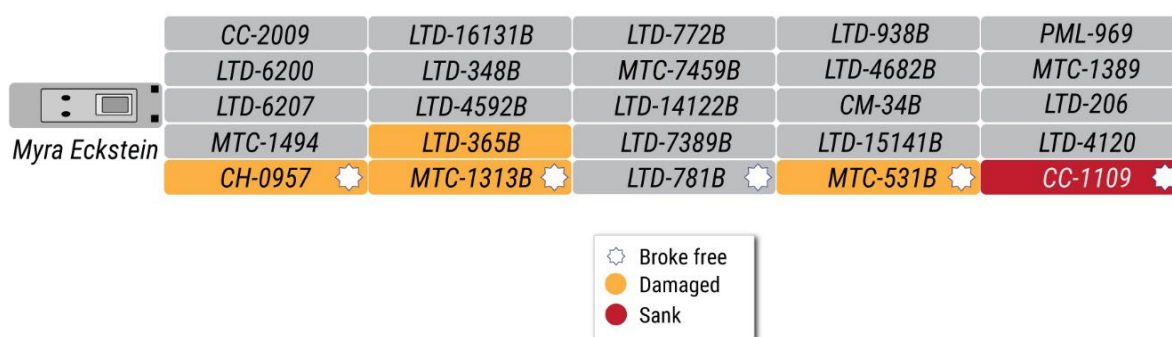
Damage to the sunken barge (CC-1109) was estimated at \$550,000 and the loss of its cargo was \$250,000. Other barges in the tow sustained damage, and repairs were estimated at \$141,000 (see figure 6). Damage to barges in the tow included:

- CH-0957—Towing button was pulled off deck,
- LTD-365B—Cleat was detached from the deck,
- MTC-531B—Frames in the wing void were bent, and
- MTC-1313B—A side in a void space was dented.

**Figure 6.** Barges that broke away, were damaged, and/or sank as a result of the contact.

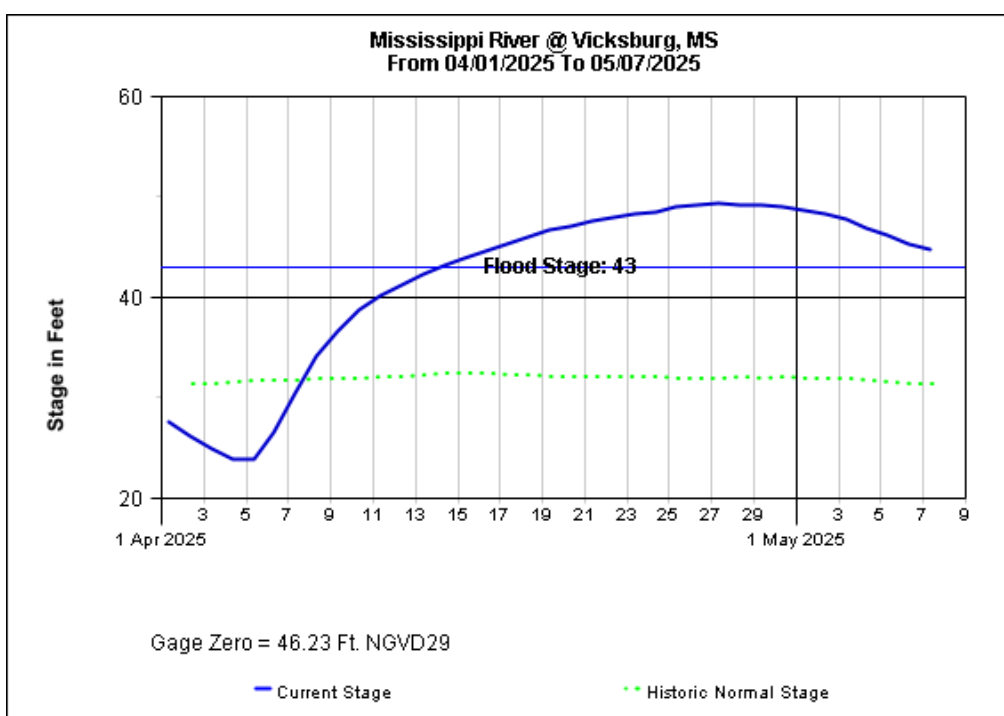
On May 5, the day of the casualty, the Vicksburg gage read 46.17 feet (about 3.17 feet above major flood stage and about 16 feet above historic normal stage) and falling (see figure 7). Visibility was about 10 miles, with fair skies and south-southeasterly winds at 5 mph. The captain of the *Myra Eckstein* estimated that the current was about 6 mph.

**Figure 7.** Mississippi River water level in feet at Vicksburg, April 2-May 5, 2025. (Source: Corps of Engineers)
