July 14, 2026

MIR-26-21

## Fire aboard Towing Vessel *William D*

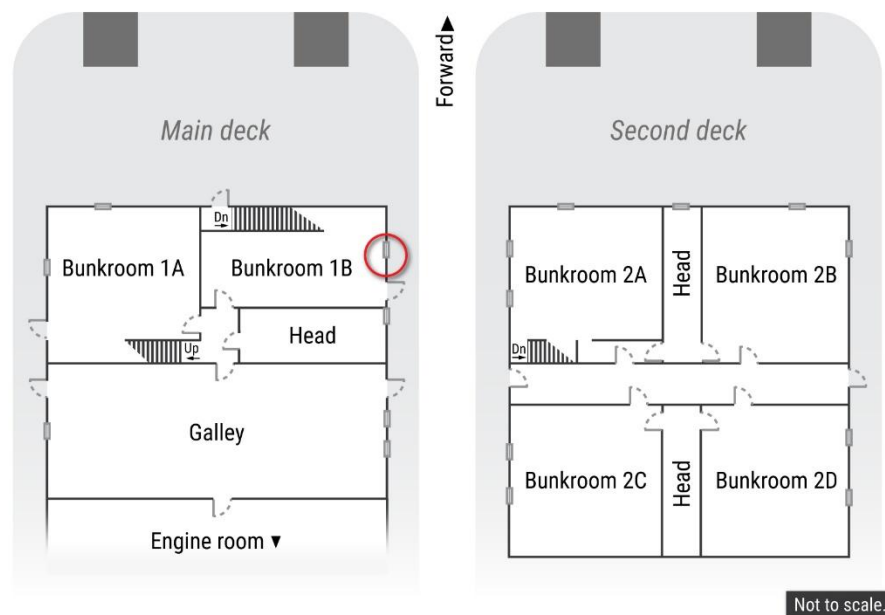
The vessel's main deck consisted of the galley, two bunkrooms (Bunkroom 1A on the port side and Bunkroom 1B on the starboard side), and the upper level of the engine room (see figure 3). Bunkrooms 1A and 1B each had an exit to an internal passageway and an exit to the external weather decks. A head was located on the main deck, and its entrance was in the internal passageway that connected Bunkrooms 1A and 1B. The lower level of the engine room, as well as the forward machine room (which contained air compressors and storage racks), were located below the main deck. The second deck, which was above the main deck, was comprised of four bunkrooms (Bunkrooms 2A through 2D) with two adjoining heads. Most bunkrooms had a window and were outfitted with a window-mounted air conditioning (A/C) unit. The wheelhouse was above the second deck. According to the captain, the bulkheads of the passageways, the interior bulkheads of the wheelhouse, and the interior bulkheads of all bunkrooms were covered in wood paneling.

**Figure 3.** Partial plan views of the main and second decks of the *William D*. The location where the fire was first observed is circled. (Not to scale.)

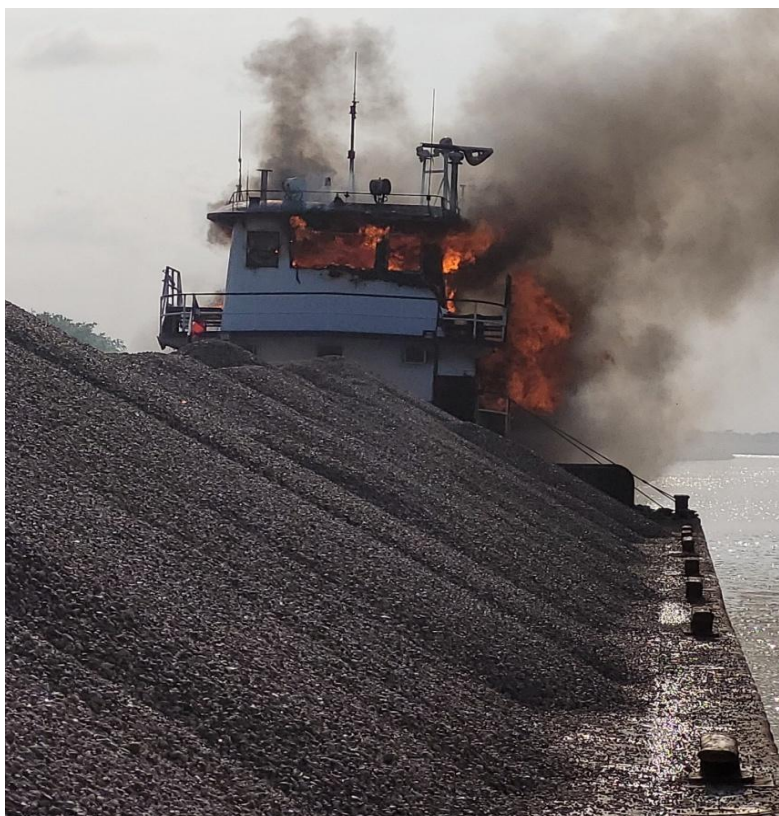
While the crew was fighting the fire, the captain stopped the tow. The fire had climbed to the second deck of the vessel, and the wheelhouse had begun to fill with smoke. The captain ordered deckhand 4 to pull the emergency fuel stops (located on the aft transverse bulkhead of the main deck superstructure) for the generator and main engines. The captain then ordered all crewmembers to evacuate forward onto the barges. Deckhand 3 reported that, at this time, he saw windows cracking and popping on the main and second decks as the flames contacted the glass. With the wheelhouse full of smoke and both sides of the vessel aflame, the captain descended the forward walkway onto the lower decks, where he evacuated to the barges (see figure 4).

**Figure 4.** The *William D* on fire as seen from the barges during the casualty. (Source: Pinnacle III)

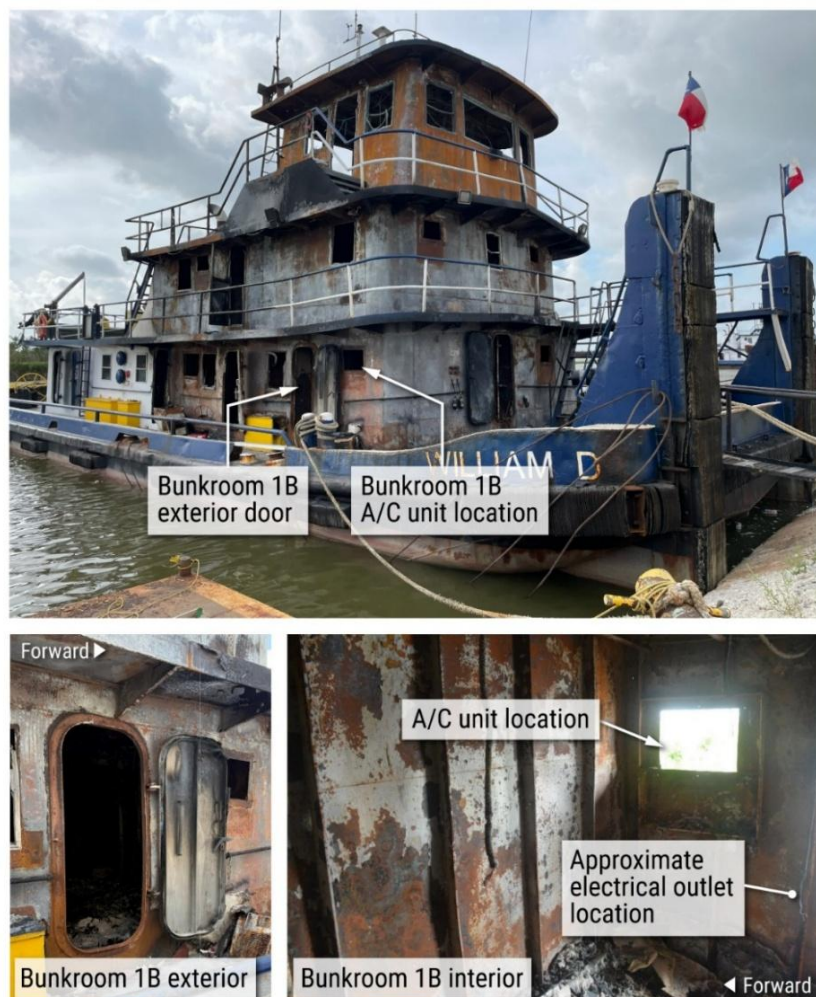
ATF fire investigators concluded that the fire originated in Bunkroom 1B, which had extensive thermal damage, with the bed, bulkhead paneling, and other furnishing almost totally consumed and the steel structural bulkheads sustaining heavy charring and warping.

Based on the fire patterns and damage, witness statements, and the likely movement of the fire within the vessel's internal spaces due to ventilation, ATF investigators concluded that the fire most likely originated on the starboard bulkhead of Bunkroom 1B (where the electrical outlet powering the bunkroom's A/C had been mounted before the fire) (see figure 5). ATF investigators noted no electrical wiring remained within the starboard bulkhead at the location of electrical outlet (where crewmembers stated they first observed flames), which could indicate the possible origin area or cause of fire. ATF investigators identified electrical failure as the most probable cause of the fire and, ultimately, classified the cause of the fire as accidental. However, ATF investigators determined the extent of thermal damage "prevented conclusive identification [of] a specific electrical fault" and that further forensic testing would be required to determine a more precise point of failure.

**Figure 5.** Starboard view of the *William D* after the fire, the exterior door of Bunkroom 1B, and the interior of Bunkroom 1B, showing the location of the A/C unit and the approximate location of the electrical outlet. (Background sources: Pinnacle III [bottom left] and ATF [bottom right])

A postcasualty investigation conducted by the ATF indicated that the starboard bulkhead of Bunkroom 1B, located on the main deck, was the likely origin location of the fire and identified electrical failure as the "most probable cause" of the fire. An electrical outlet on the bulkhead was providing power to a window-mounted A/C unit (turned on) and a phone charger (no device connected to it) when the fire broke out. An electrical fault—such as a loose, broken, or frayed wire, or broken receptacle hardware—within the outlet or nearby circuitry, could have created excessive resistance heating sufficient to ignite nearby combustibles. However, due to the extent of the fire damage, the exact ignition source and exact cause of the fire could not be determined.

The National Transportation Safety Board determines that the probable cause of the fire aboard the towing vessel *William D* was likely an unknown electrical source in the starboard main deck bunkroom. Contributing to the rapid spread of the fire and the extent of the damage were air introduced through open doors, windows, and other openings, and the substantial use of combustible wood paneling throughout the accommodation spaces.
