July 15, 2026

MIR-26-22

## Explosion aboard Sludge Vessel *Hunts Point*

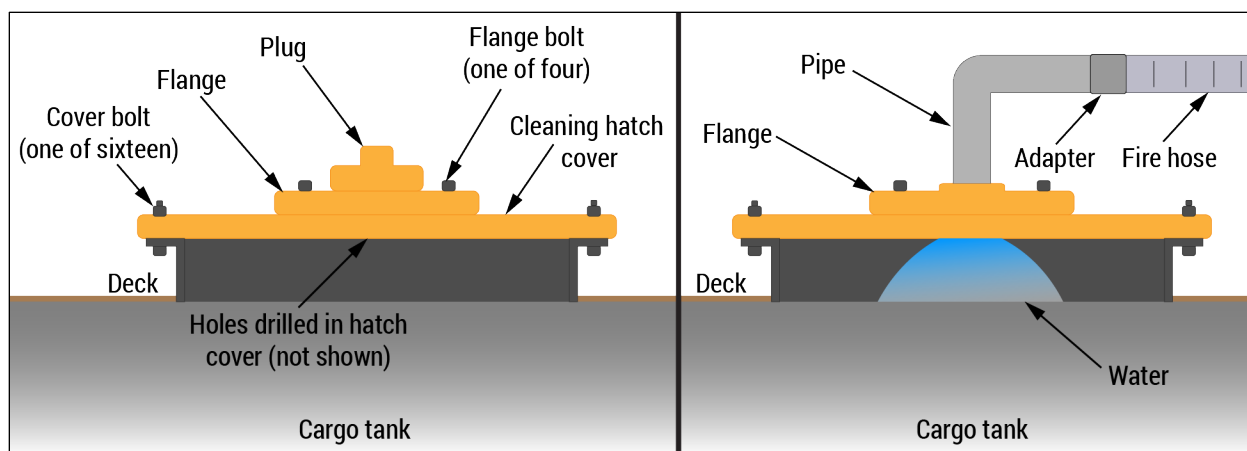
The alteration changed the innage reduction process. To complete innage reduction using the modified hatch covers, each cover's pipe plug was removed, a fabricated 2.5-inch external pipe was threaded into the flange, and a fire hose was connected to the pipe via an adapter (see figure 3). This enabled water to be directly sprayed into each tank, via a fire hose connection, without the need to remove the hatch cover. When not in use, the flange opening was secured with the pipe plug. The *Hunts Point* was the only NYC DEP vessel with this specialized modification to the cleaning hatch covers.

**Figure 3.** Left to right: Simplified diagram showing the typical arrangement for the innage reduction process and the modifications to cleaning hatch cover. (Not to scale9.)

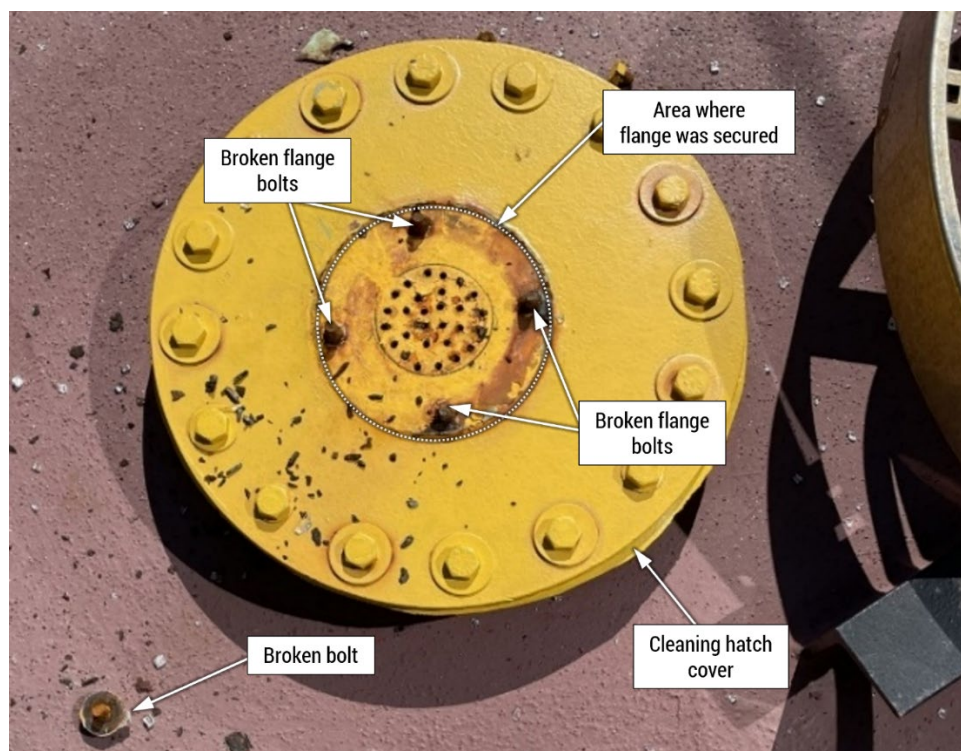
Before the chief engineer left to take the watch in the engine room, he directed the assistant engineer to remove the flanges that were still attached to the cleaning hatch covers. The assistant engineer attempted to remove the flange for the no. 1 port cargo tank, but all of the bolts snapped, leaving the threaded sections of the bolts in the cleaning hatch cover (see figure 4). The assistant engineer told investigators that the broken bolts had to be removed from the cover so the flange could be attached and secured for the innage reduction process. He stated that the rusted condition of the bolts made removing the broken parts from the hatch very difficult.

**Figure 4.** Cleaning hatch cover for no. 1 port cargo tank postcasualty, showing all four broken flange bolts that partially remained in the cover.

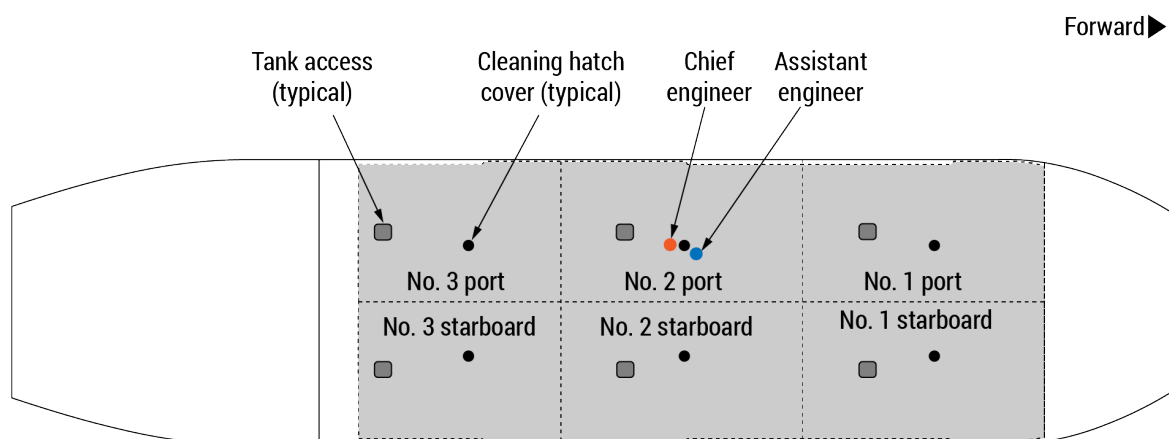
**Figure 5.** Simplified layout of the *Hunts Point* main deck showing the cargo tanks and approximate location of the chief engineer and the assistant engineer before the casualty.

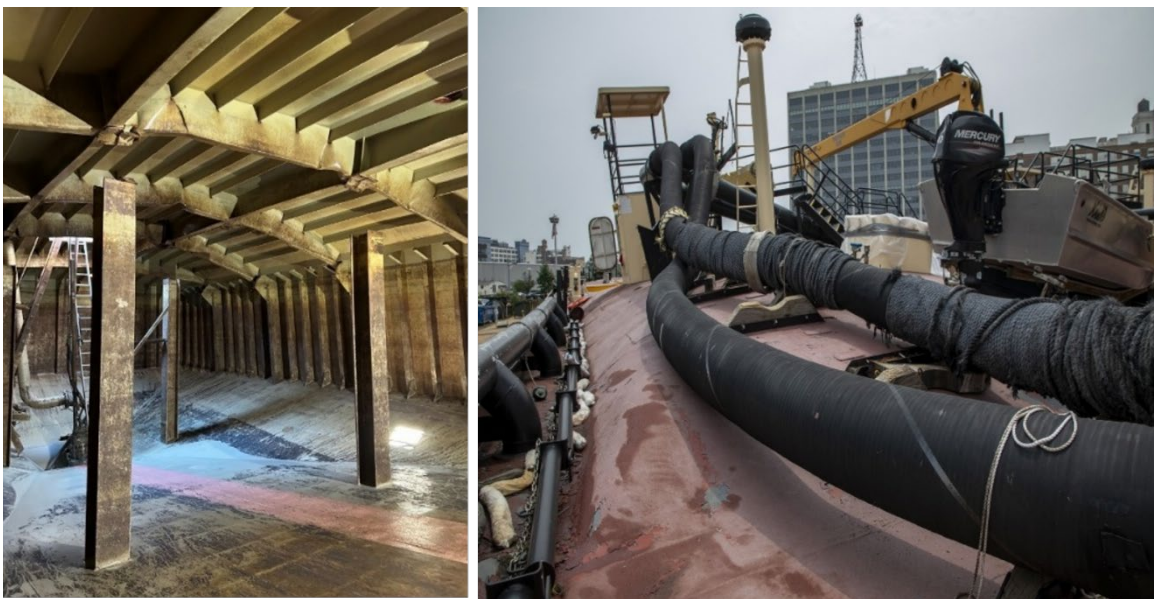
After the explosion, Coast Guard and National Transportation Safety Board investigators boarded the vessel to examine the damage. The no. 2 port cargo tank expanded upward about 4 feet during the explosion (see figure 6).

**Figure 6.** Left to right: Structural damage to the *Hunts Point* no. 2 port cargo tank from the interior and the exterior, following the May 24, 2025, explosion. (Source: NYC DEP)

The ignition of the methane gas by the torch flame caused a deflagration that expanded within the tank.<sup>6</sup> As the flame front expanded into and within the confined space of the cargo tank, it ignited any remaining flammable gas, causing the temperature and pressure within the cargo tank to grow significantly. At some point after the initiating event, the pressure within the cargo tank exceeded the structural strength of the vessel's tank, resulting in the explosion.

In addition, the NYC DEP began removing and replacing the *Hunts Point* hatch covers (while the vessel is undergoing other repairs related to the casualty). Once the repairs are completed, the 16 bolts on the new hatch covers will have to be removed to gain access into the tanks and conduct an innage reduction.

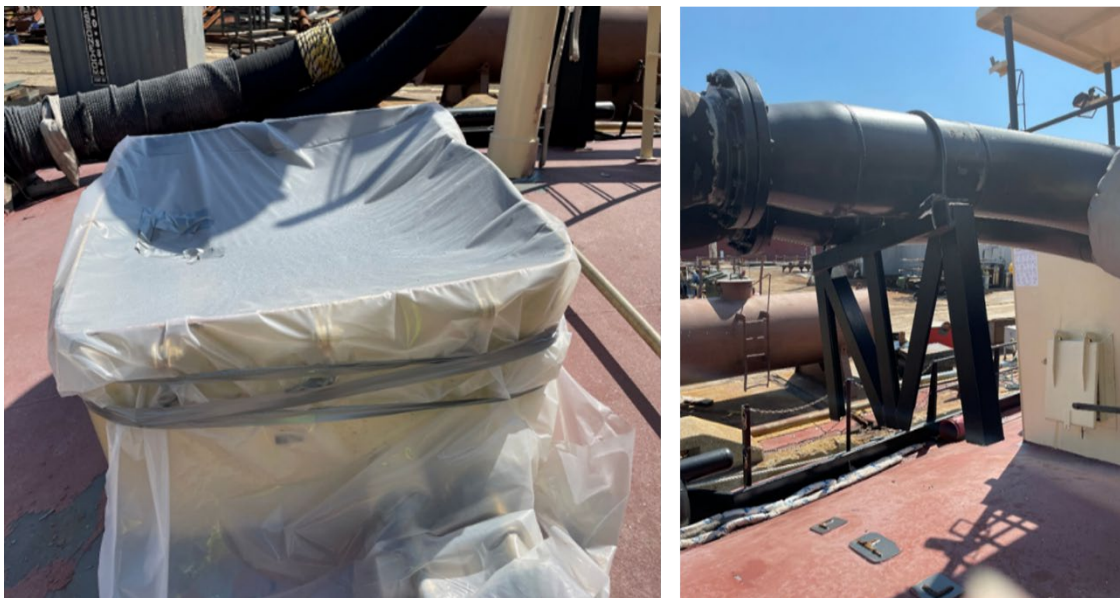
The hatch cover for the submersible cargo pump for the no. 2 port cargo tank was blown into the Hudson River and was not recovered. The spill valve for the no. 2 port cargo tank was blown off the piping. There was also extensive damage to the cargo piping system as well as to raised catwalks and stairs in the area where the explosion occurred (see figure 7).

**Figure 7.** Damage to vessel following the May 24, 2025, explosion. Left to right: Hatch to the no. 2 port cargo tank submersible pump covered in plastic, with hatch cover shown missing. Deformed cargo piping on deck.

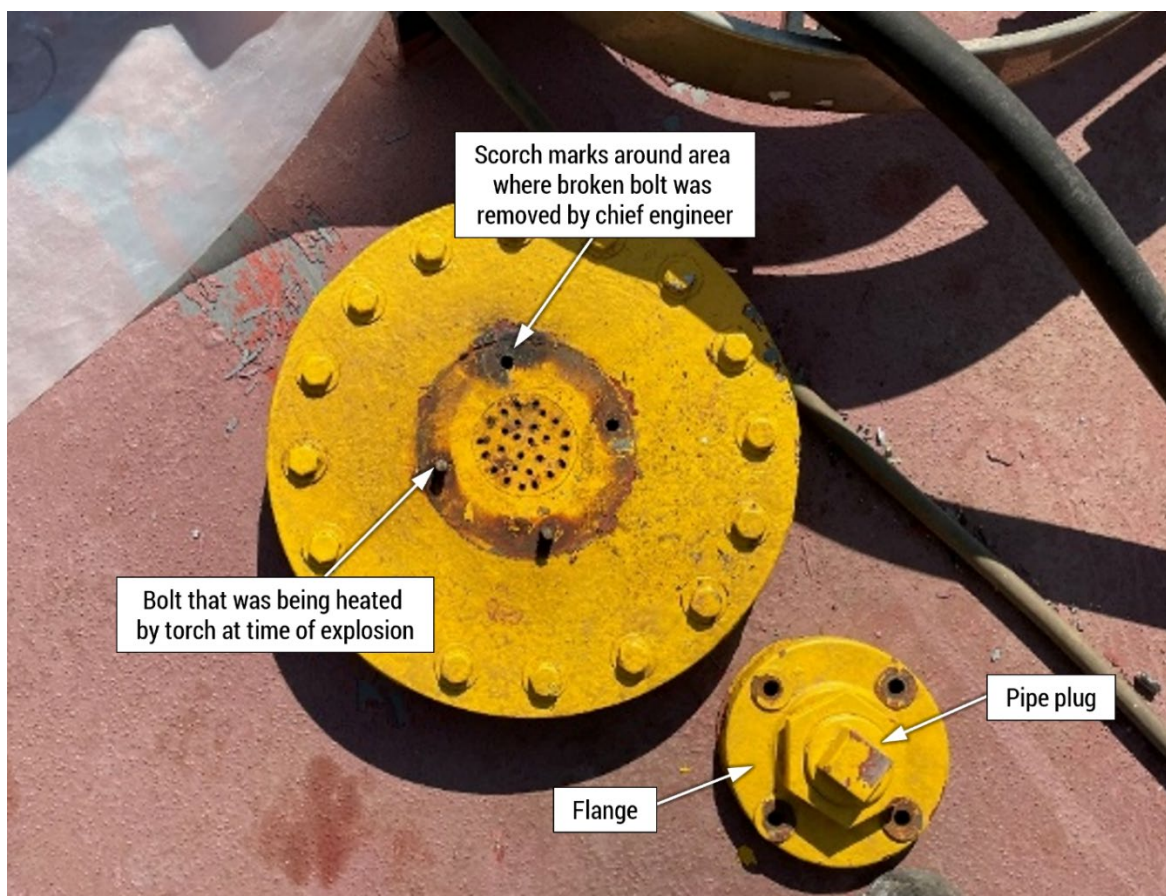
During the postcasualty exam of the vessel, investigators found that, for each of the six cargo tank cleaning hatch covers, the rusted pipe plugs appeared frozen or rusted in place within all of their flanges. Investigators also found burn/scorch marks on the cargo tank no. 2 port cleaning hatch cover (see figure 8). The assistant engineer told investigators these burn marks had not been on the cover before the casualty. He stated that they were from a broken bolt that the chief had removed by heating before the assistant engineer's return.

**Figure 8.** No. 2 port cargo tank cleaning hatch cover after the explosion, showing burn/scorch marks indicating area where a broken bolt was removed and where a bolt was being heated by the torch when the explosion occurred.

lighter than air and would have accumulated at the top of the cargo tank. Methane gas can be ignited at about 999°F, and propane torches, like the one used by the chief engineer, can produce flames reaching a maximum temperature of 3,623°F.<sup>5</sup> Therefore, it is likely that methane at the top of the cargo tank was ignited by the torch flame.
