Marine Investigation Report MIR-26-24

# Collision Between Bulk Carrier *Yangze 7* and Towing Vessel *Miss Peggy*

Houston Ship Channel  
Lynchburg, Texas  
July 19, 2024

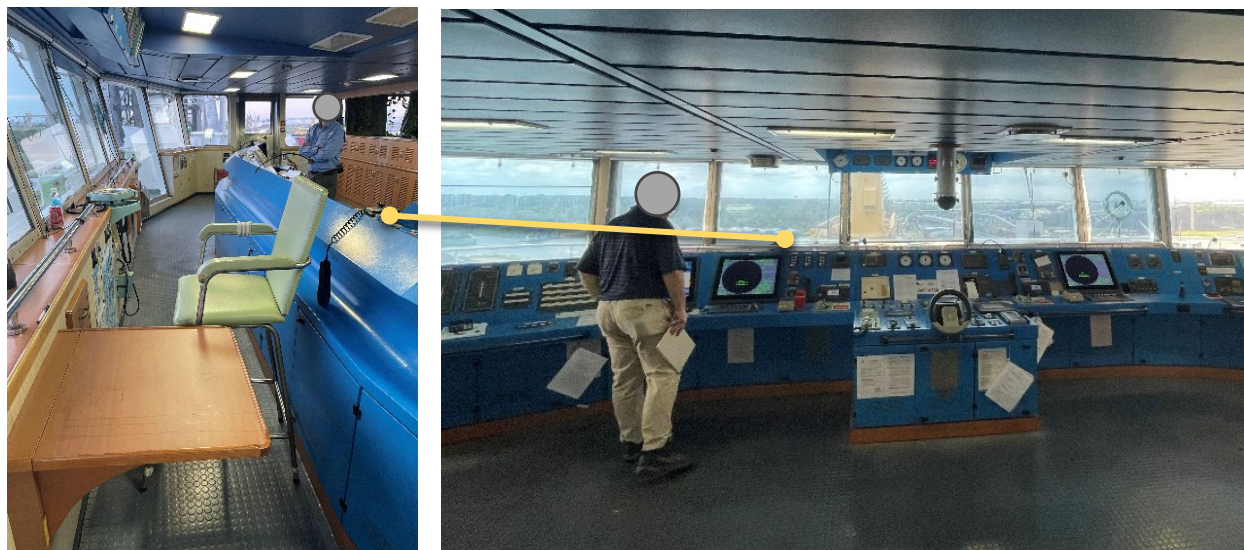
The pilot set up his portable pilot unit (PPU) and sat between the bridge navigation consoles and the forward bridge windows.<sup>7</sup> He was seated to port of the ship's centerline and within reach of one of the very high frequency (VHF) radio handsets (see figure 5).

**Figure 5.** Left to right: Postcasualty reconstruction of the placement of the pilot's chair on the bridge of the *Yangze 7*, and the layout of the vessel's bridge. The location of the pilot's chair relative to the bridge layout is indicated by the yellow line.

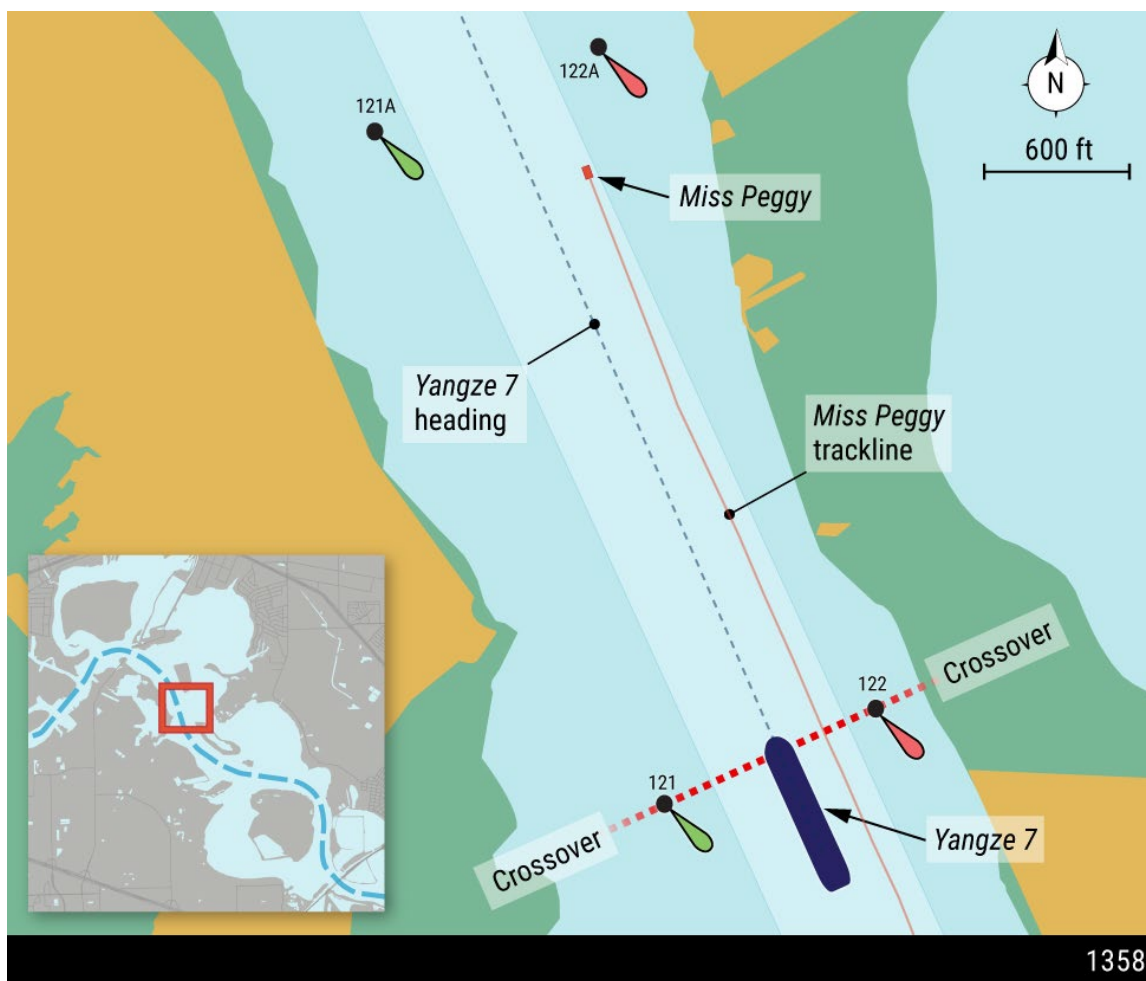
**Figure 7.** Locations of the *Yangze 7* and the *Miss Peggy* at 1358. The area depicted in the graphic is indicated by the rectangle on the inset map. CMs 121 and 122 mark Crossover, the mandatory VTS reporting point. (Channel markers not to scale.) (Background sources: NOAA ENC US5HOUEF and Google Maps)

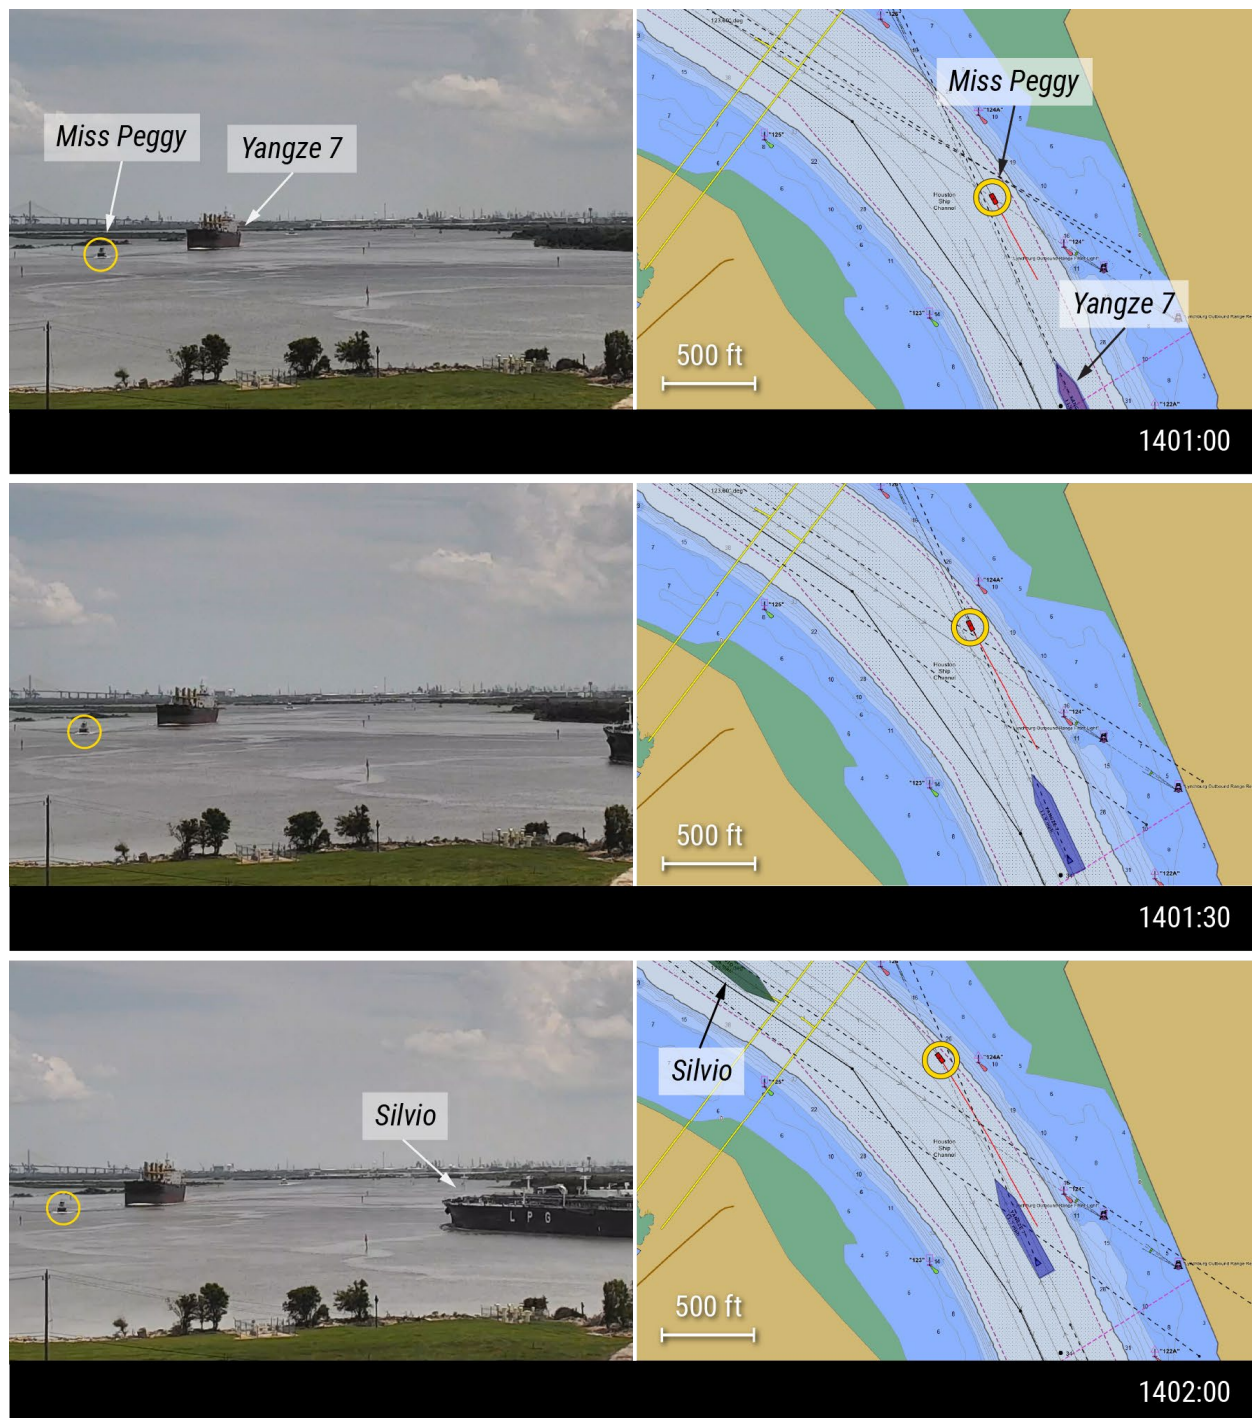
At 1401, the *Miss Peggy* was about 1.8 ship lengths (1,151.0 feet [350.8 meters]) ahead of the *Yangze 7* (see figure 8). The *Yangze 7* was passing red CM 122A, and the *Miss Peggy* was between red CMs 124A and 124. At this time, the *Yangze 7* bridge VDR captured the pilot ordering port 10° on the rudder, the helmsman reading the order back, and the pilot saying, “I’m going to hang up with you.” The pilot’s cell phone records indicated that the phone call ended at 14:01:44. The pilot then continued issuing midship and port 10° rudder orders as the ship approached the bend at Lynchburg.<sup>12</sup> At 1402:00, the *Yangze 7* was still at full ahead and about 1.2 ship lengths (781.0 feet [238.0 meters]) astern of the *Miss Peggy* (see figure 8 and figure 9).

**Figure 8.** Timelapse sequence of camera footage (left) and the vessels' locations as recorded in Rose Point electronic charting system (ECS) (right) from 1401:00 to 1402:00, showing the *Miss Peggy* (circled) ahead and starboard of the *Yangze 7* as the *Silvio* prepared to pass the *Yangze 7* port to port. (Background sources: US Coast Guard and Rose Point ECS)

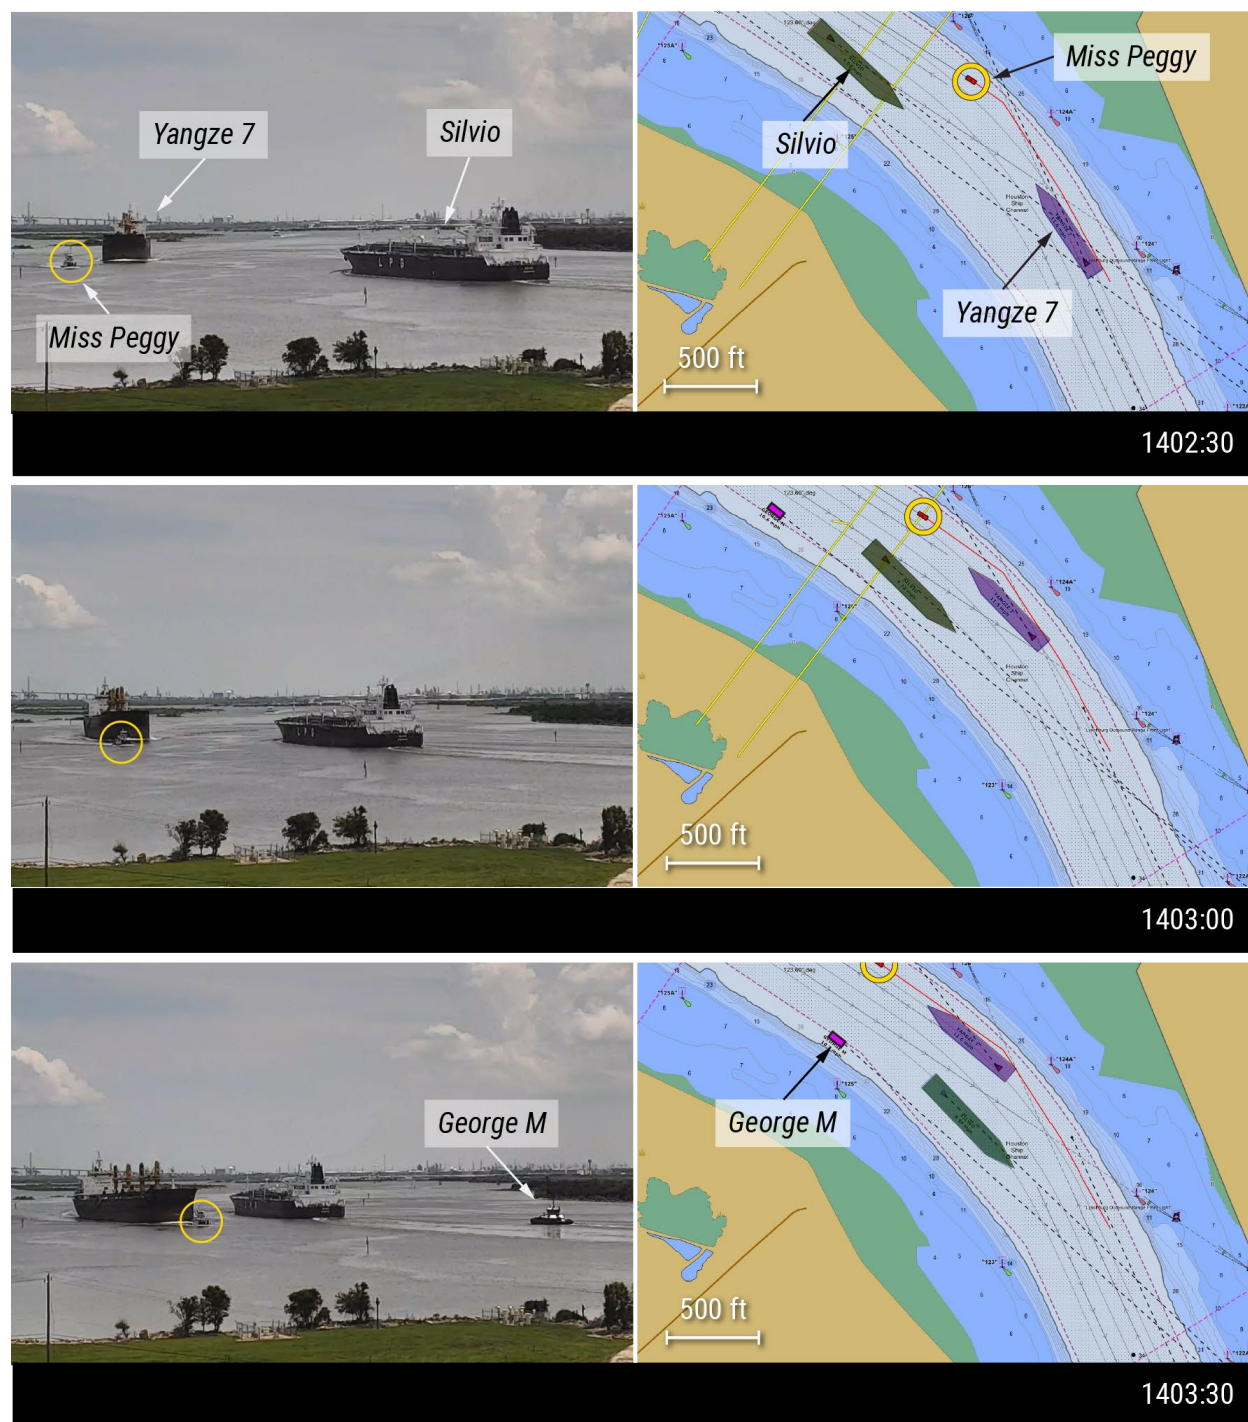
**Figure 11.** Timelapse sequence of camera footage (left) and the vessels' locations as recorded in Rose Point ECS (right) from 1402:30 to 1403:30, showing the *Miss Peggy* ahead and starboard of the *Yangze 7* as the *Silvio* passes the *Yangze 7* port to port and as the *George M* nears the vessels. (Background source: Coast Guard)

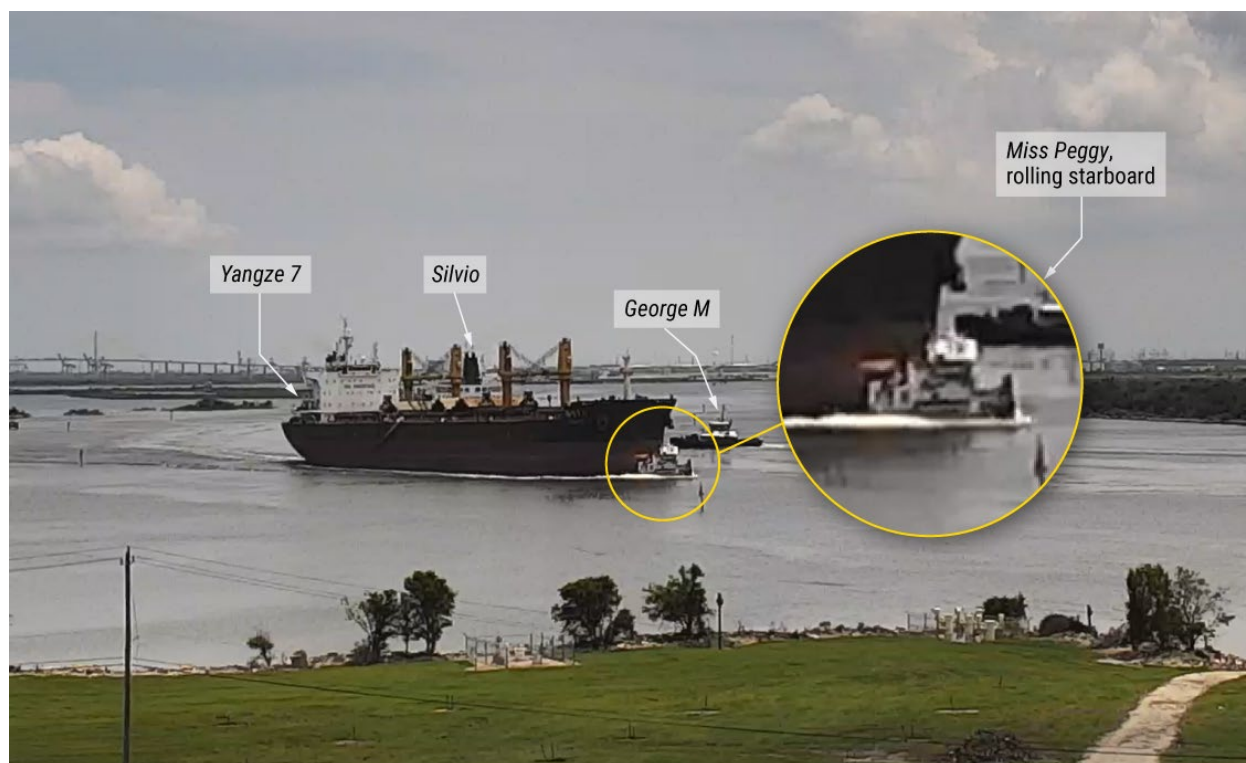
At 1403:35, the bulbous bow of the *Yangze 7* collided with the stern of the *Miss Peggy*, and the *Miss Peggy* surged forward and rolled over rapidly to starboard (see figure 12).

**Figure 12.** The *Miss Peggy*, rolling to starboard during collision with the *Yangze 7*, with the *Silvio* and the *George M* nearby. (Background source: Coast Guard)

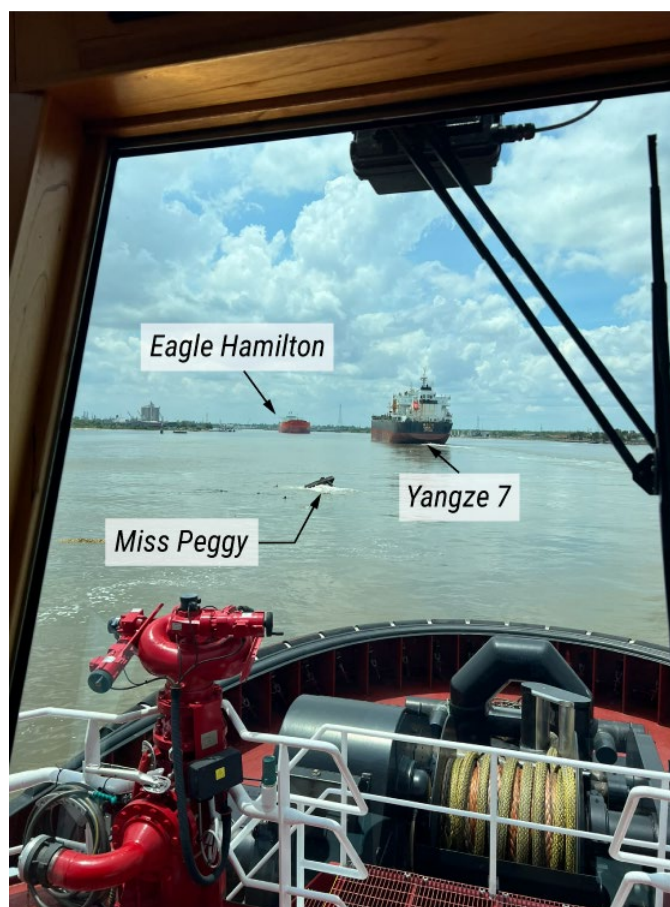
**Figure 14.** View from the *George M* of the *Miss Peggy* sinking and three of its crewmembers in the water at 1405. (Background source: G&H Towing)

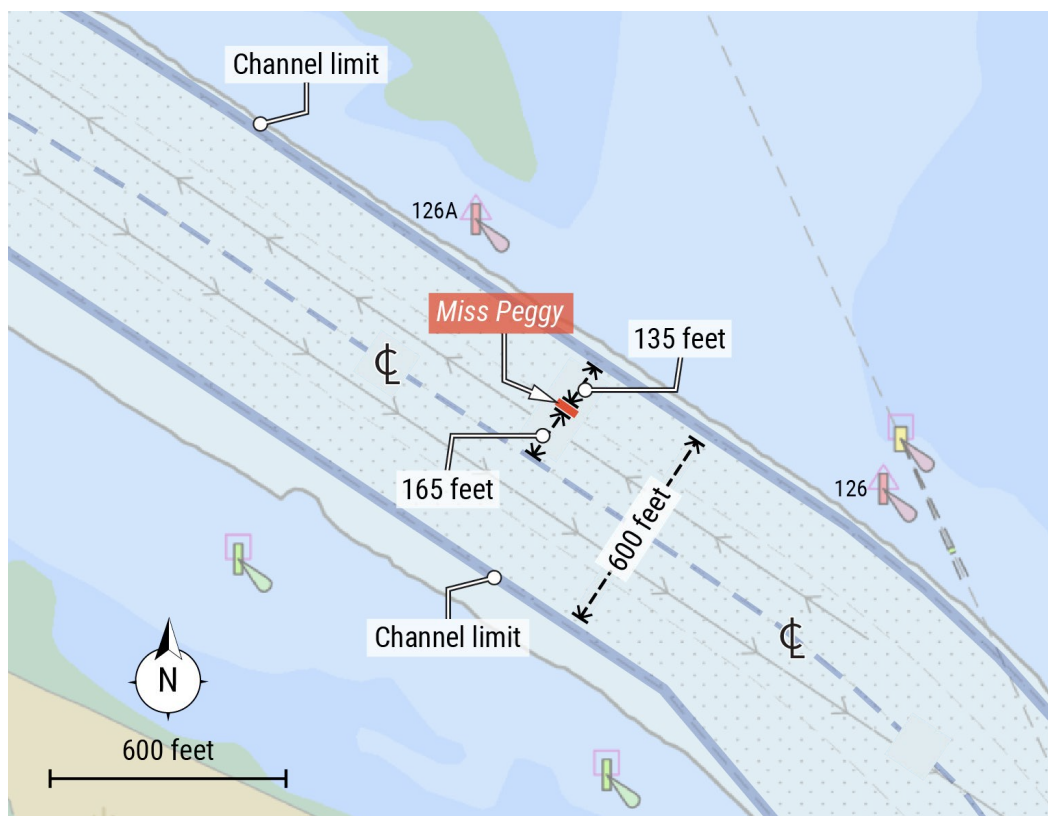
The *Miss Peggy* was later found at the bottom of the Houston Ship Channel near the collision site, lying on its starboard side at a depth of 52.0 feet (15.2 meters). Based on the last global positioning system (GPS) position transmitted from the *Miss Peggy* at 1403:55, the boat was about 135.0 feet (41.1 meters) (centerline of the boat) from the red side channel limit and about 165.0 feet (50.3 meters) from the centerline of the channel (see figure 15).

**Figure 15.** Last position at 1403:55 of the *Miss Peggy* in the Houston Ship Channel, indicating the distance that the towboat was inside the channel. (Channel markers not to scale.) (Background source: NOAA ENC US5HOUF)

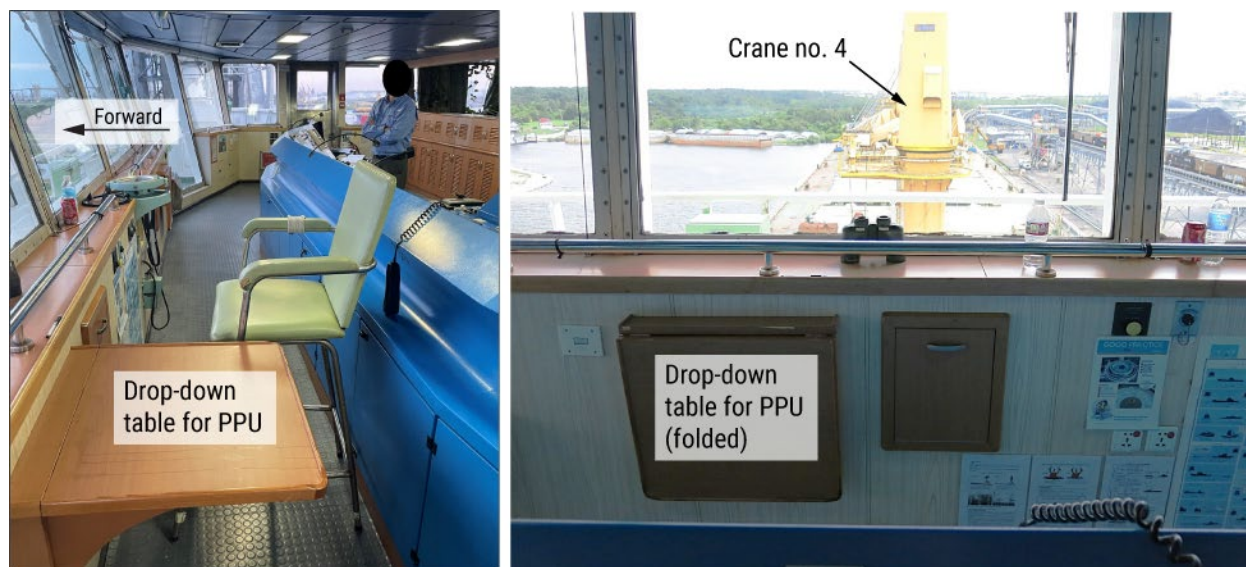
**Figure 17.** Left to right: The seat where the pilot was positioned while conning the *Yangze 7*, and the view from the pilot's seat, looking forward toward the bow.

Bulk carriers of similar construction and layout to the *Yangze 7* commonly transited the Houston Ship Channel. Pilots were familiar with the visual obstructions presented by such deck-mounted cargo cranes, which required bridge personnel to move about the bridge to see various areas past the bow.

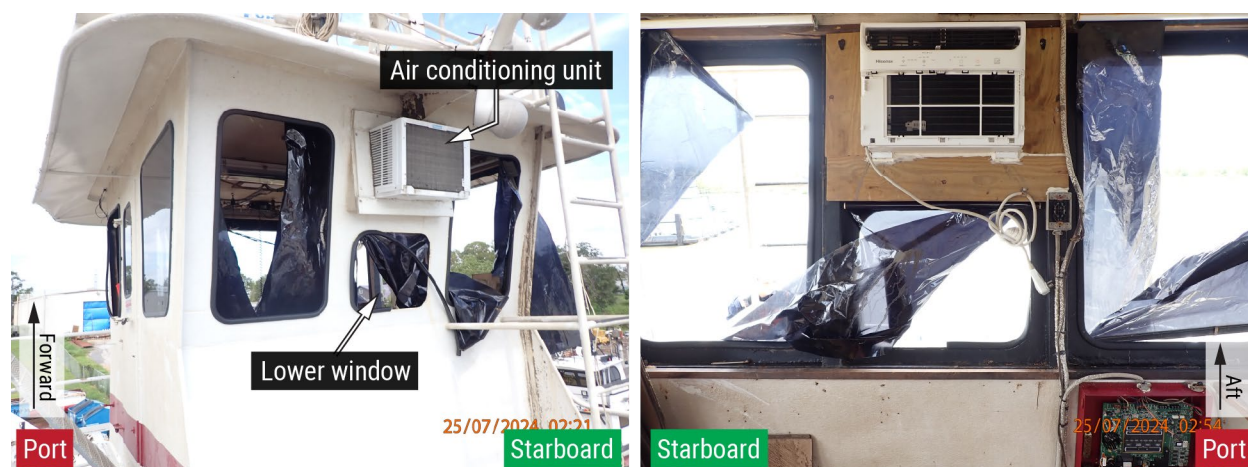
The top structure was the pilothouse. The *Miss Peggy* was not subject to any regulatory pilothouse visibility requirements. Aft of the conning position, three windows provided visibility. The upper window of the center portion was obscured by a window air conditioning unit (see figure 18).

**Figure 18.** Left to right: The exterior of the *Miss Peggy* pilothouse after salvage, showing the location of the aft window air conditioning unit, and the window air conditioning unit as viewed from the helm conning position, when looking directly aft. (Background source: Coast Guard)

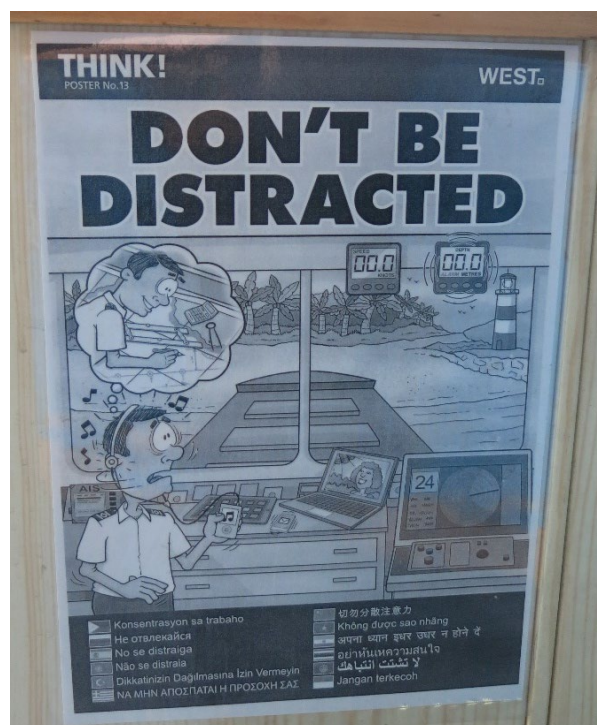
The master of the *Yangze 7* told investigators that the use of cell phones by on-duty personnel was forbidden. He included this prohibition in his standing orders, which stated, “use of mobile phones or other personal electronic equipment is prohibited on the bridge.” Likewise, signage warning against distractions due to nonoperational use of personal electronic devices (PED) was displayed on the bridge (see figure 21).

**Figure 21.** “DON’T BE DISTRACTED” poster aboard the *Yangze 7*, located below the forward wheelhouse windows to port of centerline, near where the pilot was conning the ship.
