MIR-26-25

## Fire aboard Fishing Vessel *GITN'R DUN*

On July 24, 2025, about 0900 local time, a fire broke out in the engine compartment aboard the fishing vessel *GITN'R DUN* while the two crewmembers aboard were hauling lobster traps in the Gulf of Maine near Mount Desert Rock, Maine (see figure 1 and figure 2).<sup>1</sup> The captain of the vessel attempted to put out the fire but was unsuccessful. Both crewmembers abandoned the vessel, which burned to the waterline and sank. There were no injuries, and no pollution was reported. The vessel was a total loss, with damages estimated at \$717,500.

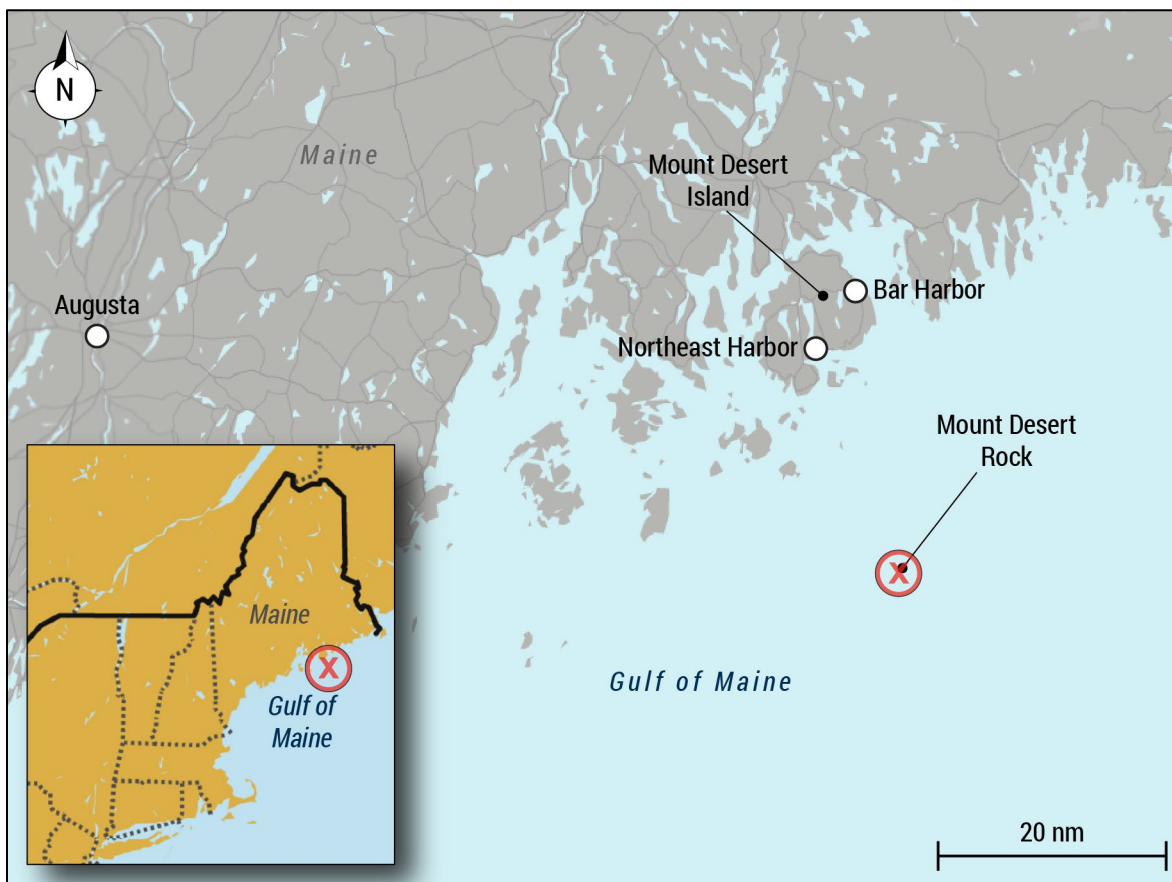
**Figure 2.** Area where the fire broke out aboard the fishing vessel *GITN'R DUN*, as indicated by a circled X. (Background source: Google Maps)

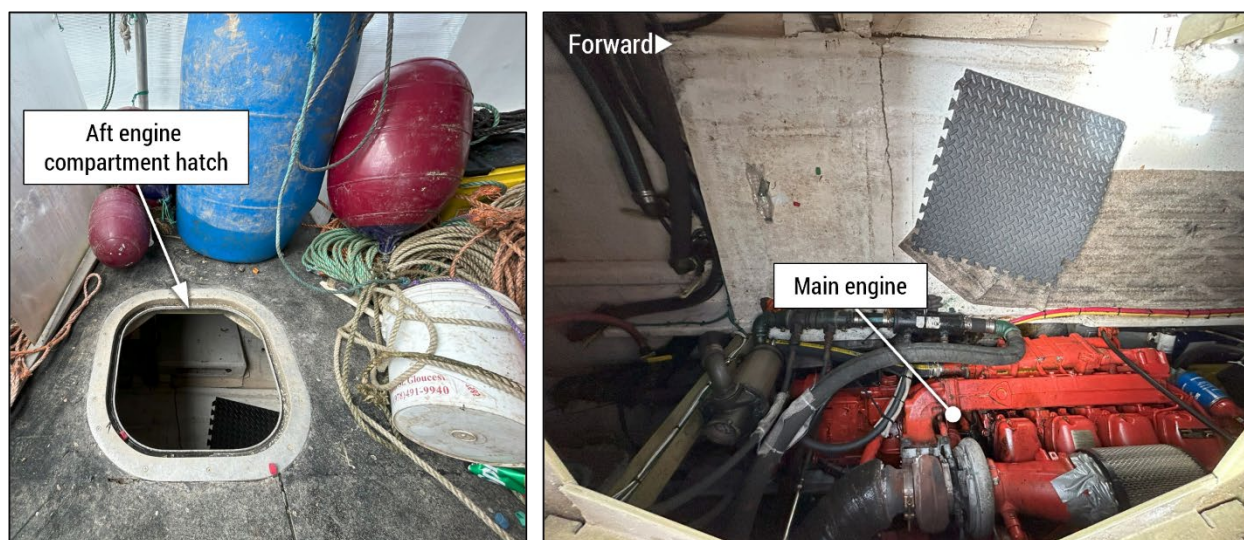
**Figure 4.** Left to right: Aft engine compartment hatch (open), and view of engine compartment looking down through the open hatch, both in May 2025, before the fire. (Background source: Coast Guard)

After smelling burning fiberglass, the captain discovered flames and light gray smoke in the engine compartment, aft on the vessel. The engine compartment contained multiple potential heat and ignition sources, including main engine exhaust components, high pressure hydraulic equipment that was operational at the time of the fire, electrical systems, batteries, and combustible materials. However, because the *GITN'R DUN* burned to the waterline, subsequently sank, and was not salvaged, investigators were unable to access and inspect the vessel to determine the exact ignition source.

- Installing an engine compartment camera system, a dedicated fire detection system, a fixed fire extinguishing system, and improved ventilation control;
- Having a longer painter line and improved staging for the liferaft;
- Providing crewmembers with personal locator beacons; and
- Having more accessible immersion suit storage locations.

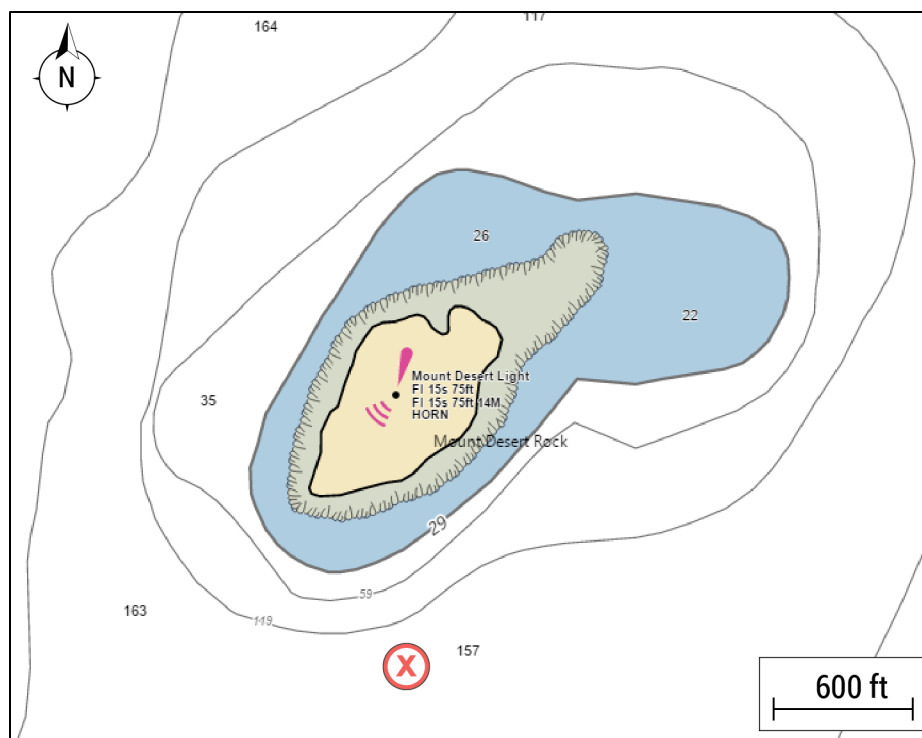
**Figure 5.** Location where the fire broke out aboard the *GITN'R DUN*, as indicated by a circled X, relative to Mount Desert Rock and the Mount Desert watch tower (light). (Background source: National Oceanic and Atmospheric Administration Office of Coast Survey)

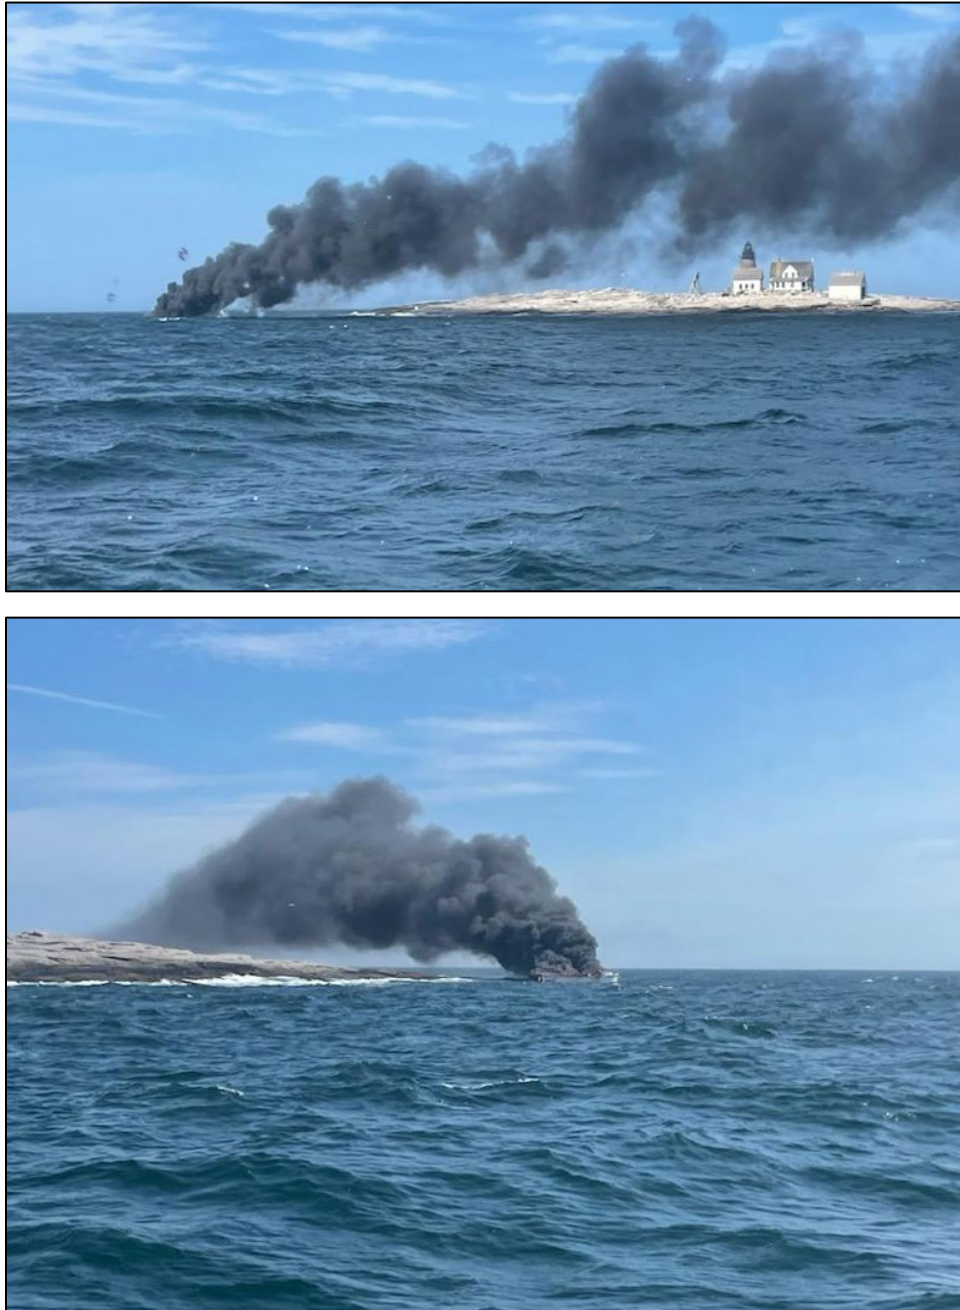
About 0912, Mount Desert Rock watchstanders noted that the smoke was turning heavy and black, and the fire was spreading (see figure 6). Three students launched a 13-foot-long rigid inflatable boat from the northern cove of the island and headed toward the burning *GITN'R DUN*.

**Figure 6.** Fire aboard the fishing vessel *GITN'R DUN*. From top: Views of the vessel's port side and starboard side. (Source: Coast Guard)

After the crew abandoned the *GITN'R DUN*, the vessel continued to burn. It drifted toward the rocky shoreline on the east side of Mount Desert Rock, and waves battered the hull into the rocks and caused the hull to break up. The vessel burned to the waterline and subsequently sank. The vessel was declared a total loss. The vessel was not salvaged and was unable to be accessed and examined by investigators.
