August 26, 2026

MIR-26-27

# Contact of Offshore Supply Vessel *Dry Tortugas* with Offshore Gas and Condensate Production Platform VK-817A

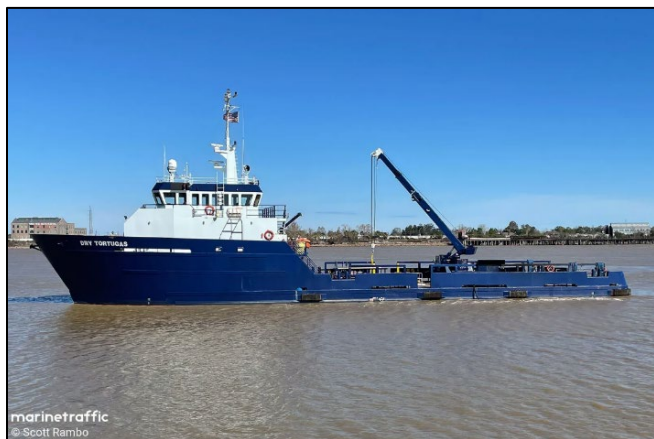
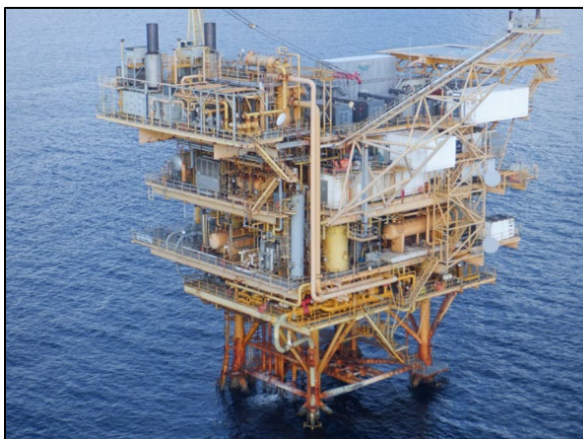
**Figure 1.** Left to right: The *Dry Tortugas* underway in January 2024, and platform VK-817A at an unknown date after the casualty. (Sources: Scott Rambo, marinetraffic.com, and Third Coast)

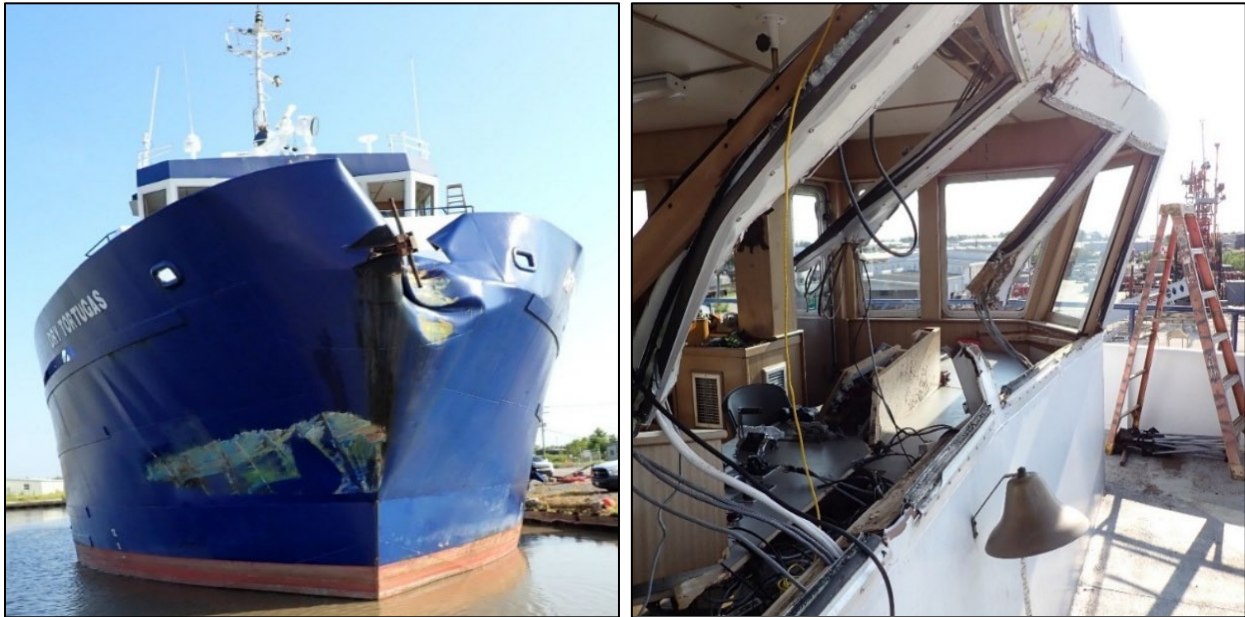
As a result of the contact with platform VK-817A, the forecastle deck and bow hull plating of the *Dry Tortugas* were damaged (see figure 3). The wheelhouse structure and interior components, exterior components atop the wheelhouse (the mast, search light, and horn, and the automatic identification system antenna), and the exterior wheelhouse deck and handrails were also damaged. Total damages to the *Dry Tortugas* were reported at \$500,000. The contact of *Dry Tortugas* with platform VK-817A damaged under-support structures, piping, walkways, and an access ladder (see figure 4). Total damages to platform VK-817A were estimated at \$4.5 million.

**Figure 3.** Left to right: Damage to the bow of the *Dry Tortugas*, and the wheelhouse structure after contacting platform VK-817A. (Source: US Coast Guard)

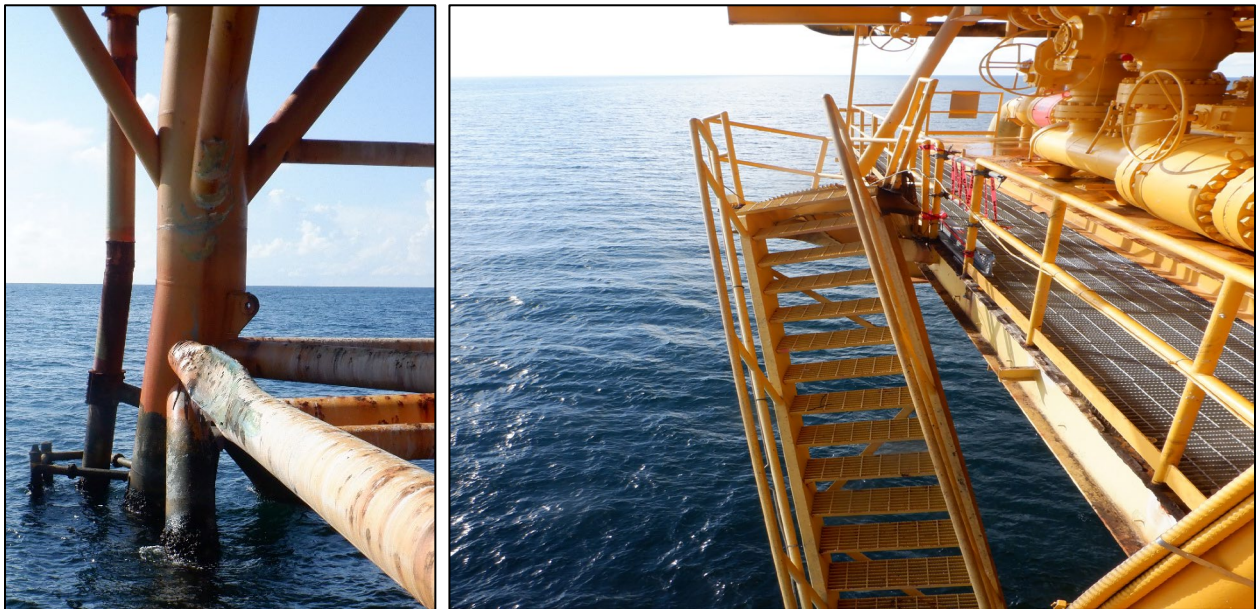
**Figure 4.** Left to right: Damage to the under-support piping, and the damaged access ladder on platform VK-817A. (Source: Third Coast)
