MIR-26-28

# Flooding and Sinking of Charter Fishing Vessel *Jig Strike*

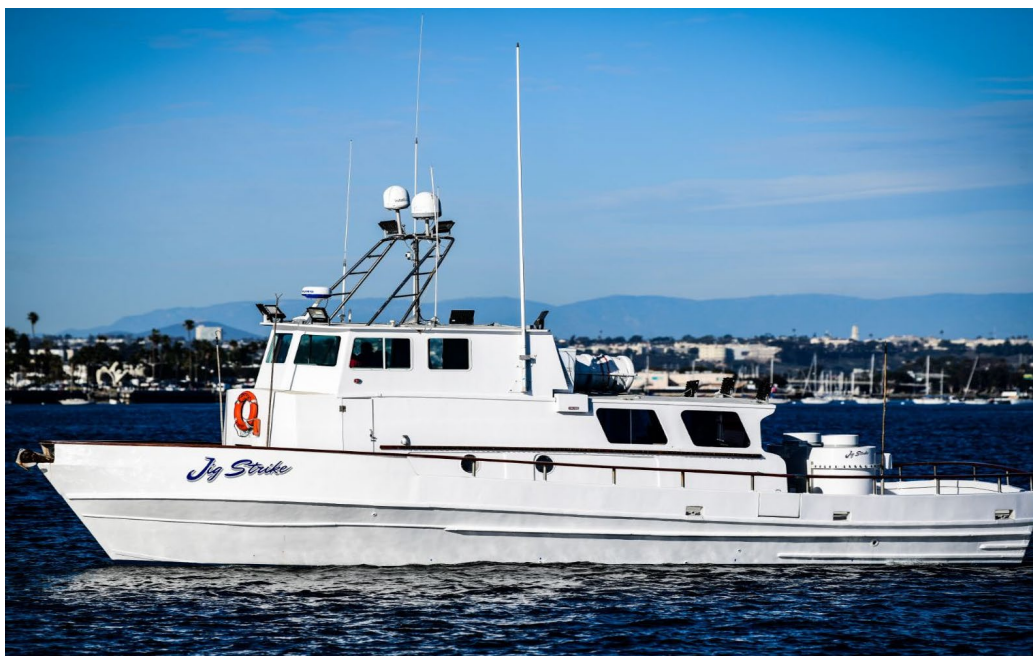
**Figure 1.** *Jig Strike* underway at unknown date. (Source: Jig Strike Sportfishing, facebook.com)

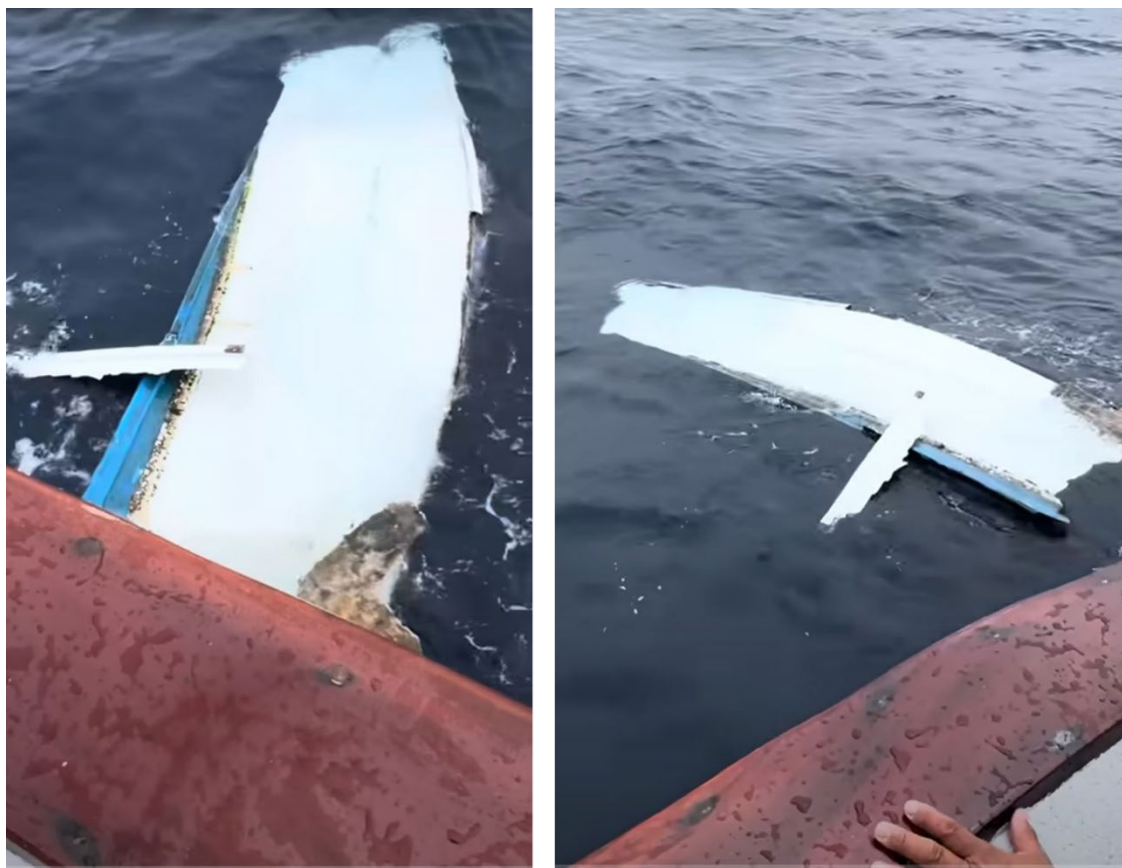
At the same time, one of the deckhands (deckhand 1) and the second captain were standing on the port side, aft of the house, when they saw “a piece of the boat floating down the port side right next to the boat” (see figure 3). Neither crewmember reported hearing or feeling anything related to the piece (section) of the hull separating.

**Figure 3.** Large section of hull seen floating as viewed from good Samaritan vessel, *Legend*, near location of *Jig Strike*. (Source: Joshynews, facebook.com)

Partially submerged hazards such as logs and even shipping containers have been identified in the Pacific Ocean off the coast of California. However, according to the captain and other crewmembers, there was no indication that the vessel struck an object as it transited on the morning of the casualty. The vessel was in good water and did not ground. Therefore, it is likely that the exterior fiberglass sheathing for the vessel's hull failed, thus allowing water to penetrate beneath the fiberglass layer. A small delamination of a section of the fiberglass sheathing facing forward could rapidly expand as the vessel moved through the water (seas and swells) as it transited, ultimately causing a larger section of the hull to separate, including portions of the plywood, as seen by the second captain and deckhand 1.

The National Transportation Safety Board determines that the probable cause of the flooding and sinking of the charter fishing vessel *Jig Strike* was likely an initial delamination of fiberglass hull sheathing that resulted in a large section of the plywood and fiberglass hull separating while the vessel was underway.

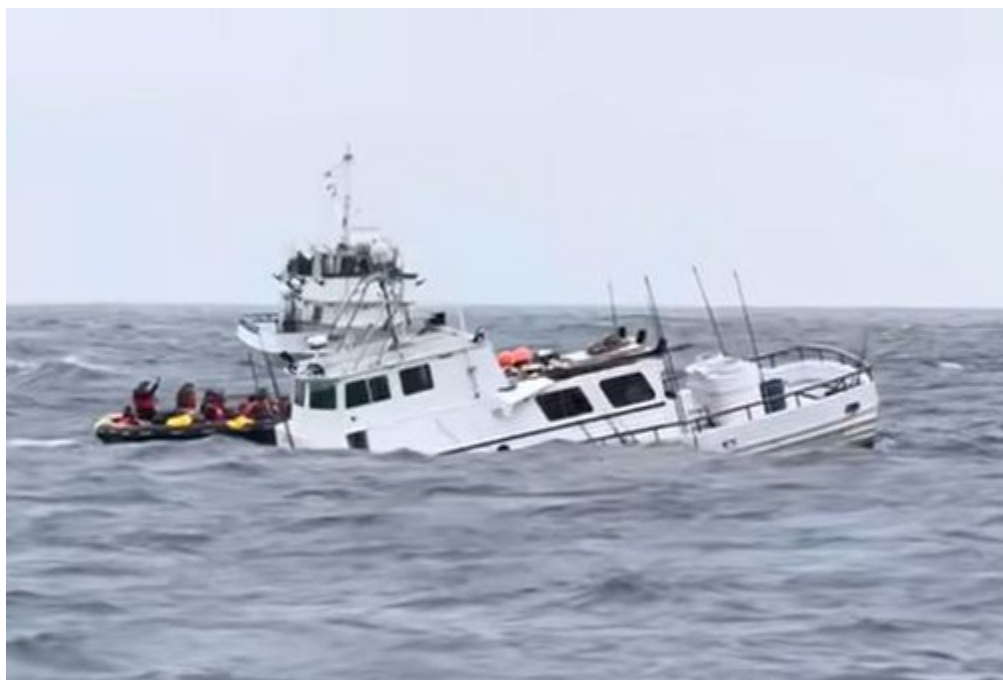
The crew handed out lifejackets and directed all passengers to move to the stern of the vessel. The second captain and deckhand 1 went to the top of the house to deploy the liferaft. After they got the liferaft into the water, they pulled the painter to deploy it. The liferaft initially deployed upside down, but they were able to turn it over. The captain estimated that within about 5 minutes, all persons on board had evacuated directly into the liferaft (see figure 4).

**Figure 4.** Crew and passengers evacuated into liferaft as the *Jig Strike* sinks. (Source: Joshynews, facebook.com)
