August 27, 2026

MIR-26-29

# Engine Room Fire aboard Chemical Tanker *Scot Stuttgart*

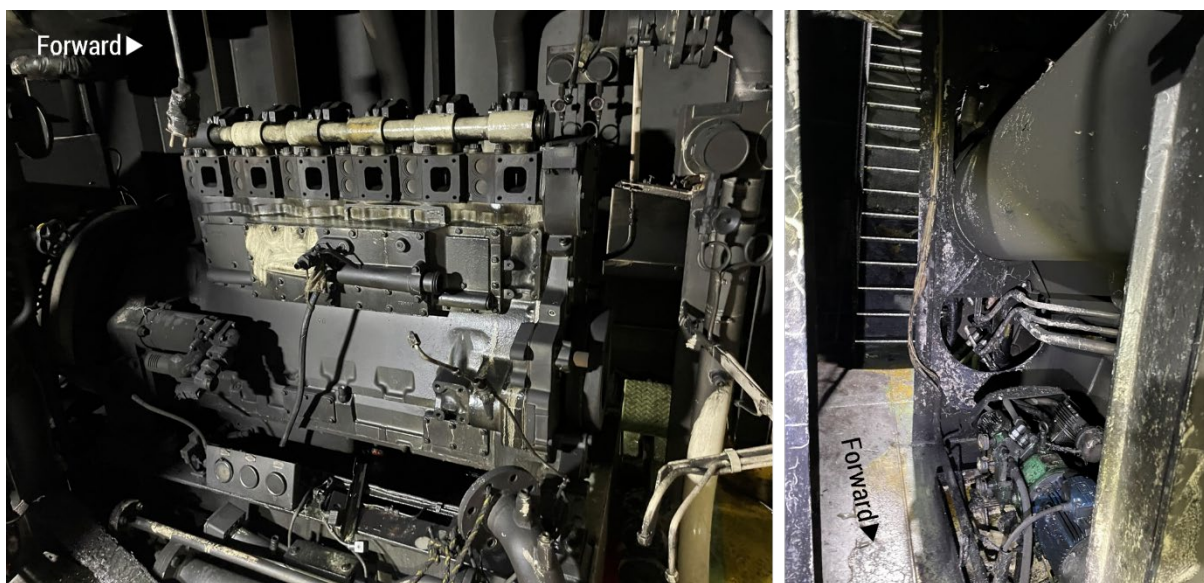
The damage was particularly extensive around the port auxiliary diesel generator and the areas directly aft and below the auxiliary generator containment skid on the main deck (see figure 4).<sup>3</sup> On the second deck, the area below the containment skid contained the start air compressor, start air compressor control panel, and exhaust gas economizer with thermal oil piping—used for liquid cargo heating—which was in operation at the time of the fire. The economizer's thermal oil circulated at temperatures about 356–392°F. Outside these areas, the port main switchboard, several electrical cabinets, electrical cabling, piping, smoke and flame detectors, surrounding lighting, and framework were also damaged by the smoke and heat from the fire.

**Figure 4.** Left to right: Inboard side of port auxiliary diesel generator skid and second deck area below generator, showing the port main engine start air compressor.

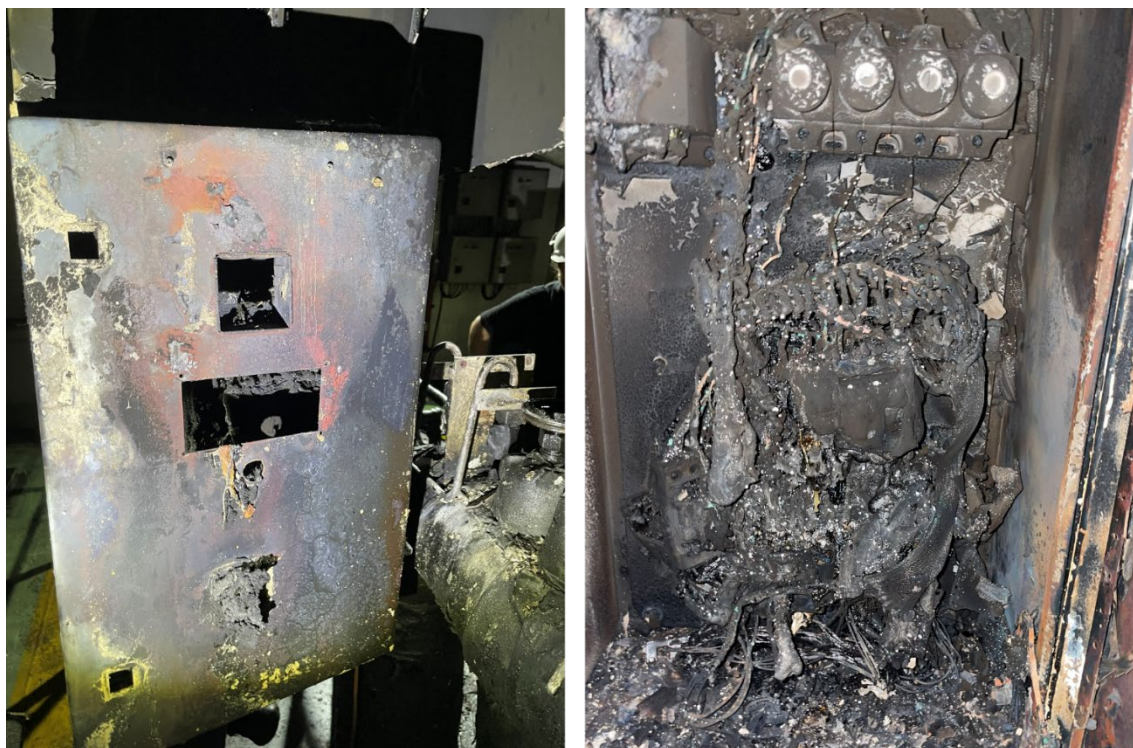
On the second deck, investigators found extensive fire damage to the electrical control cabinet for the port main engine start air compressor and surrounding wiring and piping. The exterior of the steel electrical cabinet exhibited extensive thermal damage, and some of the internal metal and plastic electrical components had melted (see figure 5). The associated feeder breaker for the port start air compressor control panel—located in the emergency generator room—was found in the tripped position. (The panel was electrically fed by the 400-volt emergency switchboard, which remained powered during the casualty.)

**Figure 5.** Left to right: Exterior and interior of port main engine start air control panel after the fire.

compressor control panel, which had been contaminated by diesel fuel. The control panel was receiving power from the emergency switchboard. After the fire, the associated circuit breaker for the control panel was found in the tripped position. The switchboard and control panel would have remained powered until the associated breaker tripped. Circuit breakers can trip due to overloaded circuits, ground faults, or short circuits. Molten metal and melted plastic were found inside the start air compressor control panel. If the diesel fuel oil had dripped onto the control panel, it could have seeped onto wires or high-resistance connections in the panel. These wires or high-resistance connections can create electrical shorts and electrical arcs that can ignite fuel vapor.

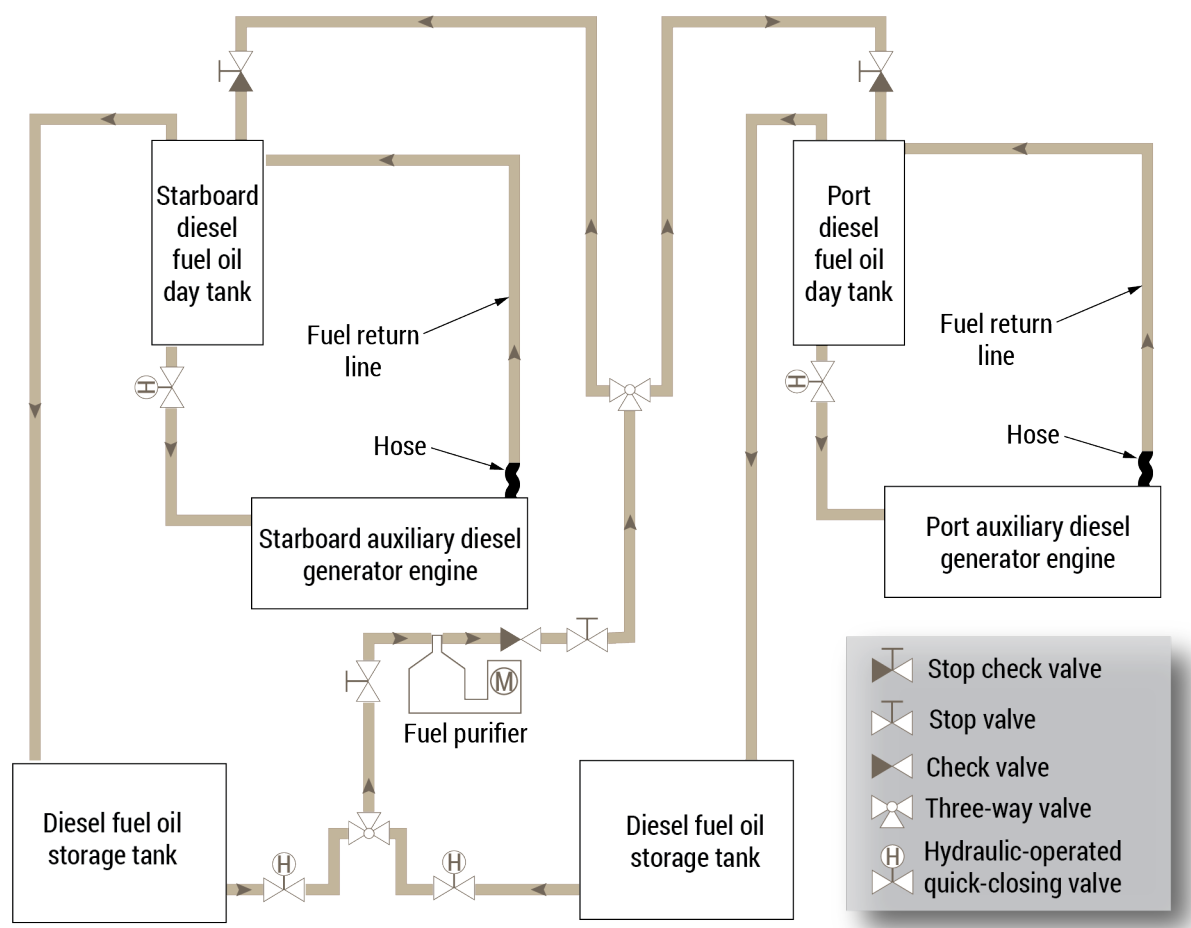
When operating on diesel fuel oil, the vessel's port main engine and port auxiliary generator engine would take suction from the port day tank. In order to maintain a sufficient fuel level in the day tanks, the vessel's diesel oil purifier took suction from one of the diesel fuel storage tanks at a rate of about 320 liters per hour (about 85 gallons per hour) and discharged to fill either the port or starboard day tank. Once the day tank was filled via the purifier, the excess fuel exited the top of the tank through "overflow" piping and flowed back to its respective storage tank.

The port auxiliary diesel generator had an attached fuel pump, which took suction from the port day tank and provided the necessary fuel pressure for the generator engine to operate. The diesel generator engine was designed with fuel return piping via a flexible hose connection, which provided a path back into the top of the diesel fuel oil day tank for unburned, excess fuel that had not been consumed by the generator engine (see figure 6). The port auxiliary diesel generator containment skid, located below the engine on the deck, surrounded the equipment to contain any spilled fluids.

**Figure 6.** Simplified diesel oil piping drawing showing flow of diesel oil through port and starboard auxiliary diesel engines. (Main engines and tank vents not shown.)

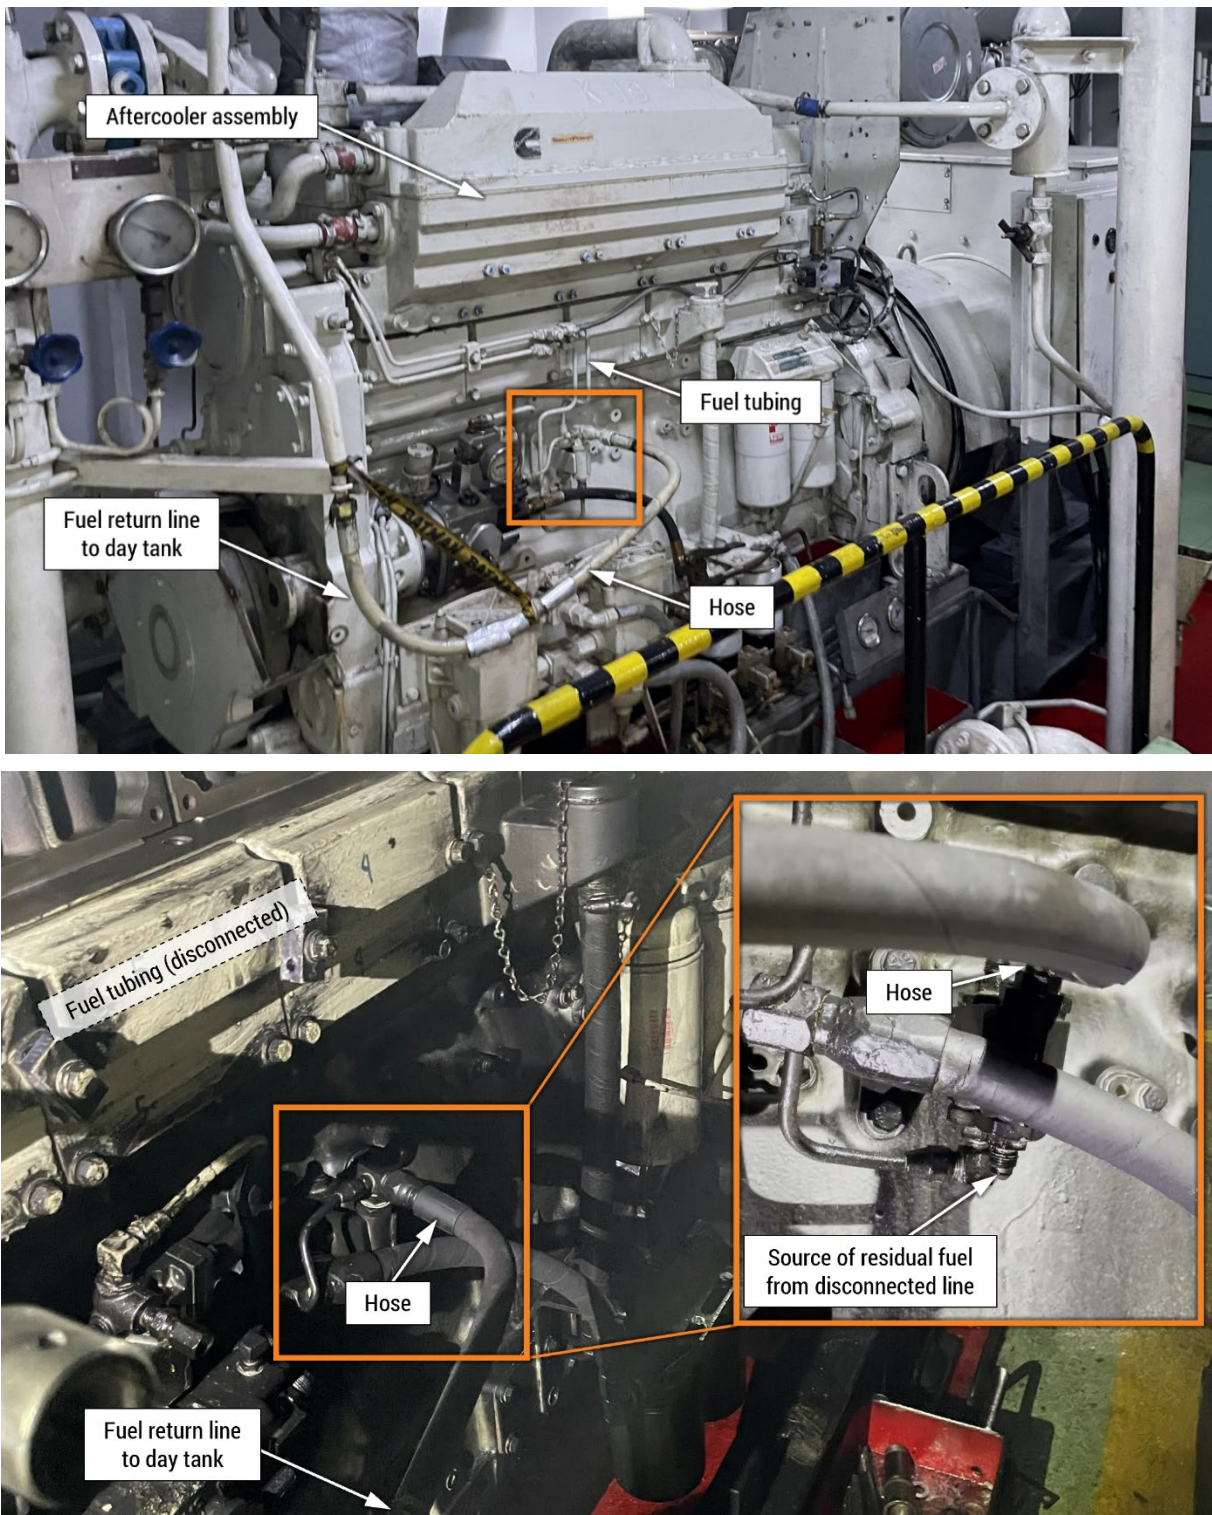
While examining the vessel damage after the fire, investigators found the port auxiliary diesel engine exhaust manifold and turbocharger had been removed from the inboard side. On the outboard side of the engine, a portion of the diesel oil supply line was found disconnected with its associated isolation valve closed. Steel tubing that was part of the diesel fuel oil return line and injector pressure line had been removed. Residual diesel fuel oil was found dripping from an open port where the return tubing had been disconnected for maintenance (see figure 7). The engine's aftercooler assembly was also removed.

**Figure 7.** Auxiliary diesel generators showing fuel return line to day tank and associated tubing connecting it to the engines. *From top:* Starboard auxiliary diesel generator (undamaged), and port auxiliary diesel generator (damaged) after the fire. (See figure 6 for details on the fuel system and its components.)

Diesel fuel oil was found on the main deck of the port engine room, and the fuel return line tubing was found disconnected with residual diesel fuel dripping from the disconnected line. Before the fire, crewmembers had tagged out the port auxiliary diesel generator for routine maintenance of the engine's aftercooler and turbo charger. When conducting this maintenance, crewmembers removed fuel return tubing from the engine. In accordance with the company's safety management system, a lock-out/tag-out permit had been completed before the maintenance. However, the fuel return line from the auxiliary diesel generator to the port diesel fuel oil day tank was not isolated because the fuel return line did not have a check valve at its inlet near the top of the day tank, nor was the disconnected tubing isolated or capped to prevent fuel from leaking or spilling.

After the fire, the operating company identified an inconsistency in the fuel return piping system on a vessel built similarly to the *Scot Stuttgart*. Like the *Scot Stuttgart*, the fuel return piping from the port and starboard auxiliary diesel generators on the similarly built vessel did not have a check valve installed in the piping at the top of the day tanks. Other vessels in the fleet with similar diesel oil systems had check valves. The operating company installed check valves at these locations on the *Scot Stuttgart* and the other similarly built vessel identified without a check valve.

The operating company also updated the lock-out/tag-out procedures to "include precautions related to fuel line isolation and residual pressure hazards." Additionally, the company distributed a technical bulletin and schematic guide among the fleet describing the fuel oil return line risks and the variations between similar vessels. Finally, the company installed thermal imaging cameras to enhance the vessel's firefighting capability.

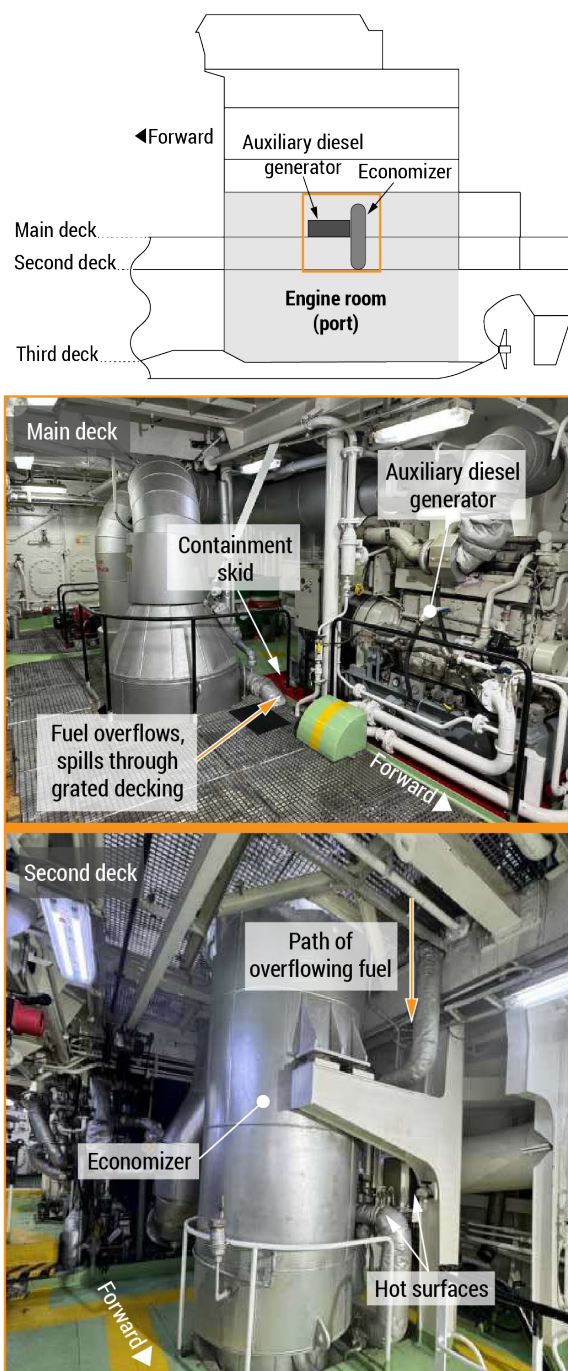
Before the fire, the fuel oil purifier was operating, transferring fuel at about 85 gallons per hour from one of the diesel fuel oil storage tanks and filling the port diesel fuel oil day tank. Therefore, as the level of fuel reached the top of the diesel fuel oil day tank, the oil would have backflowed through the fuel oil return line, out of the fuel port, and into the port auxiliary diesel generator containment skid. Once diesel fuel filled the containment skid, it would have spilled onto the main deck of the port engine room, down through the main deck's grated decking to the second deck of port engine room, where the exhaust gas economizer, comprised of thermal oil lines used for heating cargo tanks, and the 400-volt control panel for the start air compressor were located (see figure 8).

A postcasualty investigation report produced by the local fire marshal indicated the fire was caused by an electrical arc produced by the start air

**Figure 8.** Path of fuel from auxiliary generator on main deck to economizer and air start compressor control panel on second deck. (Background source: Scot Stuttgart SA)
