September 18, 2026

MIR-26-30

## Grounding of Fishing Vessel *Mystery*

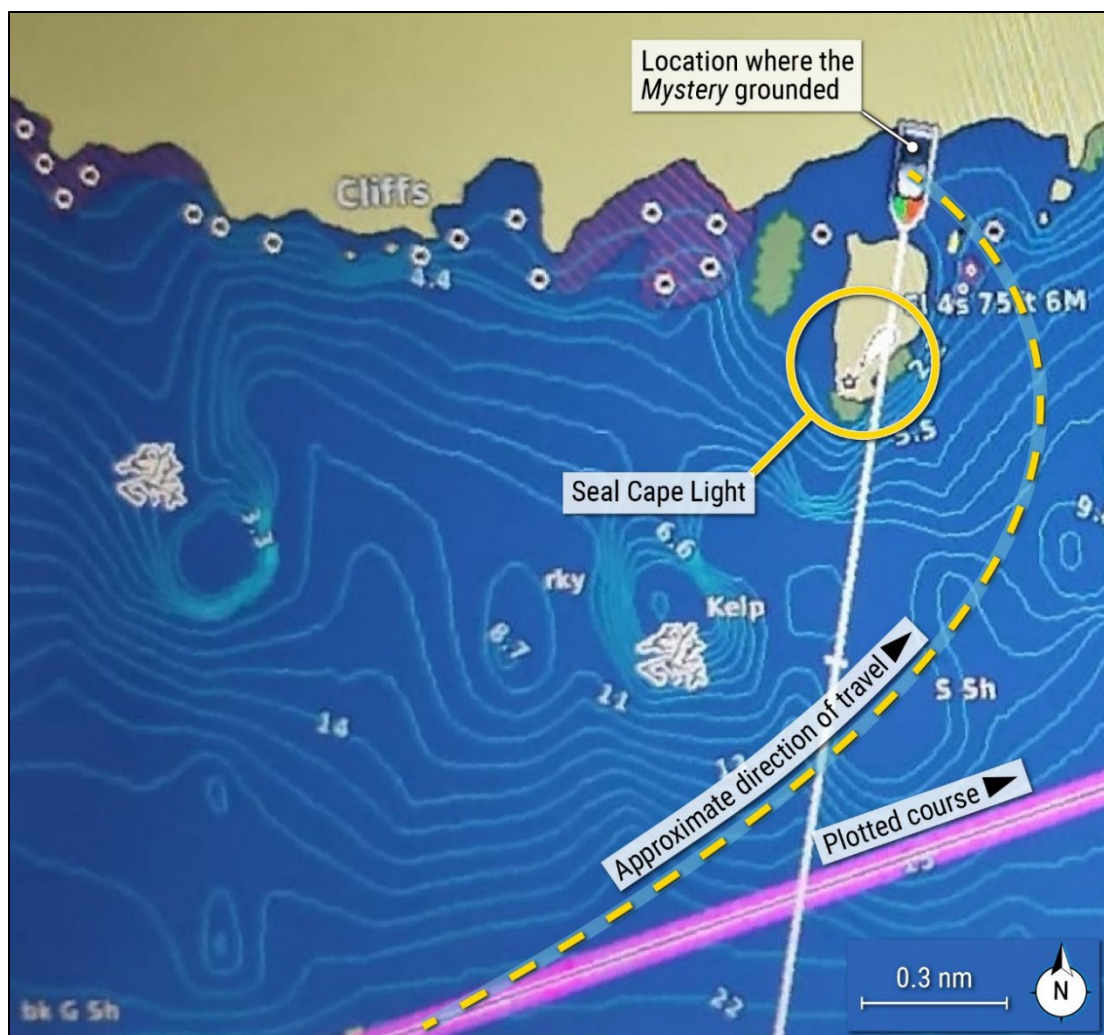
Before going to the engine room, the captain had noted the chart plotter screen was frozen and showed the time when the *Mystery* was abeam Seal Cape Light, about 15 to 20 minutes before the vessel initially grounded.<sup>5</sup> Deckhand 1 reported that he had not noticed the plotter screen being frozen during his watch. The plotted course would have taken the vessel about 0.8 miles south of the light. (Figure 3 shows the chart plotter after it had been reset, including the location where the vessel grounded and the approximate direction of travel.)

**Figure 3.** The *Mystery*'s chart plotter, taken after the unit was reset, showing the plotted course (magenta line, lower right) and the location where the vessel grounded. Annotations indicate the former location of the Seal Cape Light and the vessel's approximate direction of travel (dashed line). (Background source: *Mystery* captain)

The captain reported that the *Mystery*'s chart plotter had frozen on previous occasions. He reported that when the chart plotter froze, the autopilot would slowly turn the vessel to port, as he believed it had on the evening of the grounding. The captain noted that he had never experienced issues with the autopilot. He stated that the freezing issue could be corrected by rebooting the chart plotter. Due to similar freezing issues on previously installed chart plotters from the same manufacturer, the captain had replaced the plotter unit twice since the vessel's construction, most recently in 2018 or 2019.

On the day of the casualty, the *Mystery*'s captain navigated by entering waypoints into the chart plotter, with the autopilot steering the vessel to the waypoints on each leg of the voyage. Deckhand 1 (and later, deckhand 2) continued to use the waypoints entered by the captain and the autopilot steering system when they took the watch after the captain that evening. After the *Mystery* grounded, the captain noted that the chart plotter screen had frozen about 15 to 20 minutes earlier and remained in that state. The autopilot, which the captain stated had never had issues, likely functioned properly. However, the captain stated that the chart plotter, which the autopilot relied on for a heading to steer, would occasionally freeze, after which the autopilot would slowly turn the vessel to port. Therefore, on the night of the grounding, the chart plotter froze, and, consequently, the autopilot steered the vessel to port.

Deckhand 2's solo watch began about 30 minutes before the grounding. Based on the captain's photo of the chart plotter, which showed the system had frozen about 15 to 20 minutes before the grounding, the chart plotter malfunctioned during deckhand 2's watch. However, deckhand 2 was unaware of the frozen screen, indicating he was not actively monitoring the vessel's transit on the chart plotter. Therefore, deckhand 2 was not maintaining a proper navigation watch. (The Seal Cape Light, which should have been abeam the *Mystery*, was destroyed and extinguished at an unknown date between a November 2023 Coast Guard survey and the date of the grounding. Had the light been present, it may have visually alerted the deckhand of the *Mystery*'s proximity to shore as the vessel turned toward land.)

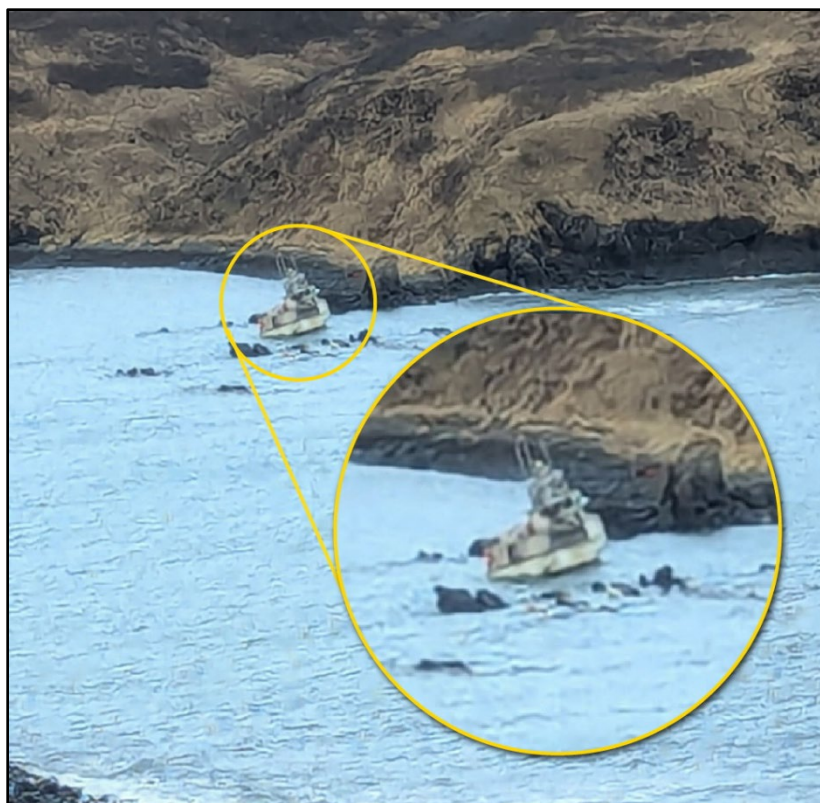
The captain told investigators that when the tide receded and while the crew was waiting for rescue, the crew saw at least three 1-foot diameter holes in the hull in the engine room and the adjacent passageway. The captain also thought the struts supporting the propeller shafts had been forced up through the hull. The *Mystery* was deemed a total loss and was abandoned at the grounding site (see figure 4).

**Figure 4.** The *Mystery* (circled) aground as seen from the former location of the Seal Cape Light on January 16, 2025. (Background source: Coast Guard)
