MIR-26-31

## Breakaway of Barge *MPC 1056* and Subsequent Contact with Marina Docks

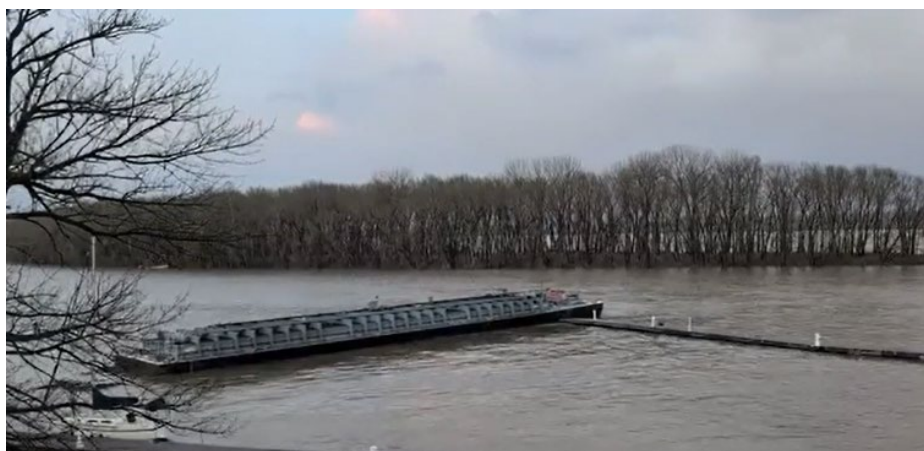
On March 19, 2025, about 1900 local time, the petroleum barge, *MPC 1056*, loaded with ethanol, broke free from an Evansville Marine Service fleeting area at mile 795.5 on the Ohio River, near Evansville, Indiana, drifted downriver, and contacted two marina docks near mile 797 (see figure 1 and figure 2).<sup>1</sup> There were no injuries, and no pollution was reported. Damage to the two docks was estimated at \$900,000. There was no reported damage to the barge.

**Figure 1.** Barge *MPC 1056* adrift in the Ohio River and contacting the Nu Plaza Yacht Club dock on the day of the casualty. (Source: John G. Dyer, facebook.com)

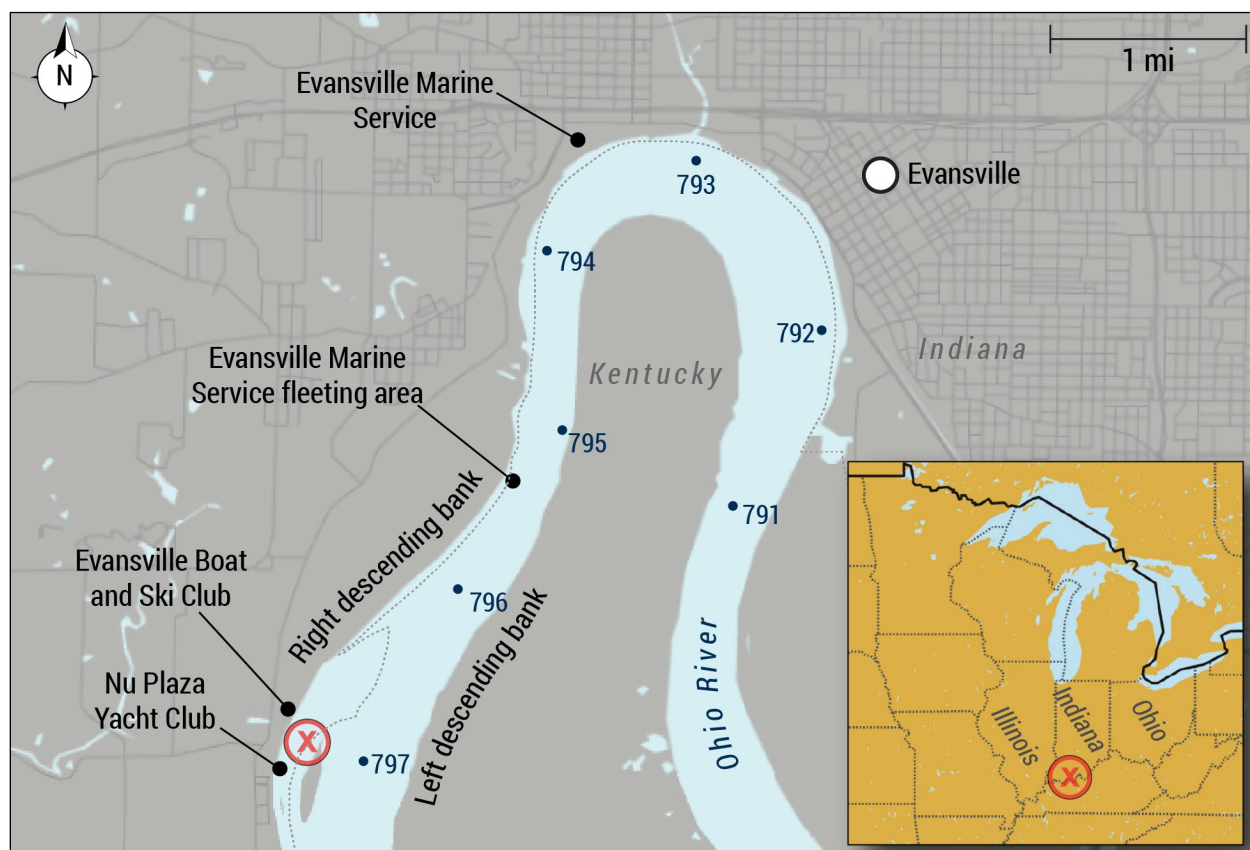
**Figure 2.** Area where the loaded petroleum barge *MPC 1056* contacted marina docks, as indicated by a circled X. (Background source: Google Maps)

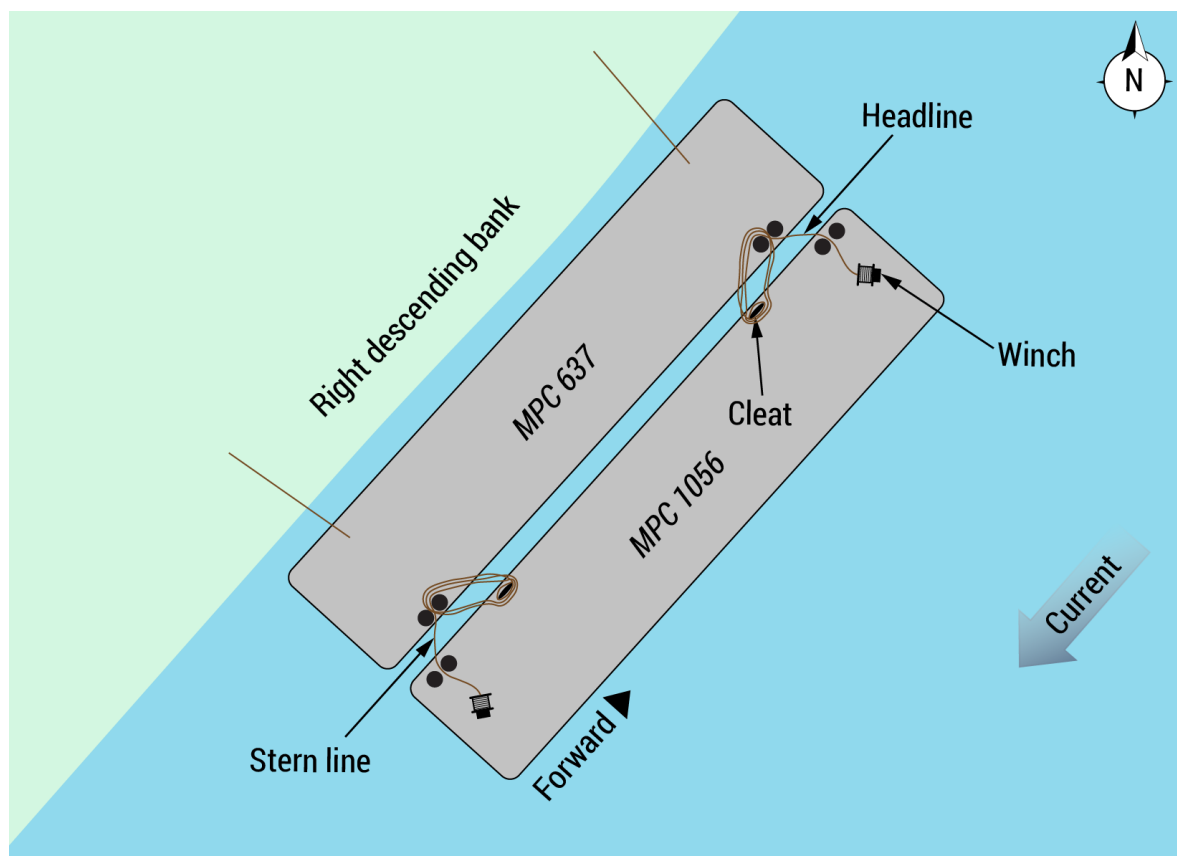
the stern (sternline).<sup>3</sup> The mooring wires were 1-inch Gorilla Super strand with a normal (tested) breaking strength of 93,651 lbs. The wires were run from winches forward and aft on the *MPC 1056* and secured to bitts on the *MPC 637* and cleats on the *MPC 1056* (see figure 3). This mooring arrangement complied with the company's procedure for securing barges in both normal and high-water conditions, and no mooring lines or extra wires were added (see section 1.3.2).

**Figure 3.** Representation of the mooring configuration of *MPC 637* and *MPC 1056* at the fleeing area.

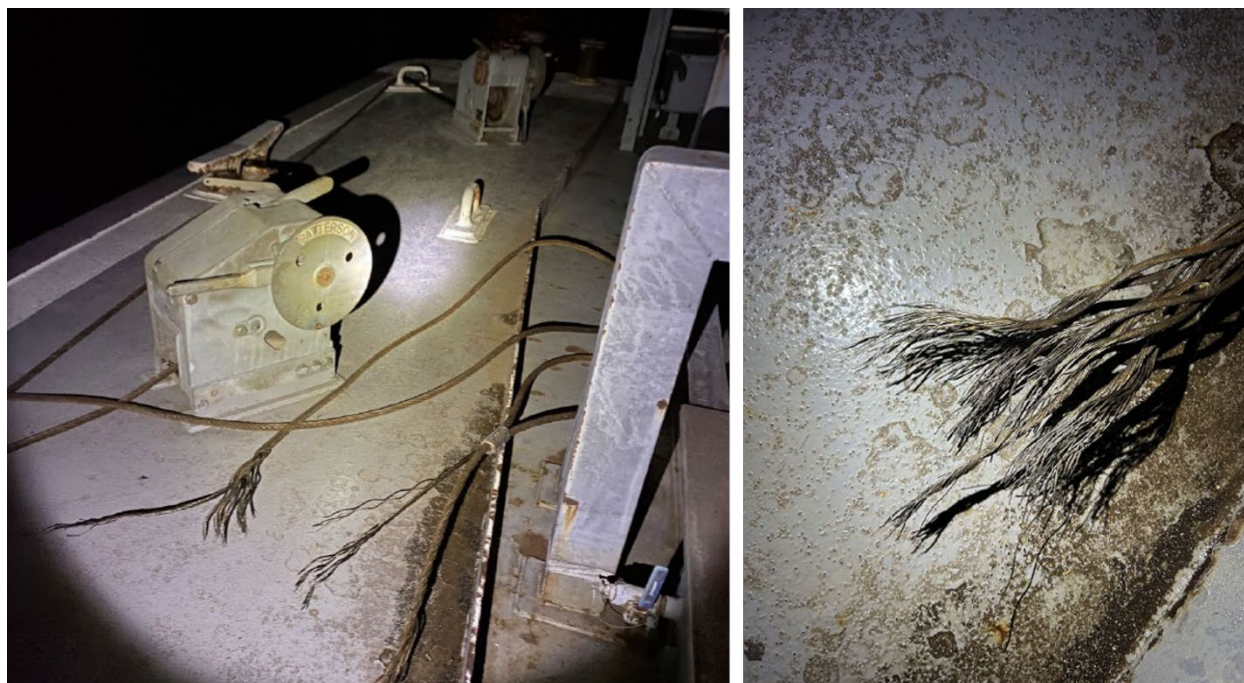
About 1930, after a private citizen called (by cell phone or VHF channel 16) the *Brantley B* to report a breakaway barge near Nu Plaza Yacht Club, the *Brantley B* responded, and the crew located the *MPC 1056*.<sup>6</sup> The crew found the headline (on the port bow) had parted, and the sternline was hanging over the side of the barge (see figure 4). At the time, the Ohio River level gage at Evansville was 28.92 feet and falling. The recorded level was in the lowest of the flood stages, the “action stage,” which begins at 24 feet.<sup>7</sup>

**Figure 4.** Left to right: Damaged port bow winch wire (headline) located forward on *MPC 1056*. (Source: Coast Guard.)

While the two barges were moored, severe weather moved through the area, including gusts exceeding 38 mph, and the nearest river gage at Evansville was at 28.9 feet (within action stage, the lowest of the flood stages). These factors would have created severe strain on the mooring lines connecting the *MPC 1056* to the *MPC 637*. The loaded barge sat deep in the water at its full draft of 10 feet. This exposed the underwater surface area of the hull at the head of the barge to the force of the river current. Additionally, the area of the river where the barges were moored was narrow compared to the bend upriver, which likely resulted in an increase in water velocity near the fleeting area. It is likely that these two environmental factors (wind and current) acting on the barge placed a strain on the headline that exceeded the wire's breaking strength, causing it to part. As a result, the *MPC 1056* was no longer flush with the *MPC 637*, allowing the *MPC 1056* to pivot downriver, connected to *MPC 637* by only the stern wire.

As the *MPC 1056* pivoted downriver, the direction of the stern wire's holding force connected to the bitts on the *MPC 637* changed. After the casualty, the sternline was found undamaged, hanging from the side of the *MPC 1056*. Therefore, the sternline likely slipped from its moorings after the headline parted. With no other lines securing the *MPC 1056* to the *MPC 637*, the barge drifted downriver about 1.5 miles and into the marina docks.

The National Transportation Safety Board determines that the probable cause of the breakaway of barge *MPC 1056* and its subsequent contact with downriver marina docks was severe weather and strong current acting on the moored barge, which exceeded the holding capacity of its mooring arrangement.

Severe weather at barge fleeting areas can include strong winds, wave chop, and high currents associated with higher river levels at flood stages, increasing the likelihood of mooring failures. Single-point mooring failures can ultimately result in vessels breaking away and causing damage to other downstream vessels and infrastructure. Operators should identify failure modes of mooring arrangements and implement controls, such as more frequent inspections and additional lines.
