Marine Investigation Report MIR-26-32

# Collision Between National Oceanic and Atmospheric Administration Uncrewed Surface Vessel and Prestige 450 Flybridge Recreational Vessel

Lake Erie

August 10, 2024

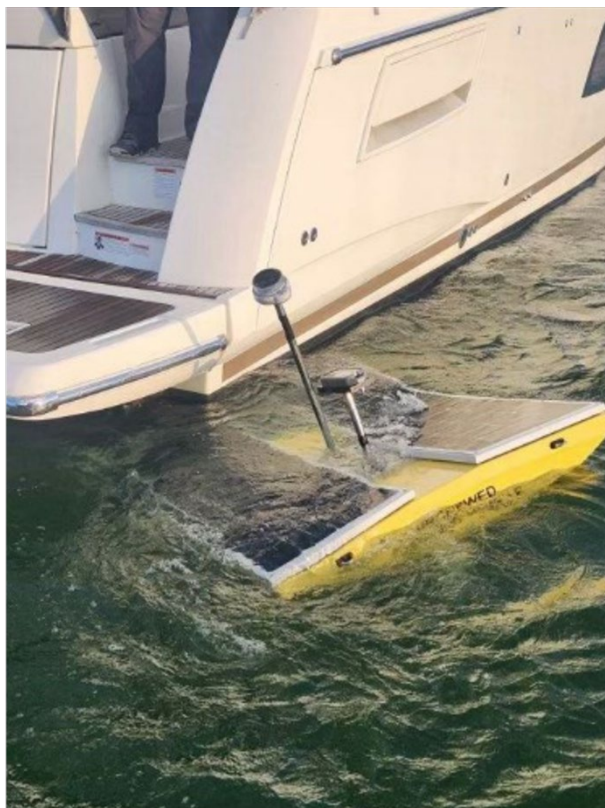
**Figure 4.** Prestige 450 Flybridge and GLERL USV conjoined after the collision. (Source: NOAA)

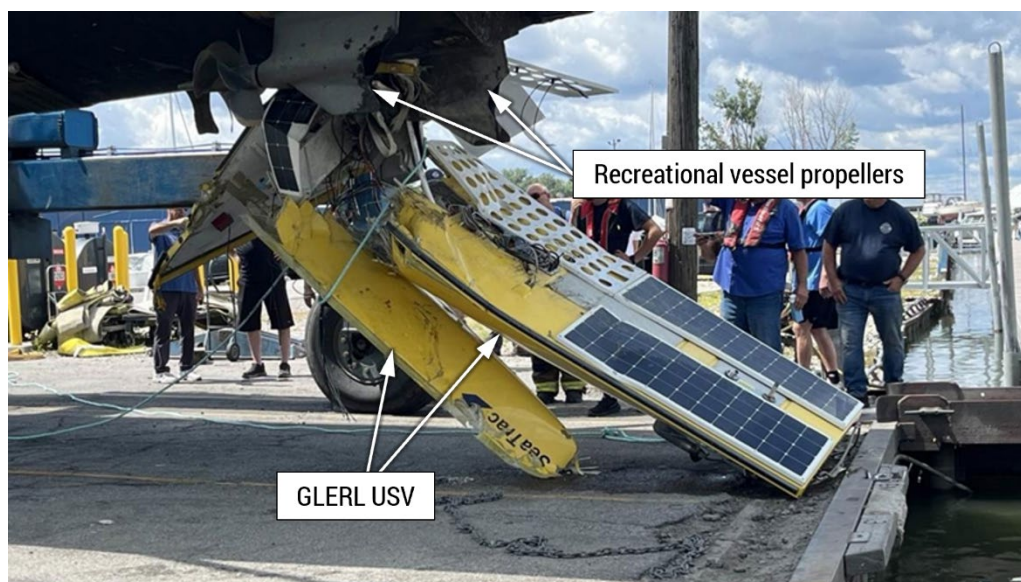
On August 12, GLERL staff and the Prestige 450 Flybridge operator were joined by members of the LaSalle Michigan Fire Department, the Monroe County Sheriff, Safe Harbor Toledo Beach staff, US Customs and Border Protection, and two vessel towing services to separate the USV and recreational vessel (see figure 5). About 1030, separation of the conjoined vessels began. The scientific payload on board the USV was recovered and returned to the GLERL laboratory. All remaining pieces of the USV were recovered by 1600.

**Figure 5.** Recreational vessel and GLERL USV hauled out of the water, with the USV split into two large pieces and fouled in the recreational vessel's starboard pod. (Source: Monroe County Sheriff)

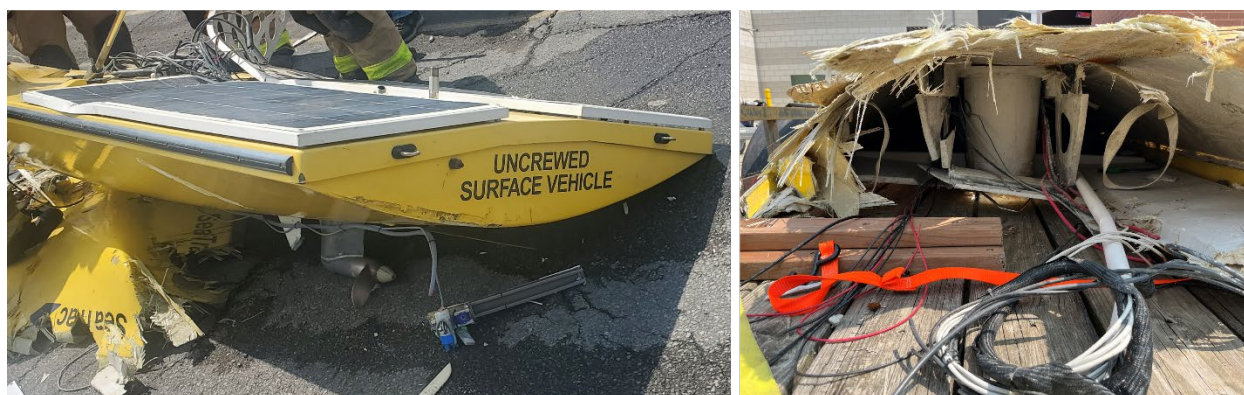
As a result of the collision, the USV's fiberglass hull was split into two pieces (the forward and aft hull sections remained), and the wiring for the vessel's systems was compromised (see figure 6). The ESP on board was not damaged. The USV was declared a constructive total loss valued at an estimated \$186,000.

**Figure 6.** Left to right: GLERL USV after the collision, showing about half of the vessel with its broken fiberglass hull and remaining solar panels intact, and the internal structure of the USV, showing the structural area for scientific equipment and vessel system electrical infrastructure.

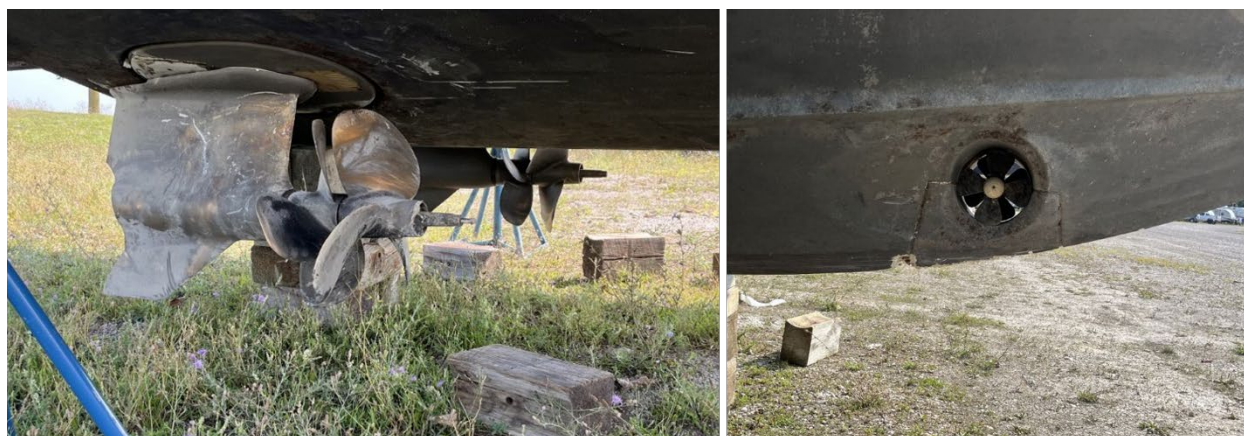
The Prestige 450 Flybridge suffered structural damage to both of its propeller pods and fiberglass hull (see figure 7). The starboard pod had to be rebuilt; the port

pod required repairs. The damages were estimated to cost about \$100,000, including salvage and insurance costs.

**Figure 7.** Left to right: Recreational vessel propeller pod damage viewed from the starboard side after the collision, and bow thruster with visible damage to the keel.

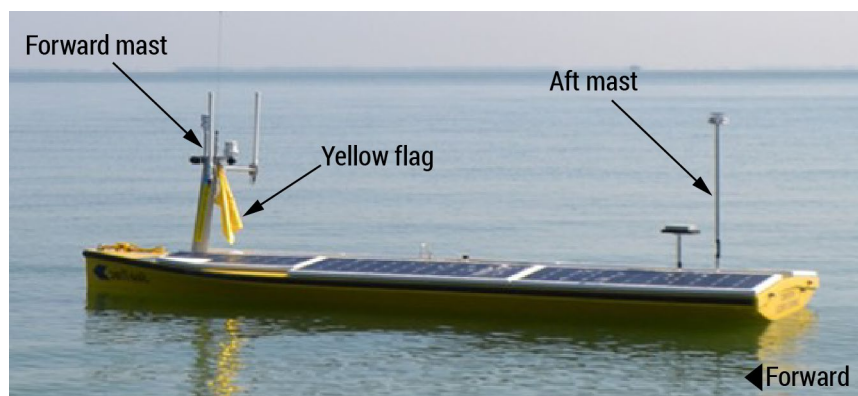
A second mast, which housed an all-around white light, was installed aft on the vessel (see figure 10). This light was added by the GLERL lead engineer to aid surrounding craft operators in spotting the vessel and for lighting redundancy. The GLERL lead engineer estimated this second mast extended about 3 feet above the deck.

**Figure 10.** Profile view of USV showing forward and aft masts. (Background source: NOAA)

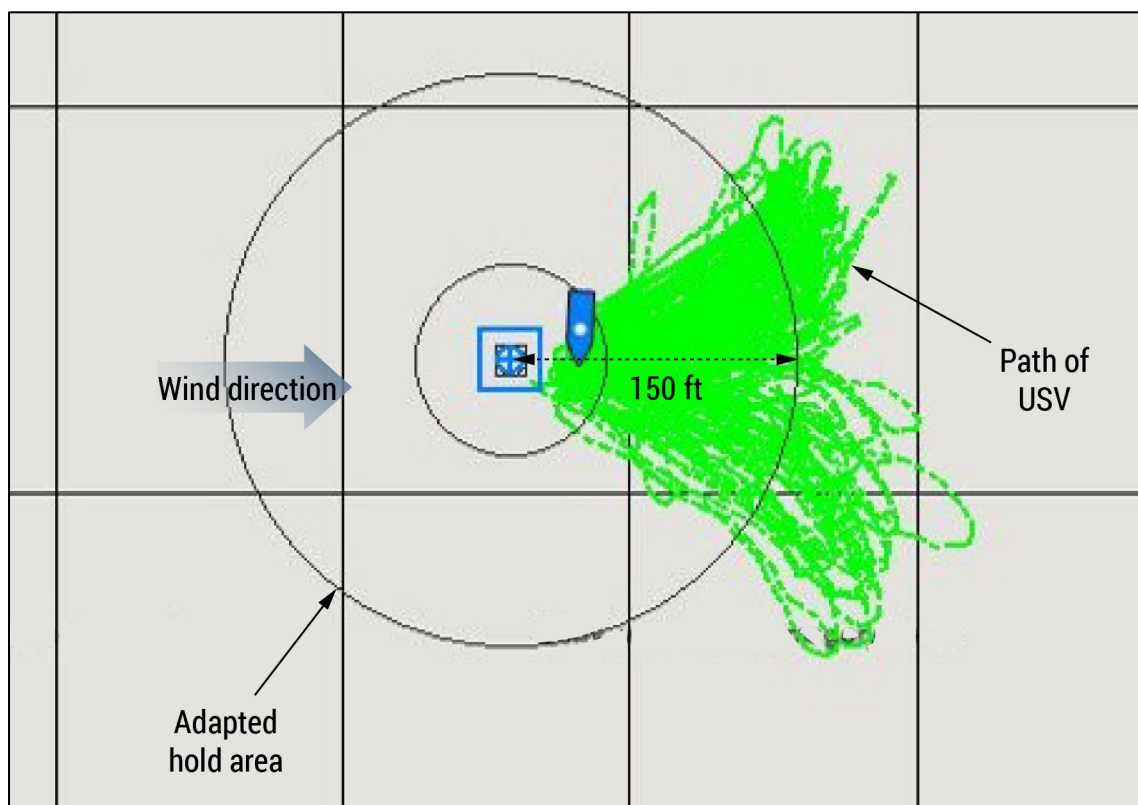
**Figure 12.** USV dashboard showing the vessel in adapted hold mode on the day of the casualty, including the center point, inner circle, and outer circle set by the pilot. The green marks indicate the vessel's past position. (Background source: GLERL)

At the time of the collision, the USV was in adapted hold mode, and the vessel's cameras were off. For each "hold" waypoint, the radius of the hold position outer circle was 150 feet, and the speed setpoint was 3 knots, as it had been for the mission all week. The lead engineer, who was piloting the USV at the time, stated, "Typically, it was really only going somewhere around 2 and 2.5 knots."

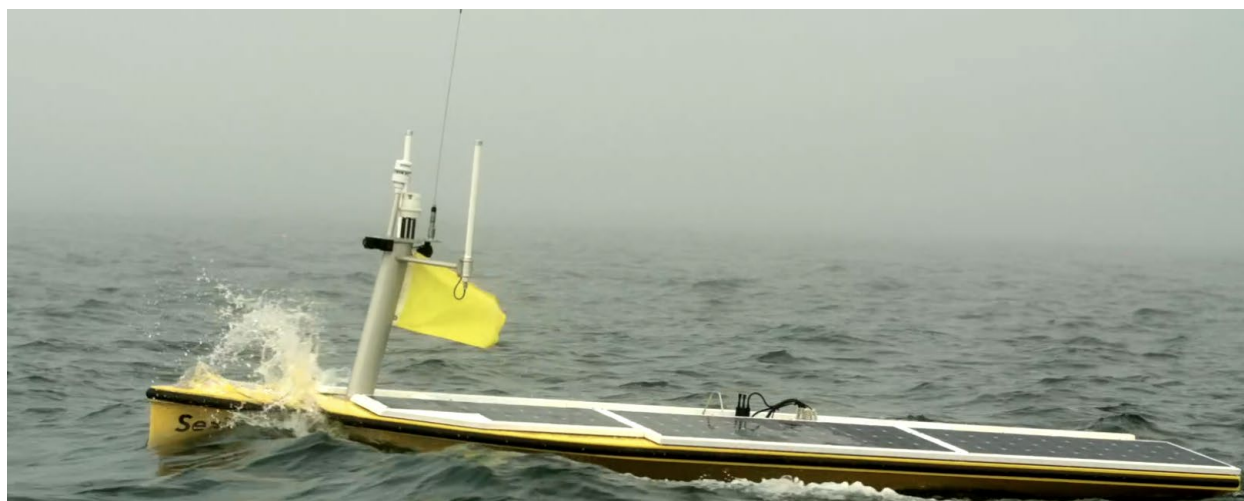
With an overall length of 15.7 feet, the USV had a similar length to a small-sized recreational vessel such as a kayak, canoe, rowboat, or powered skiff. The USV had a yellow hull, meant to help make it more visible to other vessel operators. However, due to the vessel's design, only about 1 foot of freeboard was visible. Additionally, most of the main deck was covered with solar paneling, which was dark in color, thus obscuring the vessel's yellow coloring and making it blend in with the surrounding water. At the time of the collision, waves were 3 feet, which would have intermittently obscured the USV's hull as it dropped through the troughs of the waves and made it difficult to discern the USV in the water (figure 15 shows the vessel underway in similar wave conditions). Further, most of the USV's hull appeared dark yellow when viewed from the side, as the vessel's design cast a shadow on the hull.

**Figure 15.** Portside view of the GLERL USV while underway. (Source: SeaTrac)

Because the operator of the recreational vessel could not easily perceive the GLERL USV, he could not act appropriately to avoid the collision. The NTSB concludes that, given GLERL's operation of the SeaTrac SP-48 USV in an area offshore frequented by recreational vessels, the USV's visual, electronic, and auditory perceptibility were inadequate.

We issued five recommendations to enhance the perceptibility of USVs. We recommended SeaTrac, the manufacturer of the GLERL USV, modify the design of its model SP-48 USVs to further enhance their perceptibility as practicable given the nature of the USV's work and area of operation. We also recommended that NOAA revise its internal policies contained within its "Uncrewed Marine Systems Manual" to ensure its USVs are perceptible, and to incorporate a requirement for testing USVs to ensure each USV is adequately perceptible to operators of other vessels typically in the USV's area of operation. We further recommended that the US Coast Guard develop and promulgate a national framework of perceptibility, collision avoidance capability, and navigational safety standards for USVs and incorporate these standards into regulations.
