October 14, 2026

MIR-26-33

## Collision Between Tanker *Isla de Bioko* and *Ginny Stone* Tow

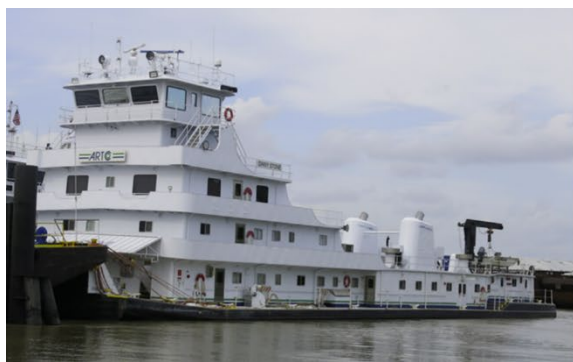
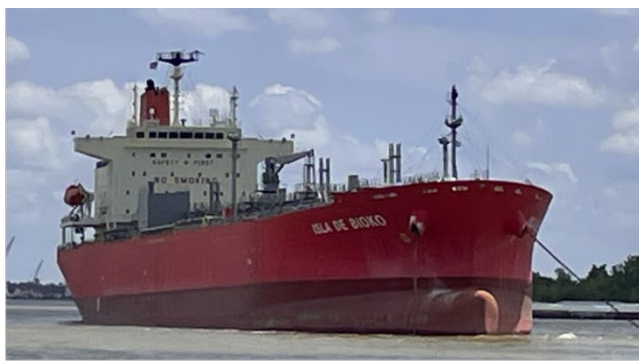
**Figure 1.** Left to right: *Ginny Stone* on April 30, 2025, and *Isla de Bioko* on April 29, 2025.

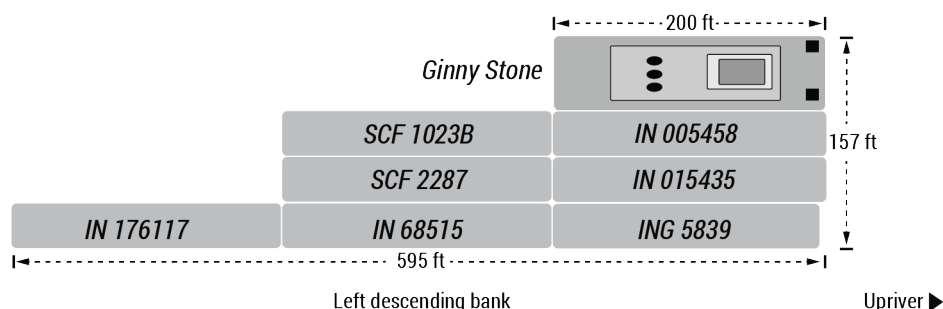
moved a seventh barge, *IN 176117*, into place, aft in the starboard string (see figure 3).

**Figure 3.** *Ginny Stone* tow arrangement at 2035 after the seventh barge was added (scale approximate).

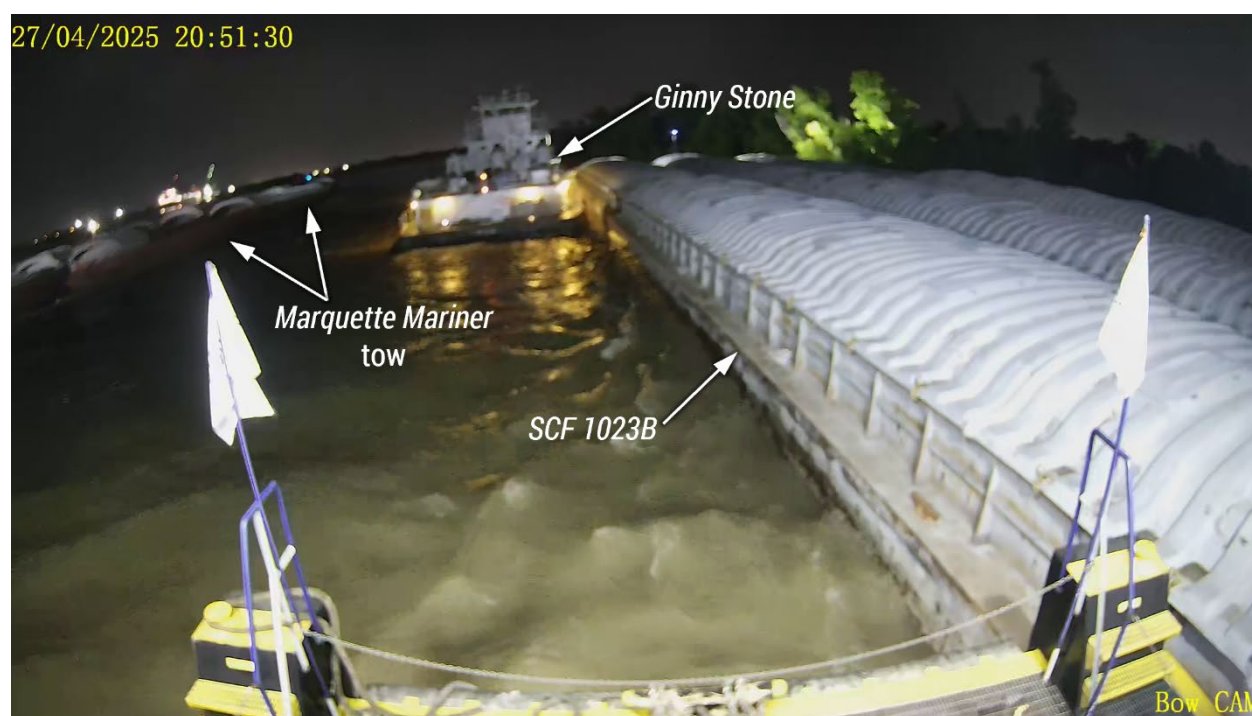
The *Capt Duffy* crew returned to the vessel from the *Ginny Stone* tow, and the *Capt Duffy* backed away and departed downriver (see figure 4). The *Ginny Stone* moved slowly from the bank as the *Marquette Mariner* continued to pass at a speed of 5.2 mph. The captain of the *Ginny Stone* increased rpms on his port engine and increased rudder to starboard to help push the tow back into the riverbank.

**Figure 4.** Screenshot from the bow CCTV of the *Capt Duffy* as it departed the *Ginny Stone* tow at 2051:30.

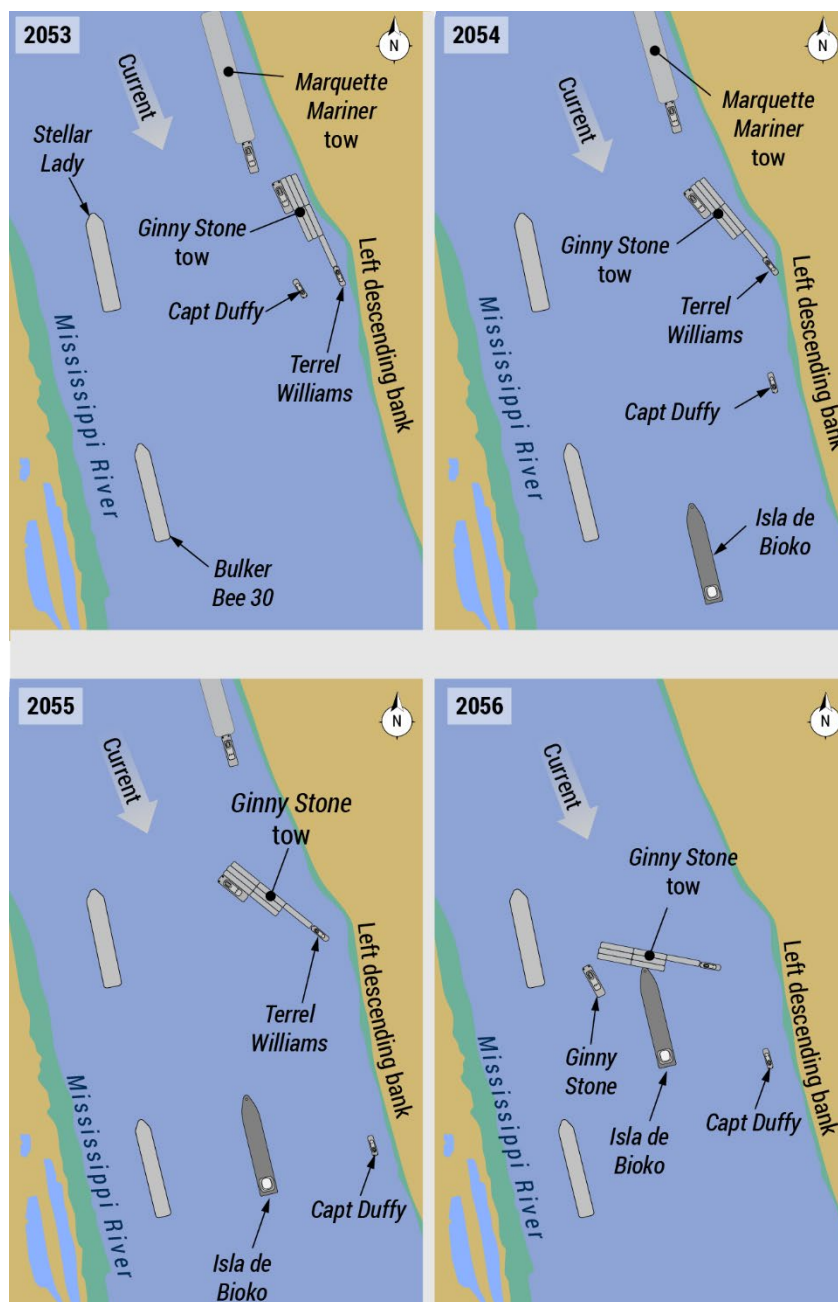
At 2056:25, the bulbous bow of the *Isla de Bioko* struck the port side of barge SCF 1023B, the second barge in the port string (see figure 5). The barge flooded and sank; the remainder of the barges broke loose and drifted downriver with the current. The *Terrel Williams* remained faced up to the aft barge in the starboard string; both drifted down the starboard side of the *Isla de Bioko*. One of the barges from the tow drifted into the Dutch-flagged bulk carrier *Bulker Bee 30*, moored near the right descending bank.

**Figure 5.** Approximate positions of *Marquette Mariner* tow, *Ginny Stone* tow, *Terrel Williams*, *Capt Duffy*, and *Isla de Bioko* from 2053 to 2056, the time of the collision. River bank shown does not reflect the high-water conditions at the time. (Background source: National Oceanic and Atmospheric Administration Electronic Navigational Chart US5MSYBB)

As the *Marquette Mariner* tow passed alongside the *Ginny Stone* tow, the velocity of water forced through the narrow gap between the tows would have increased, creating a low-pressure zone between them. This low-pressure zone caused the *Ginny Stone* tow to be pulled off the bank. As the *Marquette Mariner* tow finished passing the *Ginny Stone* tow, a low-pressure zone in the wake of the *Marquette Mariner* would have further exacerbated the movement of the *Ginny Stone* tow away from the bank.<sup>11</sup> The combined effects of these hydrodynamic forces resulted in the *Ginny Stone* moving out into the river and into the path of the northbound *Isla de Bioko*, and ultimately put the strong current on the starboard side of the *Ginny Stone*'s loaded tow.

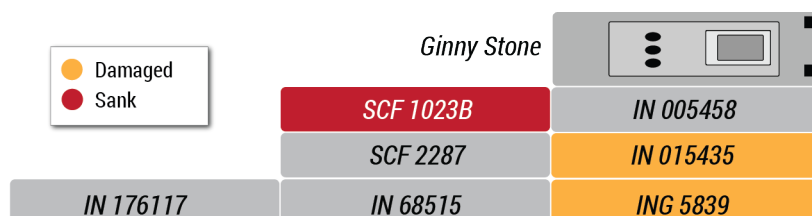
The covered hopper barge *SCF 1023B* sank with its dry cargo of about 1,635 short tons of urea and was deemed a total loss valued at \$554,587. Barges *ING 5839* and *IN 015435*, both at the forward end of the tow, sustained damages totaling \$392,172. The loss of cargo (all urea) from the barges was reported to be \$926,076. The *Ginny Stone* was not damaged. Figure 6 shows the positions of the damaged barges in the tow.

**Figure 6.** *Ginny Stone* tow arrangement, showing the location of the damaged barges in orange and the sunken barge *SCF 1023B* in red.
