Safety Recommendation Report

Improving Vessel Survivability and Passenger Emergency Egress of
DUKW Amphibious Passenger Vessels

Accident No.	DCA18MM028
Location	Table Rock Lake, near Branson, Missouri
Date	July 19, 2018
Recommendation Nos.	M-19-15 and -16
Adopted	November 6, 2019

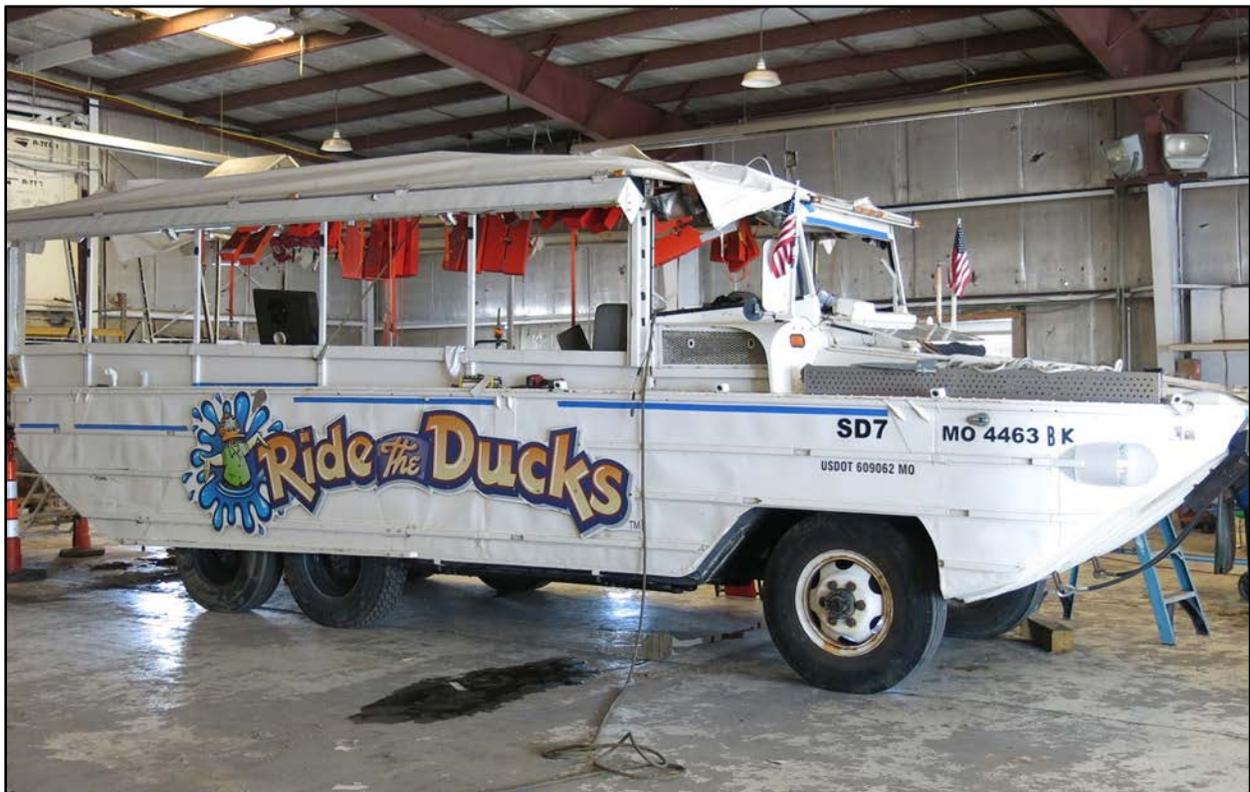
Figure 1. *Stretch Duck 7* after salvage from Table Rock Lake, July 2018.

Four days after the accident, the *Stretch Duck 7* was salvaged from a depth of 85 feet in the lake. Once the remaining water was pumped out and the vessel was refloated, investigators observed no hull breach. The canopy on the *Stretch Duck 7* was found torn along the center support beam, and the vessel's engine and electronic components were water damaged. Investigators also found that the vessel's side curtain had been released on the port side, but the curtain on the starboard side was closed.

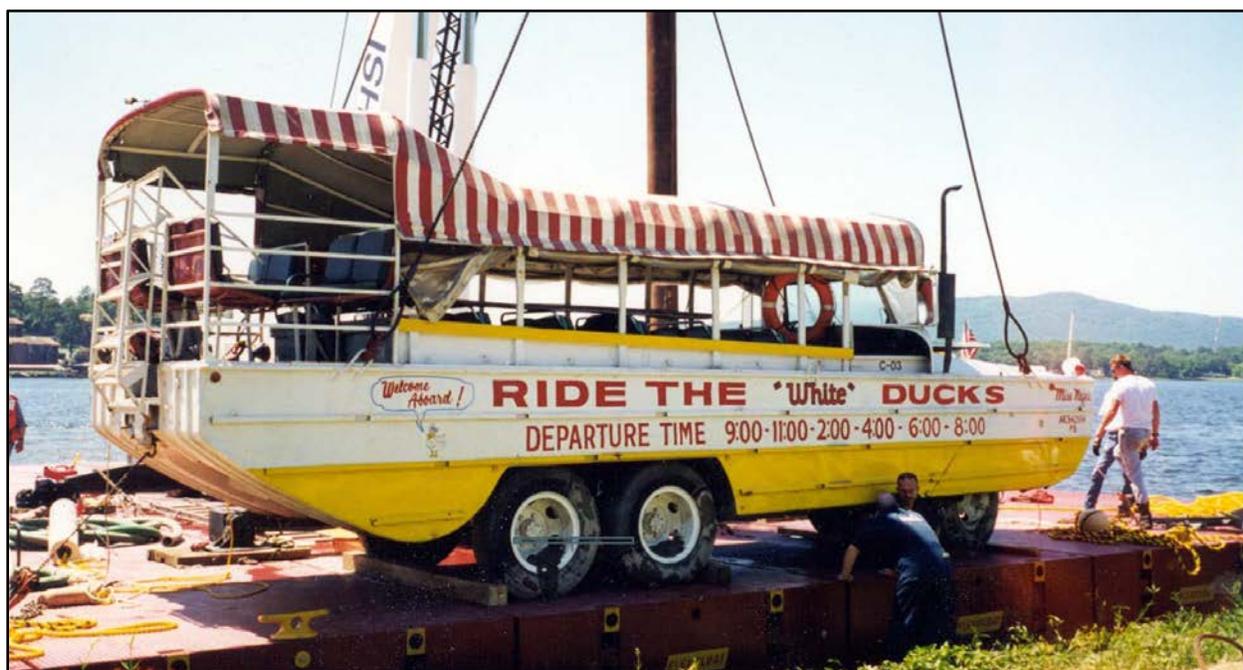
Figure 2. *Miss Majestic* post-salvage, 1999.

initially entered the *Miss Majestic* through the gap between the driveshaft and its housing via an unsecured clamp for the watertight rubber boot. Once the weight of floodwater in the aft portion of the hull reduced the freeboard at the stern to zero, water poured over the immersed transom and into the interior of the *Miss Majestic*, causing it to sink rapidly by the stern.⁵

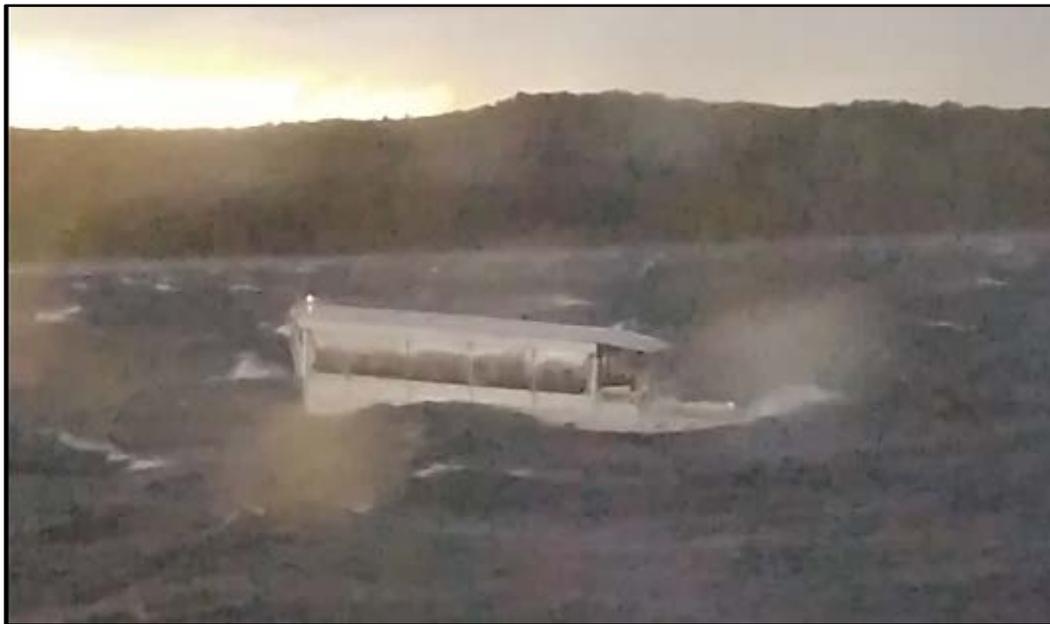
During the waterborne portion of its final voyage, the *Stretch Duck 7* was exposed to high winds and waves estimated at 3 to 5 feet. The video recorder on board captured bilge alarms sounding 4 minutes after the vessel encountered severe weather, signaling an ingress of water. About 4 minutes later, the *Stretch Duck 7* sank. Witness videos showed the vessel pitching in the storm with white-capped waves covering the bow several times (see **figure 4**). In the forward section of the vessel, the ventilation openings that supplied combustion and cooling air to and from the engine most likely permitted water to enter the engine compartment, from where it would have flowed freely throughout the rest of the hull. The additional water weight would have further lowered the vessel's freeboard and thereby subjected it to more rapid flooding.

Figure 4. *Stretch Duck 7* moments before sinking. (Source: Jennie Carr)

Surviving passengers who were interviewed after the accident recalled water quickly rising from under the floorboards of the *Stretch Duck 7*. They described how waves pushed in the starboard-side curtain and water entered from the bottom rail of the curtain where it met the gunwale. Once the water started filling the vessel, it quickly flooded and sank within seconds after covering the passengers' feet. Most passengers recalled the *Stretch Duck 7* had a starboard list in the final moments of the voyage and rapidly sank by the stern. If the *Stretch Duck 7* had been modified to include several subdivided compartments—one approach to a passive safety system—the flooding could have been contained to individual sections of the vessel, thus increasing the vessel's ability to remain afloat. The vessel could have remained afloat and upright indefinitely had it been fitted with built-in flotation or watertight compartmentalization, which can be designed and sized to provide a boat with sufficient reserve buoyancy even when the hull is fully flooded.

Require DUKW amphibious passenger vessels (commonly referred to as original and/or “stretch” DUKWs) to have sufficient reserve buoyancy through passive means, so that they remain upright and afloat with a full complement of passengers and crewmembers in the event of damage or flooding. (M-19-15)

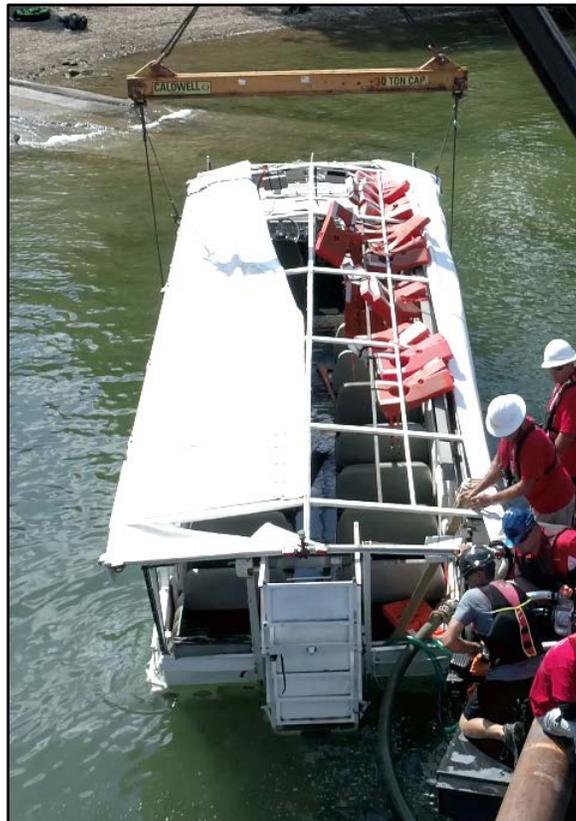
The entire passenger and crew space of the *Stretch Duck 7* had been covered by a fixed canopy. Upon recovery of the vessel, the canopy was found torn from front to back (see **figure 5**). It was peeled back over the starboard side but largely remained intact on the port side. The canopy was constructed of vinyl measuring .032 inches thick and pressed into a seam along the horizontal support at the center of the vessel. Underneath the canopy, the *Stretch Duck 7*'s personal flotation devices (PFDs, commonly called lifejackets) were stored above the seating compartment. Of the 56 lifejackets investigators counted postaccident, the majority of them—a total of 41—were still connected to the vessel's canopy framing by their straps.¹⁶ With the PFDs in their storage locations above the passengers, vertical egress was blocked during the sinking, despite the canopy being peeled back over the starboard side.

Figure 5. Torn canopy of the *Stretch Duck 7* found during recovery operations.

The canopy framing also created obstructions for clear egress from the vessel. Several surviving passengers recalled hitting various impediments and being pinned against the canopy before they could break through it to escape upward from the submerged vessel. The NTSB believes that some of the fatalities likely resulted from the presence of the canopy and its associated framing.

For DUKW amphibious passenger vessels without sufficient reserve buoyancy (commonly referred to as original and/or “stretch” DUKWs), require the removal of canopies, side curtains, and their associated framing during waterborne operations to improve emergency egress in the event of sinking. (M-19-16)
