# National Transportation Safety Board

## Pipeline Accident Brief

Accident No.:	DCA-06-MP-001
Type of System:	Natural gas distribution
Accident Type:	Pipeline break, explosion, and fire
Location:	Bergenfield, New Jersey
Date:	December 13, 2005
Time:	9:26 a.m. eastern standard time <sup>1</sup>
Owner/Operator:	Public Service Electric and Gas Company
Fatalities:	3
Injuries:	5
Property Damage and Losses:	\$863,300
Material Released:	Natural gas
Pipeline Pressure:	11 1/2 pounds per square inch, gauge
Component Affected:	1 1/4-inch steel service line

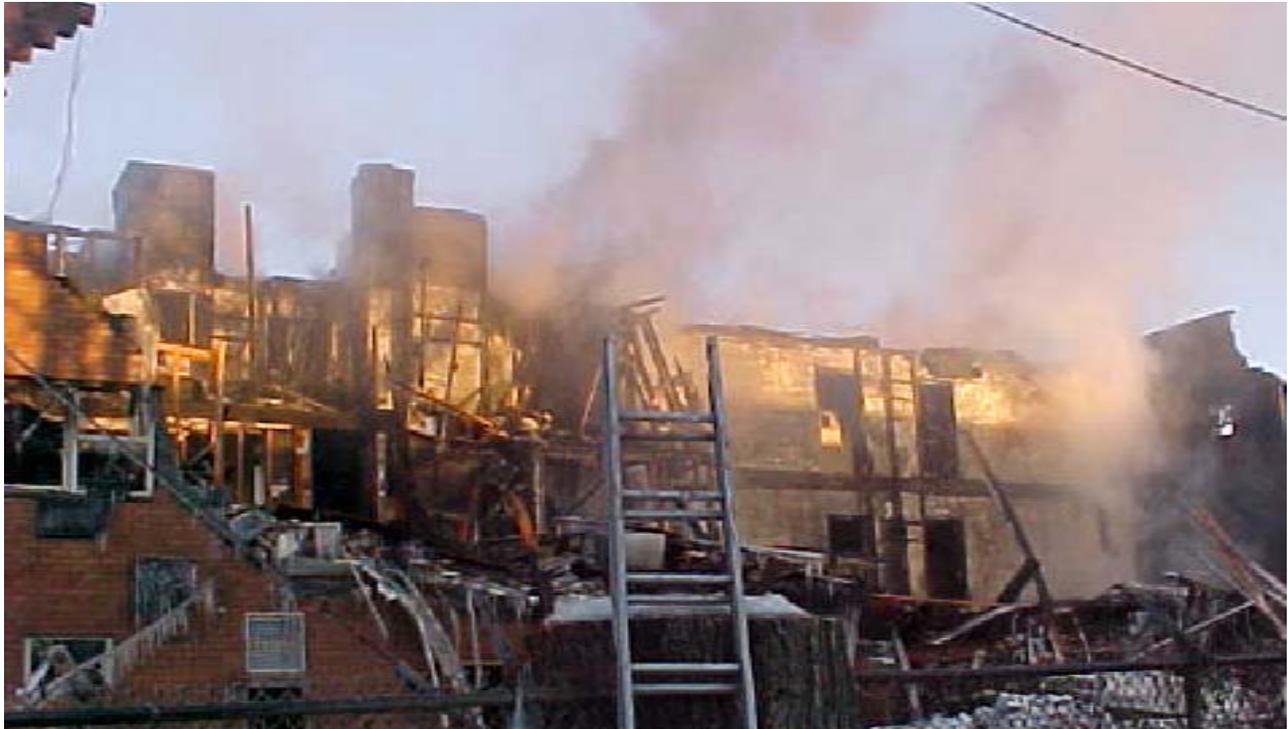
On December 13, 2005, at 9:26 a.m., an apartment building exploded in Bergenfield, New Jersey, after natural gas migrated into the building from a damaged pipeline. Investigators found a break in an underground 1 1/4-inch steel natural gas distribution service line that was operating at 11 1/2 pounds per square inch, gauge. The break occurred at an underground threaded tee connection downstream from where excavators were removing an oil tank that was buried under the asphalt parking lot adjacent to the building. The break occurred, under the parking lot, about 7 feet 4 inches from the building's wall. Three residents of the apartment building were killed. Four residents and a tank removal worker were injured and transported to hospitals. The property damage consisted of the apartment building, which was a complete loss. (See figure 1.) According to Bergen County tax records, the assessed value of the apartment building was \$863,300.

**Figure 1.** Damage caused by explosion.

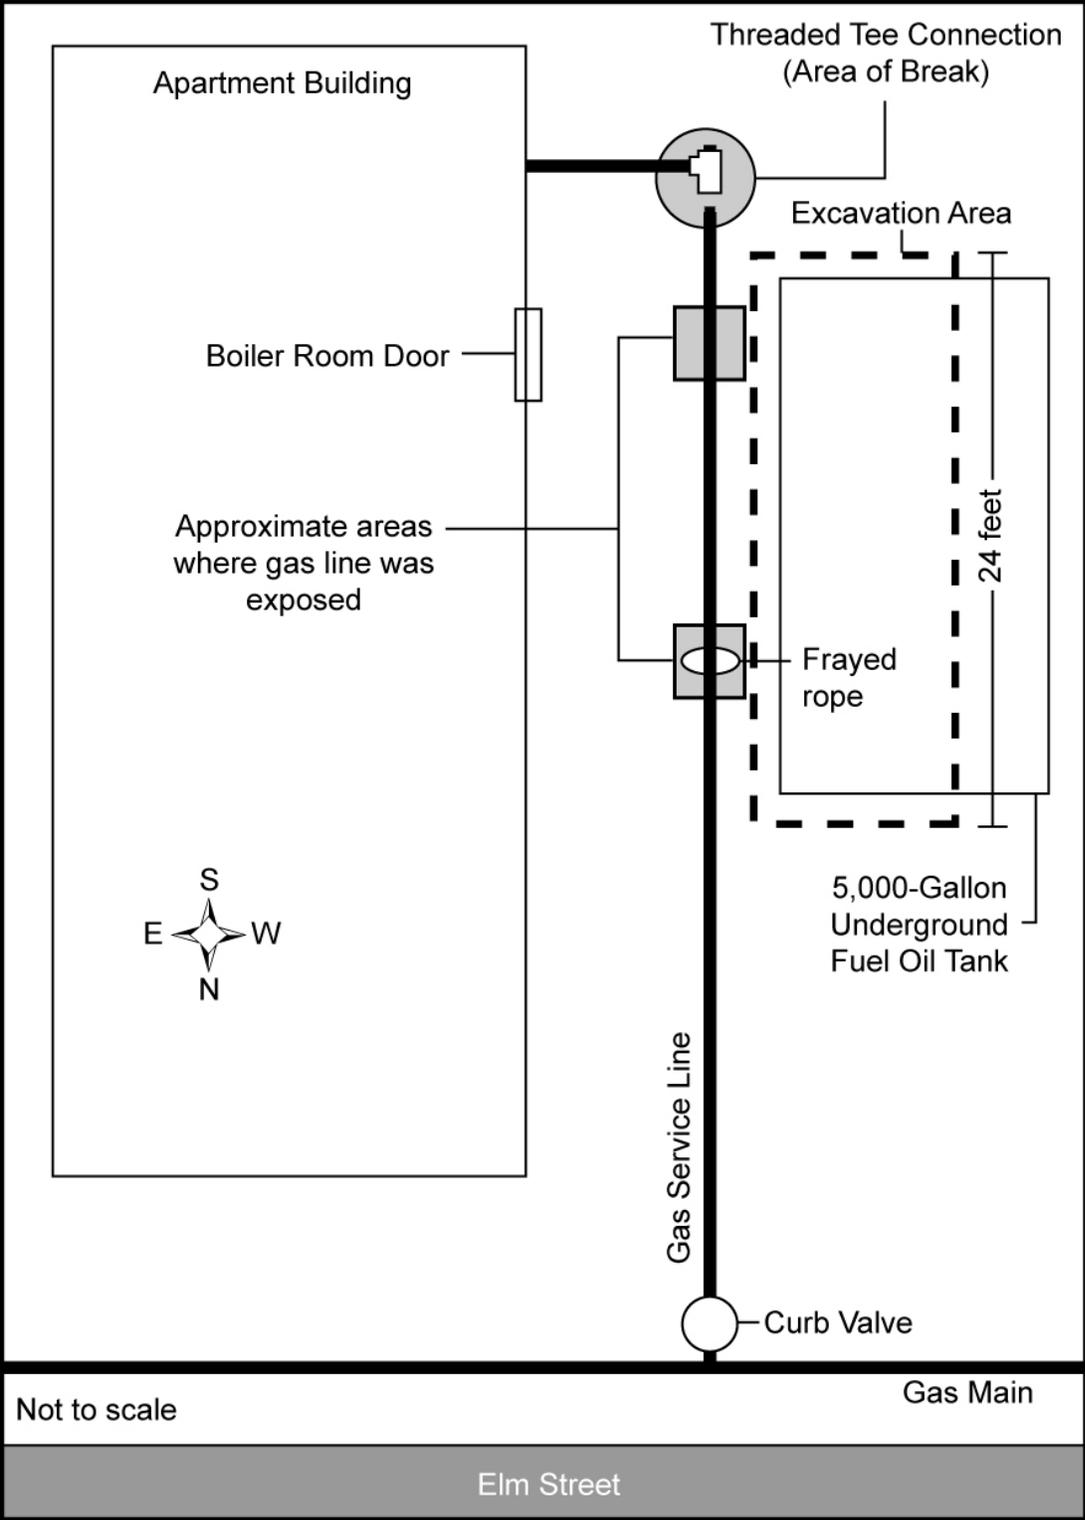
Gas Company (PSE&G)<sup>4</sup> street inspector went to the site and marked the location of the buried gas service line to the building. The marked location showed that the service line ran under the parking lot and about parallel to the building's wall. At a point downstream of the excavation area, the pipeline turned 90° toward the building. (See figure 2.)

**Figure 2.** Diagram of accident site.

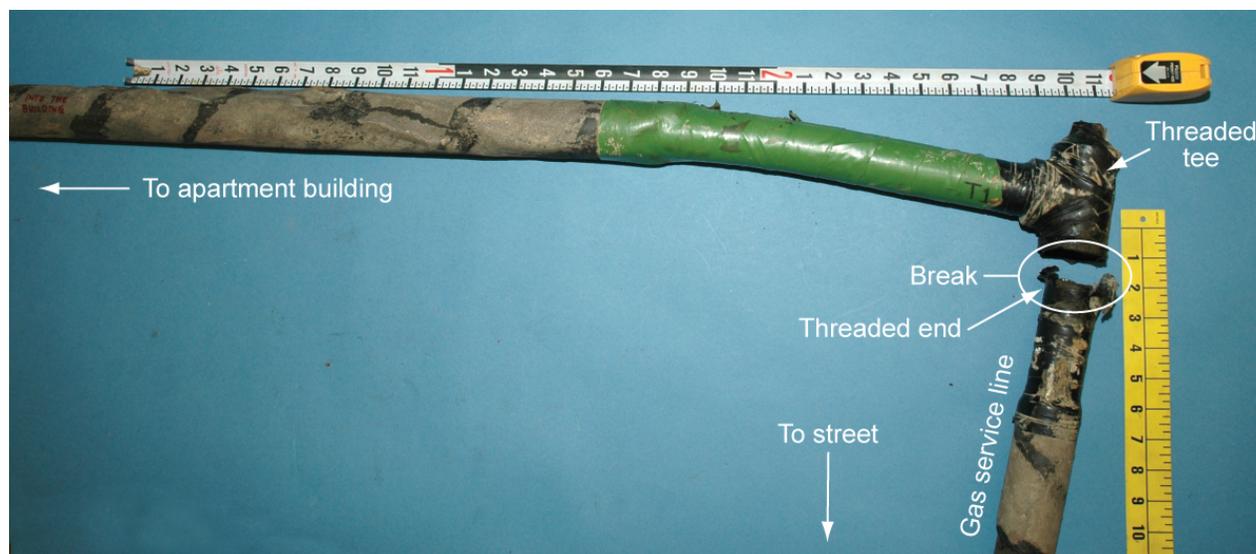
During pressure tests on the steel service line, the only leak was found at the iron threaded tee connection that was about 7 feet 4 1/2 inches from the building wall. The tee had separated from the service line and had a gap of about 3 inches. (See figure 3.) The tee and the separated end of the service line were removed and sent to the Safety Board’s Materials Laboratory for analysis.

**Figure 3.** Separation of steel service line.

The threaded end of the service line fractured at the connection. The exposed threads on either side of the mating surfaces showed no evidence of corrosion degradation or fatigue cracking. Microscopic examination of the fracture revealed features consistent with an overstress separation. The evidence is consistent with the pipeline separating in overstress after the ground collapsed into the trench and caused the pipeline to move.
