National Transportation Safety Board

Washington, D.C. 20594

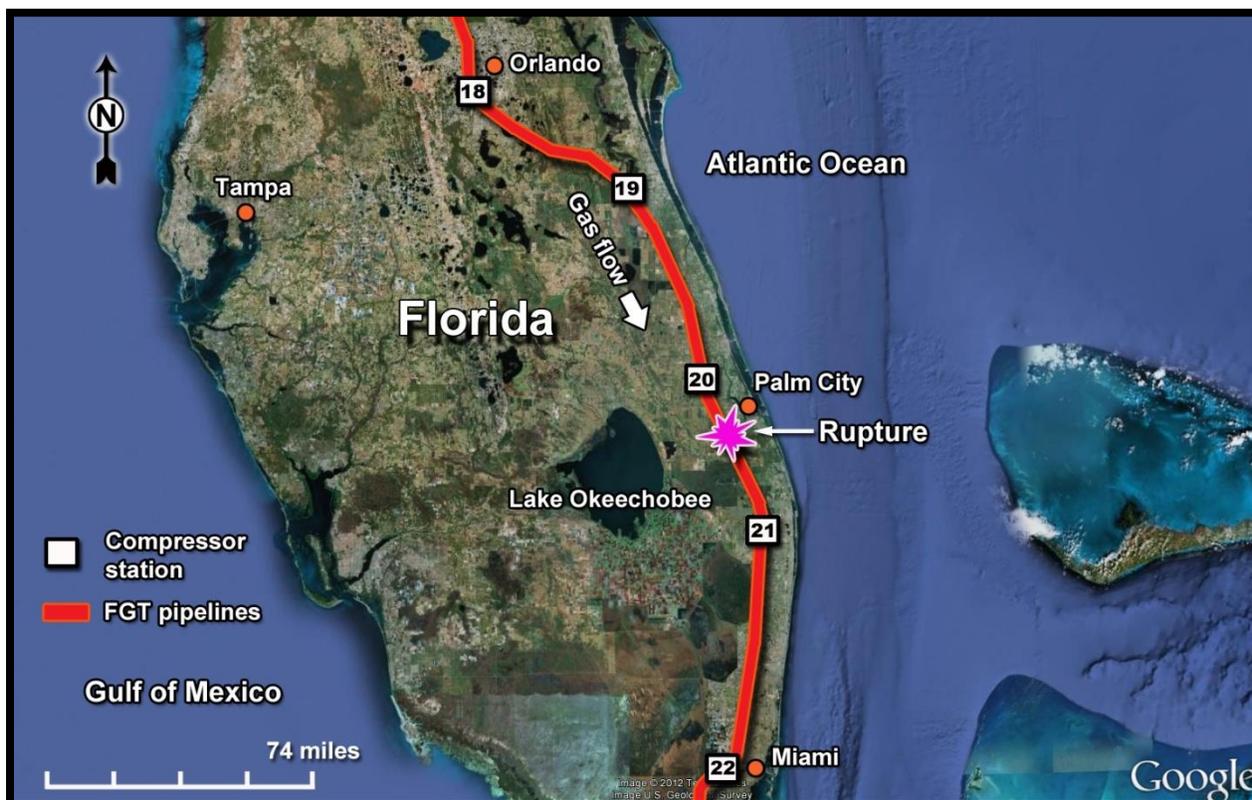
Figure 1. Route of Florida Gas Transmission's three natural gas pipelines along Florida peninsula.

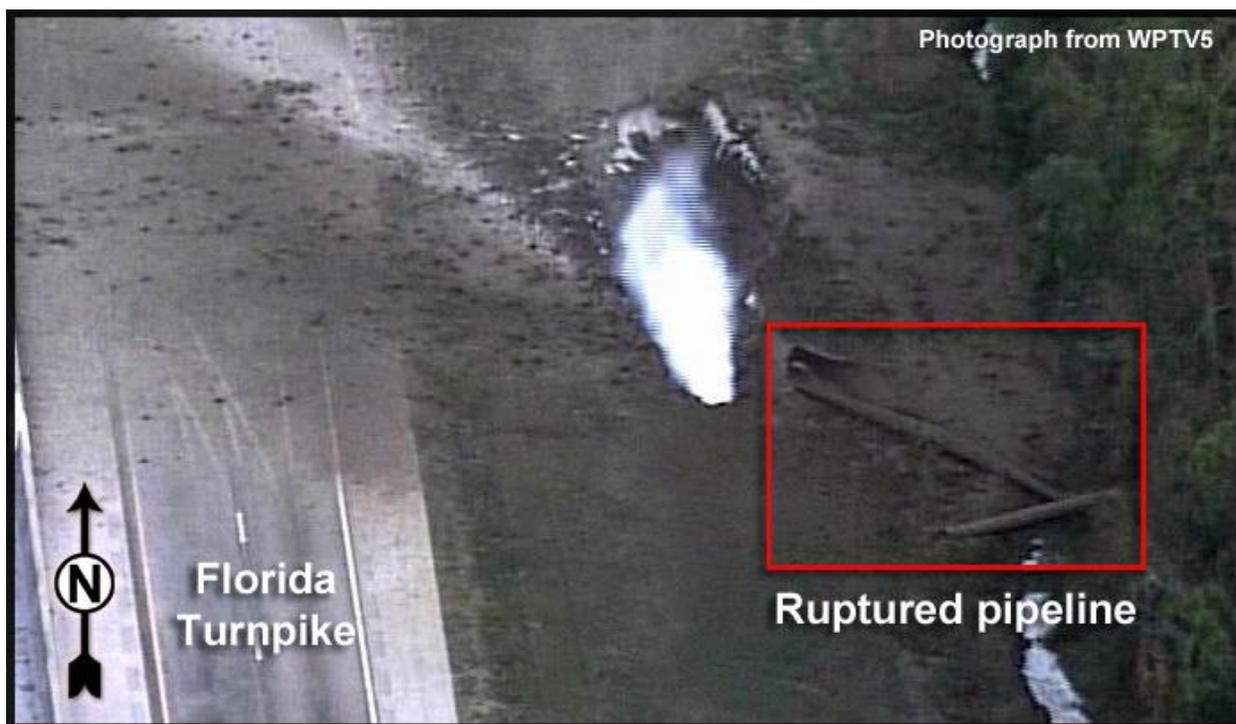
Figure 2. Aerial photograph of ruptured 18-inch pipeline showing venting gas and dislodged pipe near crater.

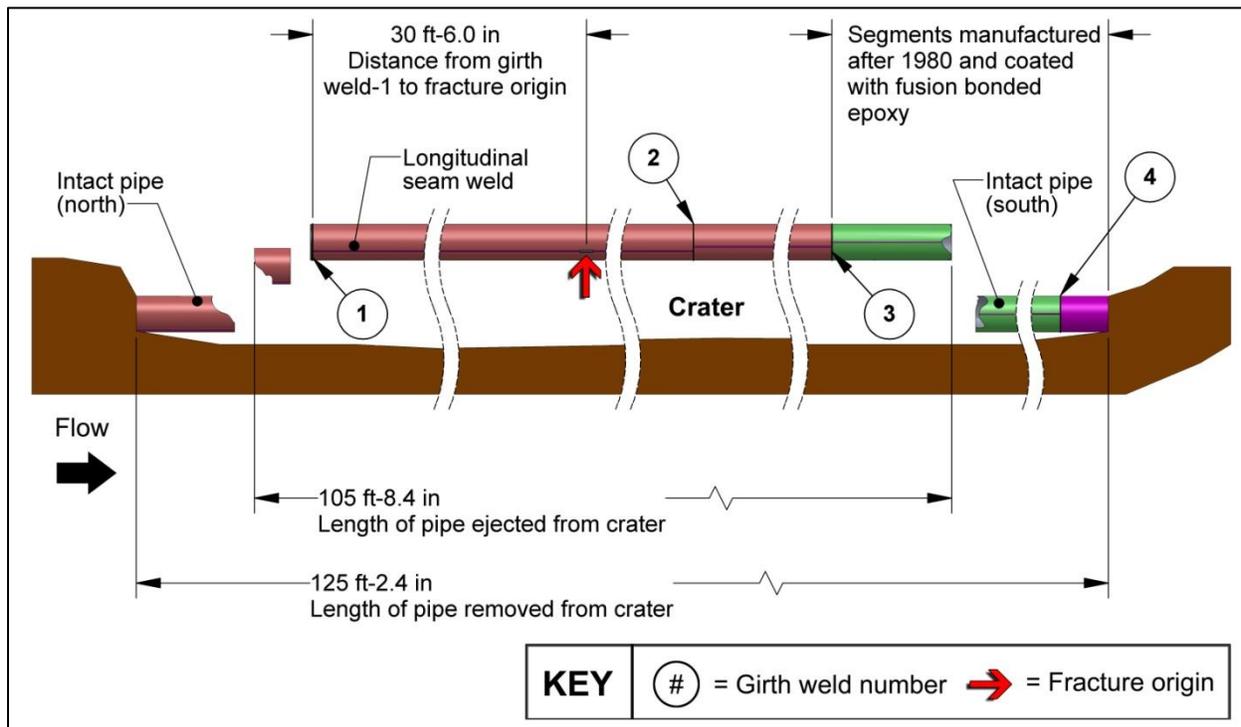
Figure 3. Side view of crater and four pipe segments of ruptured section.

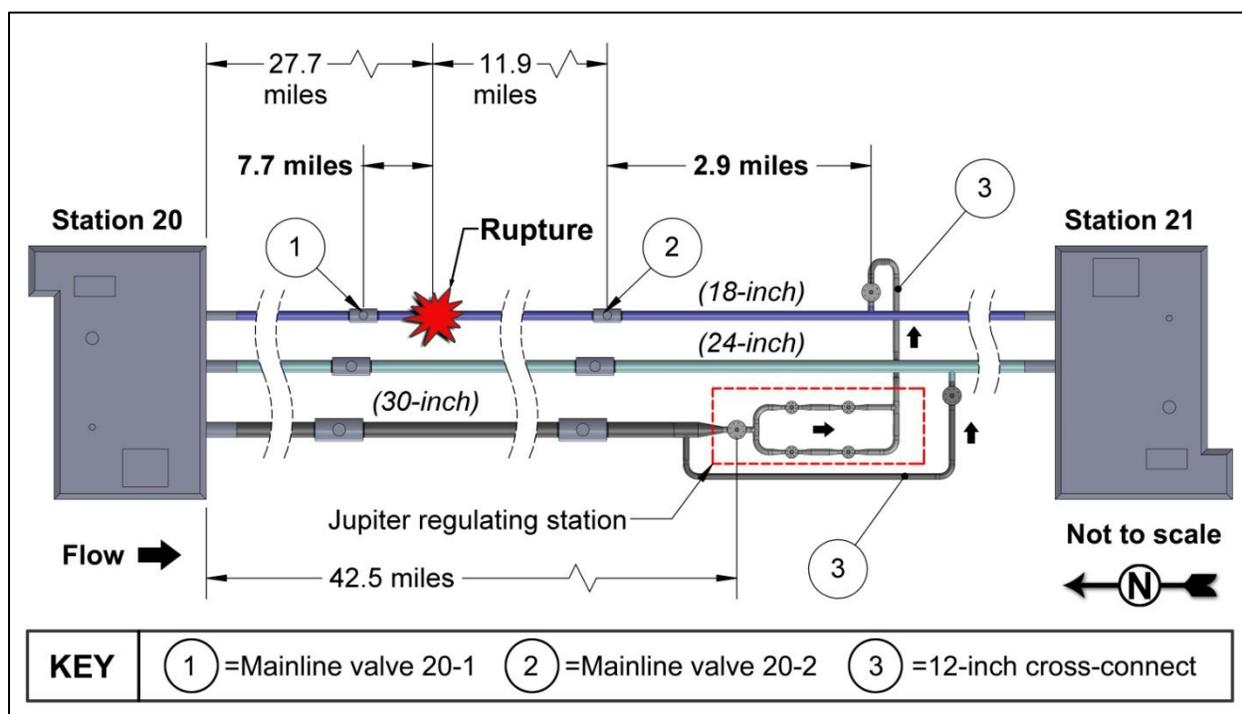
Figure 4. Simplified schematic of 18-inch, 24-inch, and 30-inch interconnected transmission lines between compressor stations 20 and 21.

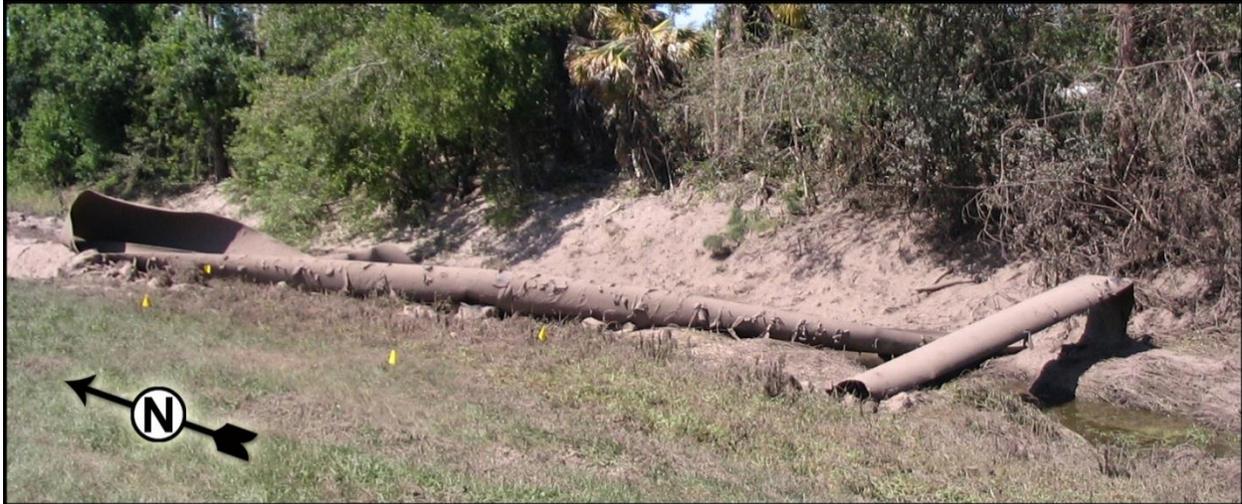
Figure 5. One hundred four-foot-long section of 18-inch buried pipe that was dislodged from the ground.

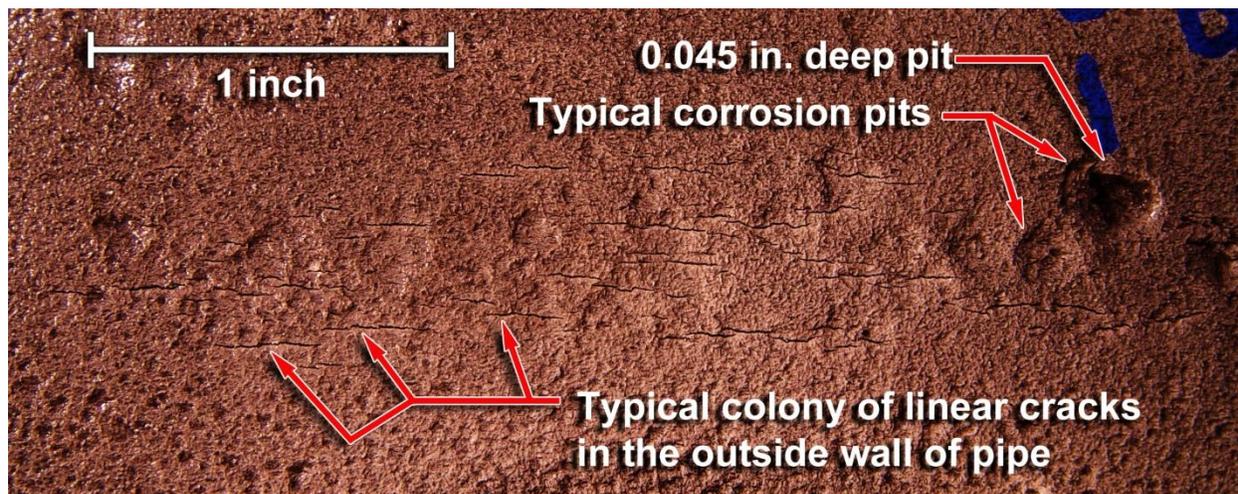
Figure 6. Longitudinal cracks and corrosion pits observed below longitudinal weld seam and upstream of rupture origin.

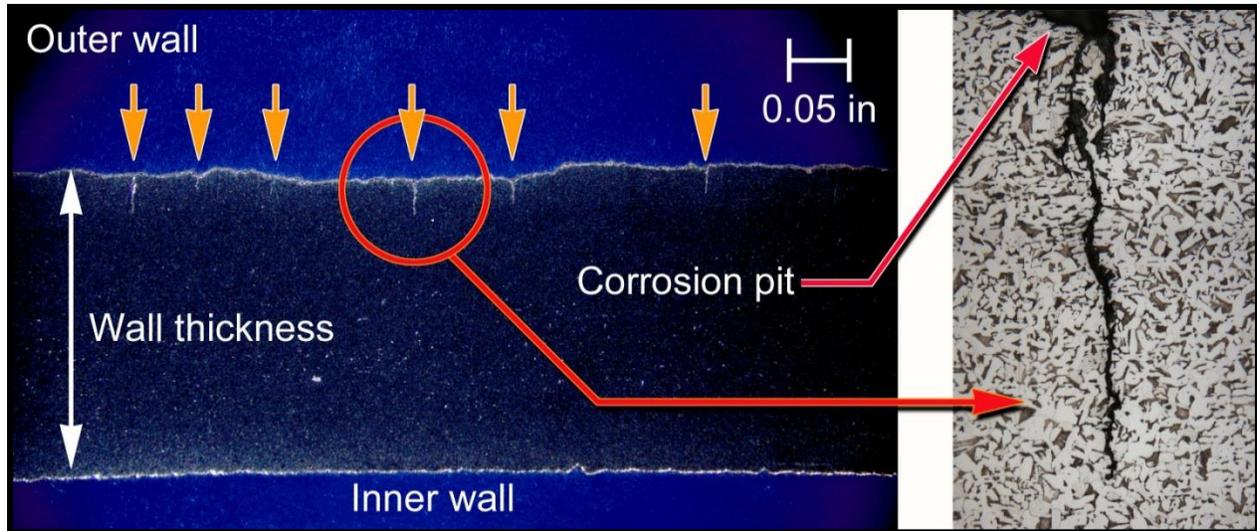
Figure 7. (Left) Cross section of colony of six longitudinal cracks (shown in figure 6) identified by arrows. (Right) magnified view of single crack (about 0.03 inches deep) advancing from corrosion pit.

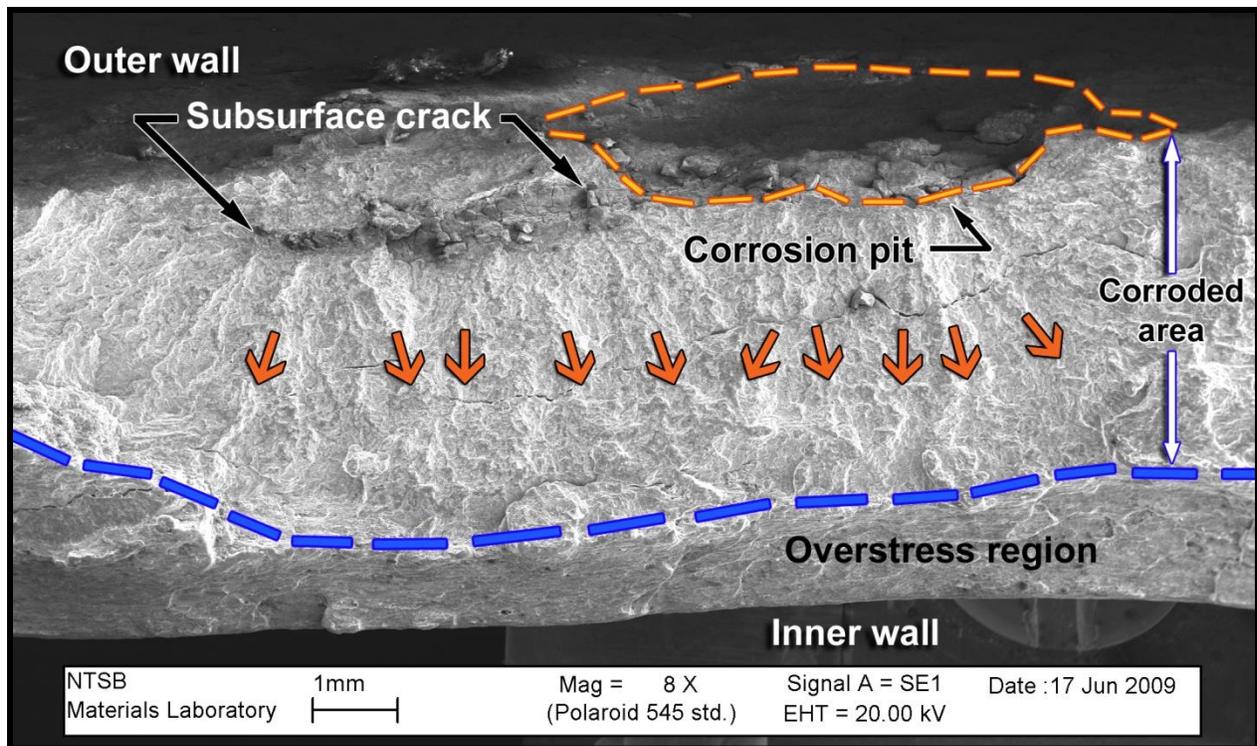
Figure 8. Scanning electron microscope photograph of a portion of the fracture origin showing corrosion pit at outer wall and subsurface crack.

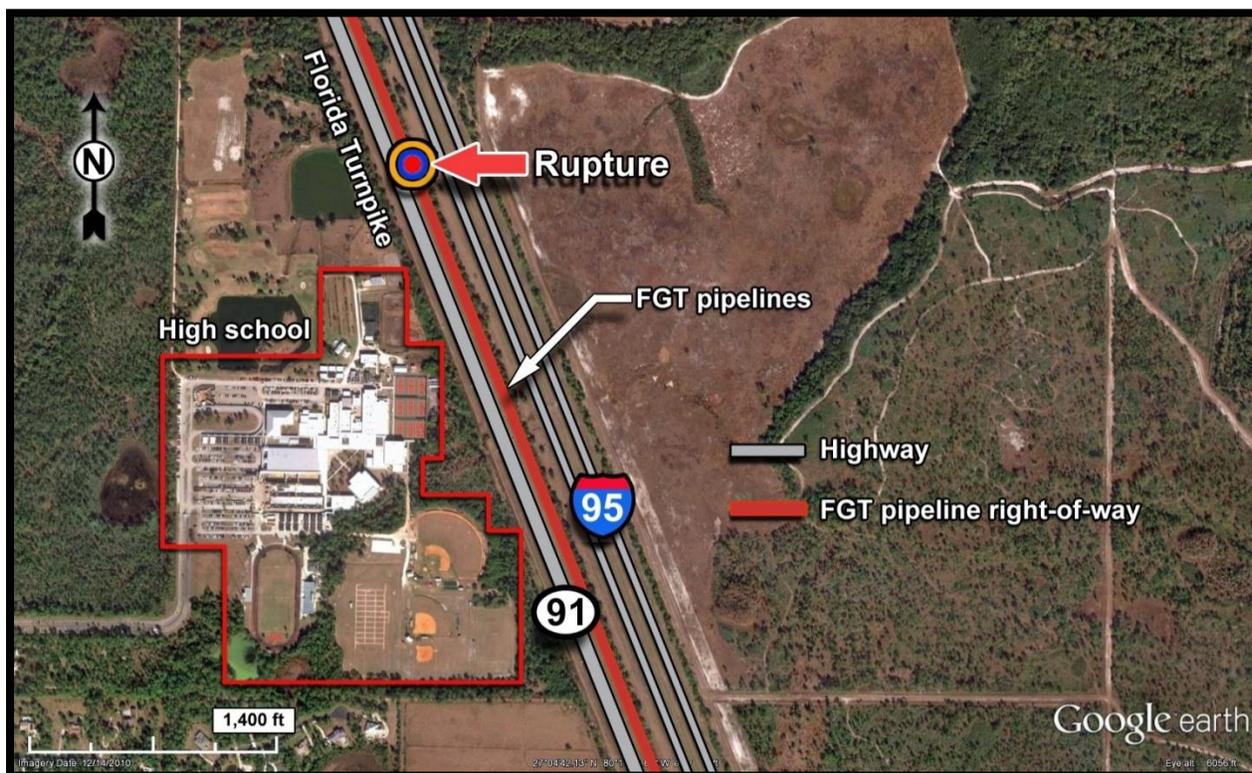
Figure 9. Rupture location shown relative to nearby high school that was determined to fall within 366-foot potential impact radius.
